Whiteabbey Presbyterian Church 602 Shore Road Newtownabbey

Detailed Condition Report (Church)

August 2022

McCOLLUM CONSERVATION

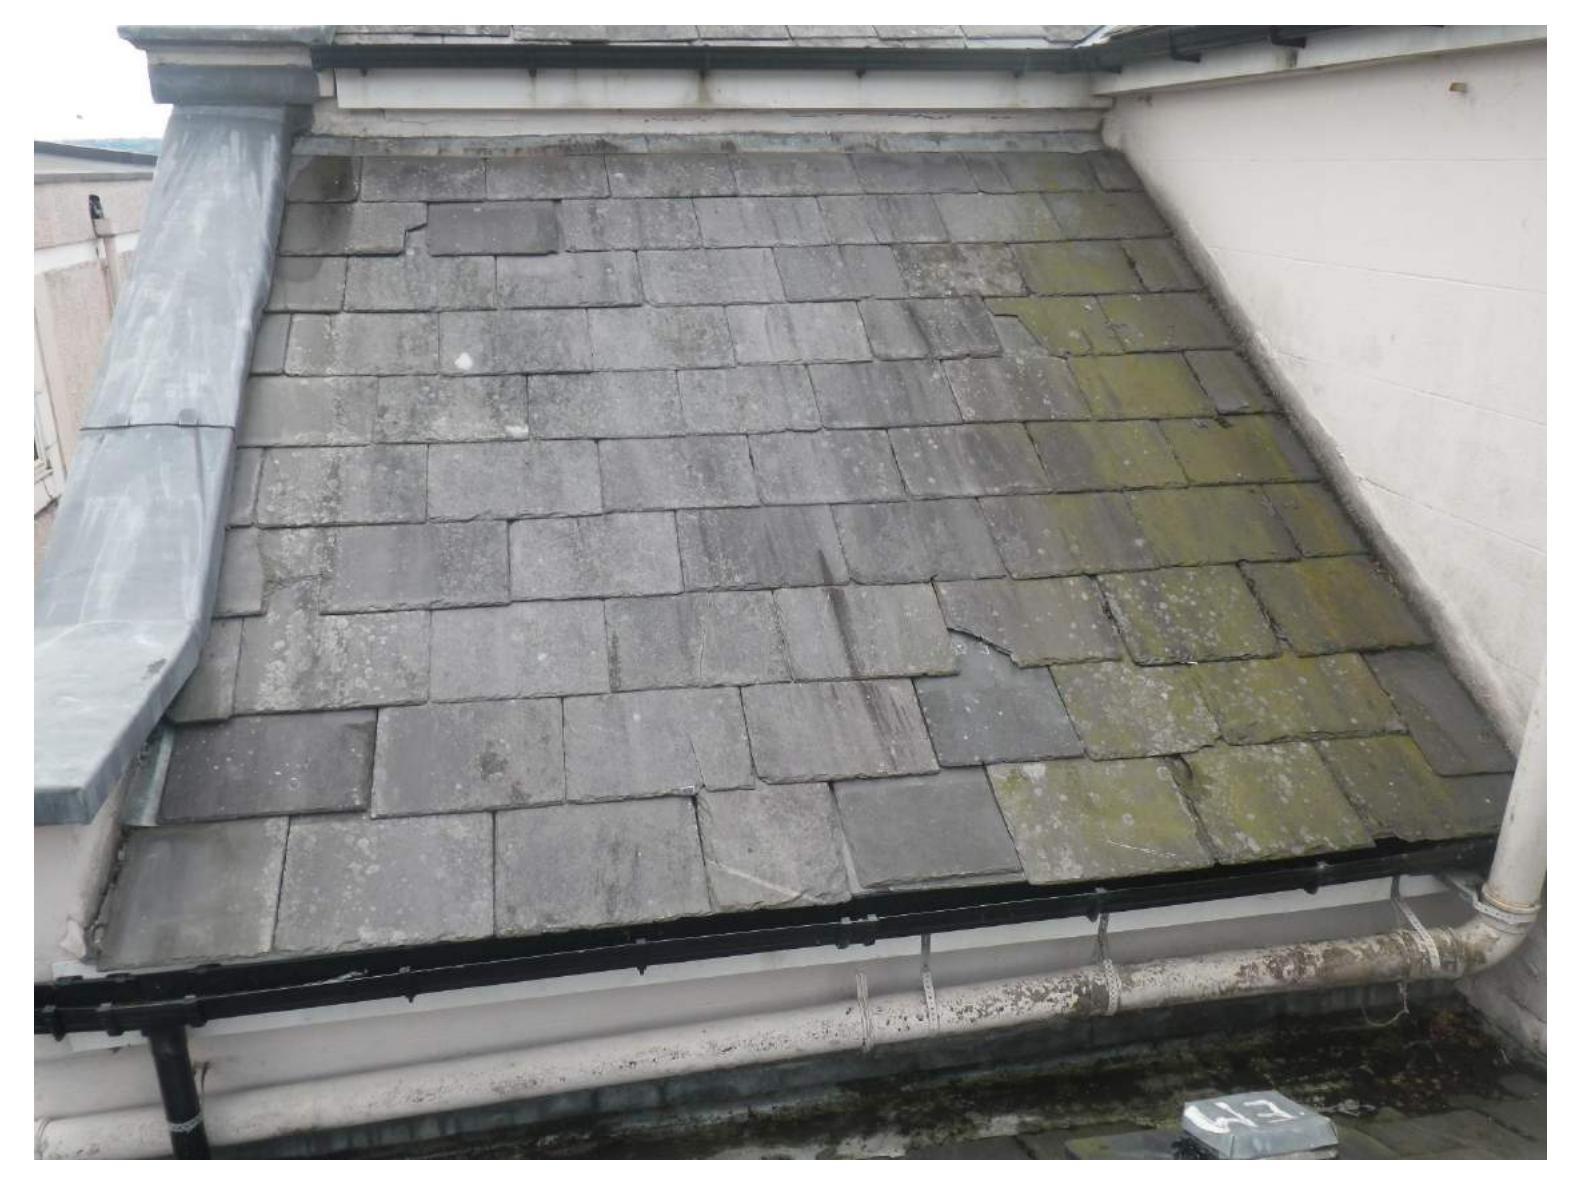
- RS13 Mono pitched roof overlaid with even coursed, even sized, older large Welsh slate. Slating in poorer condition, with four slates slipped, five broken and two cracked. This roof is at the end of its life and should be re-slated into the short term.

Roof RS13 – Cracked and Poorly Slated Areas

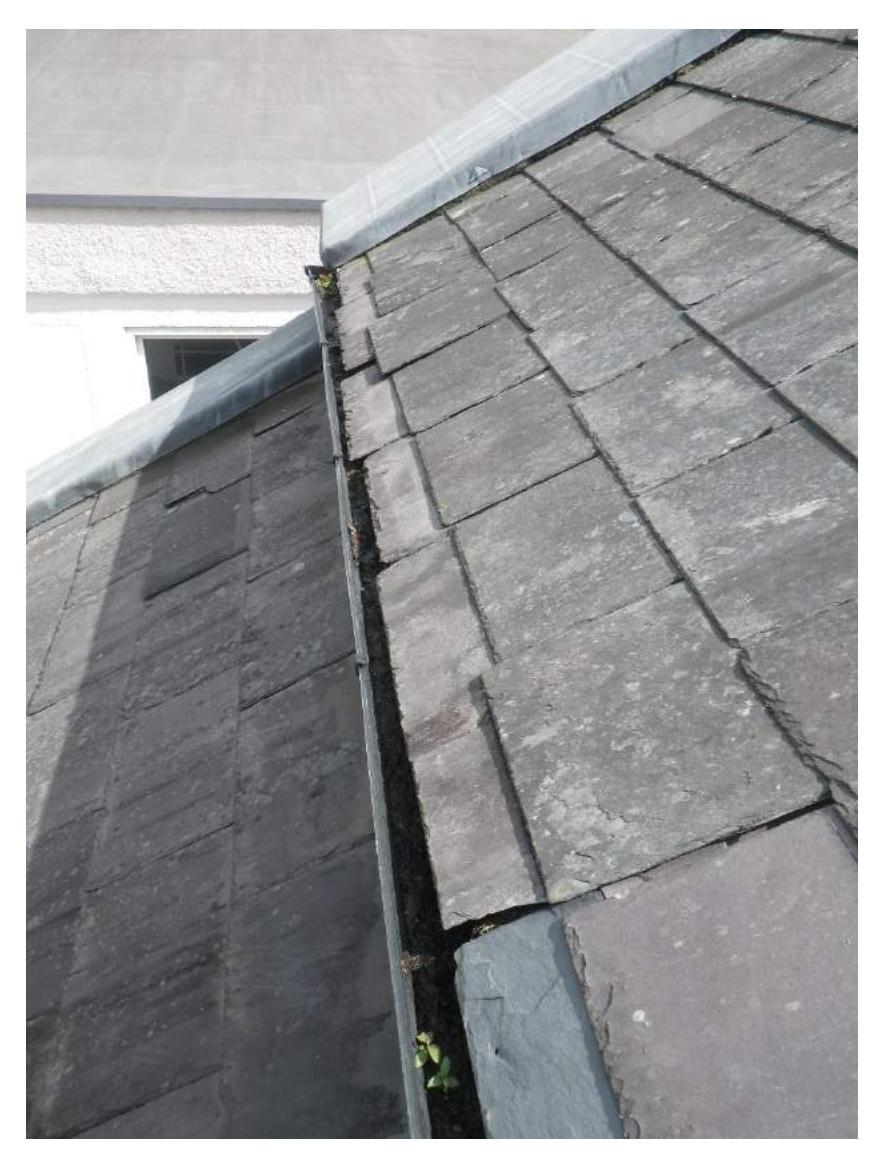
- RS08 Pitched roof overlaid with even coursed, even sized Welsh grey slate. Colour variation between original slate and repairs. Three slates slipped, two slates cracked. Slating in reasonable condition.

Roof RS08 – Poor Slating Practice at Eaves

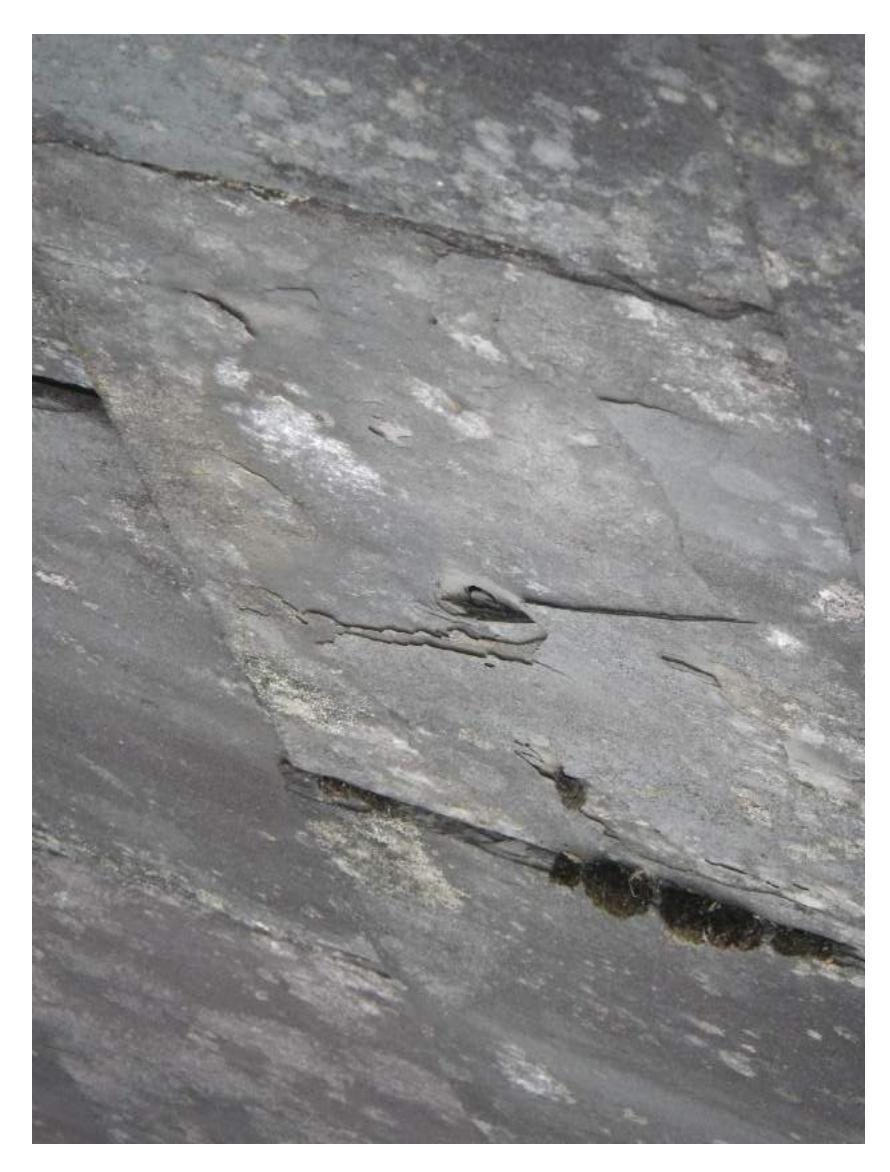
- RS02 Large pitched roof overlaid with even coursed, even sized Welsh slate. Slating in the last third of its useful life, but remains serviceable with maintenance. There are six slates clipped, six cracked, seven clipped and two broken. Slates damaged around rooflight. Where repaired, there is some poor slating practice (slates set in sideways and use of artificial slates) especially above apex RS08/RS09 and into the tapered gutter at the Tower abutment. Wind driven rain is able to penetrate the repairs at the roof apex. Slight Belly across roof where roof purlins are over spanned.

Roof RS02 – Failing Fixings to Slate

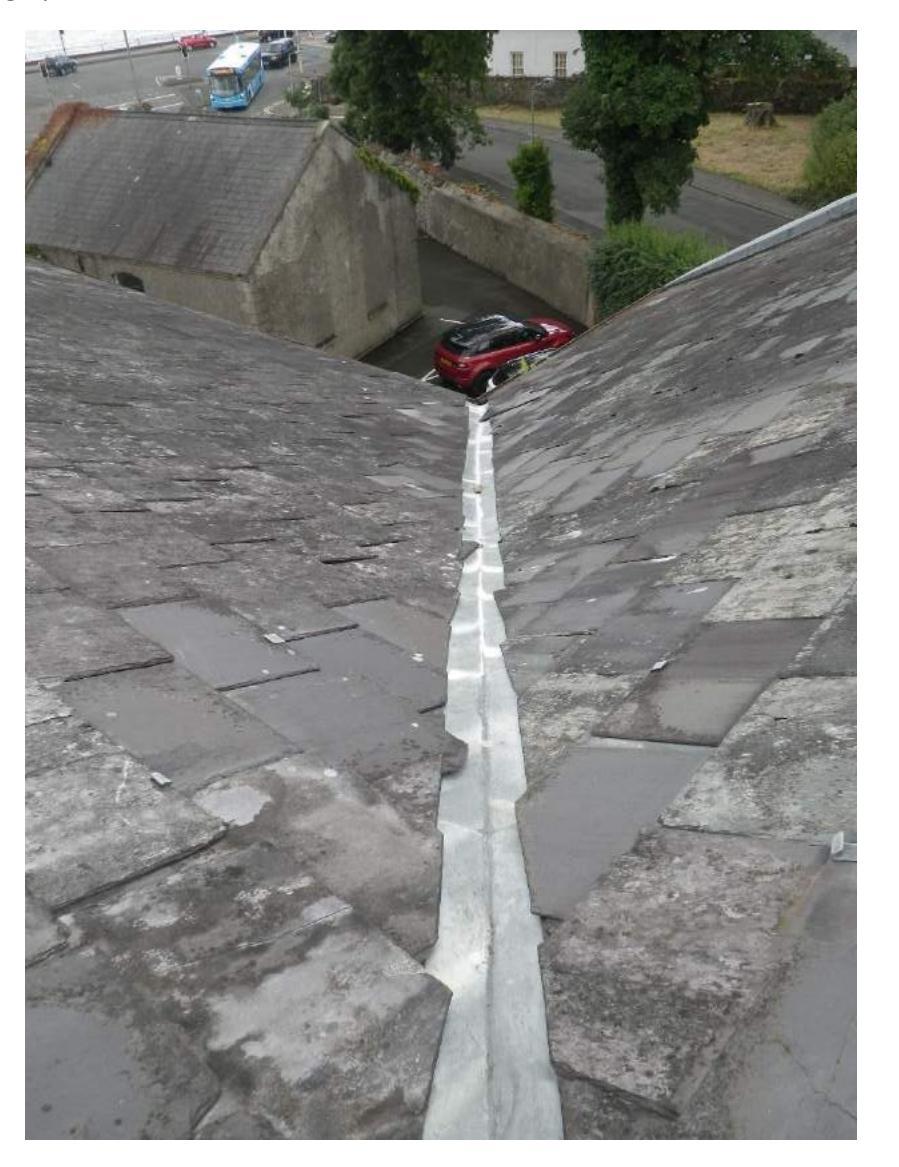
Roof RS01/RS03 – Failing Slates around Valley with Evidence of Patching and Clipping

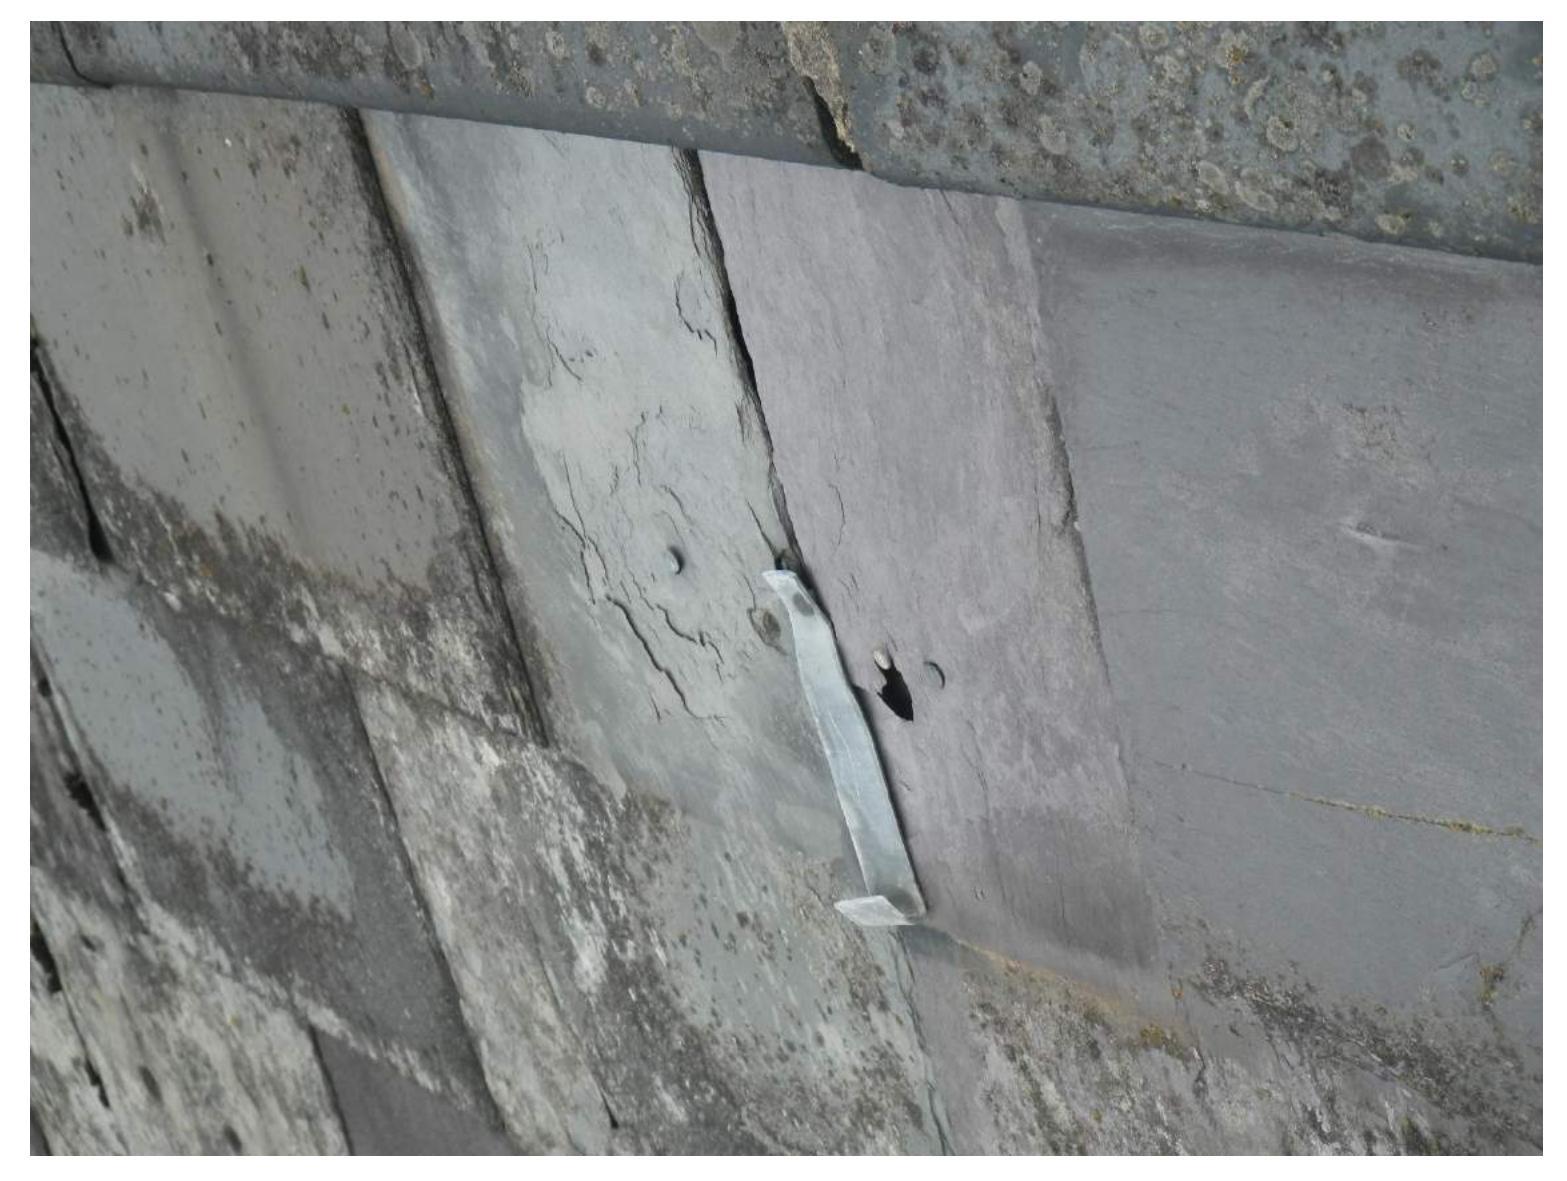
- RS01 Large pitched roof overlaid with even coursed, even sized Welsh slate. Slating is reaching the end of its life, but for now remains serviceable with maintenance. There are three slates slipped, two cracked and two clipped. A slight break in the twill of the slates indicates some nail failure. There is a slight Belly across the roof where roof purlins are over spanned.

Roof RS01 – Missing Slates Previously Clipped

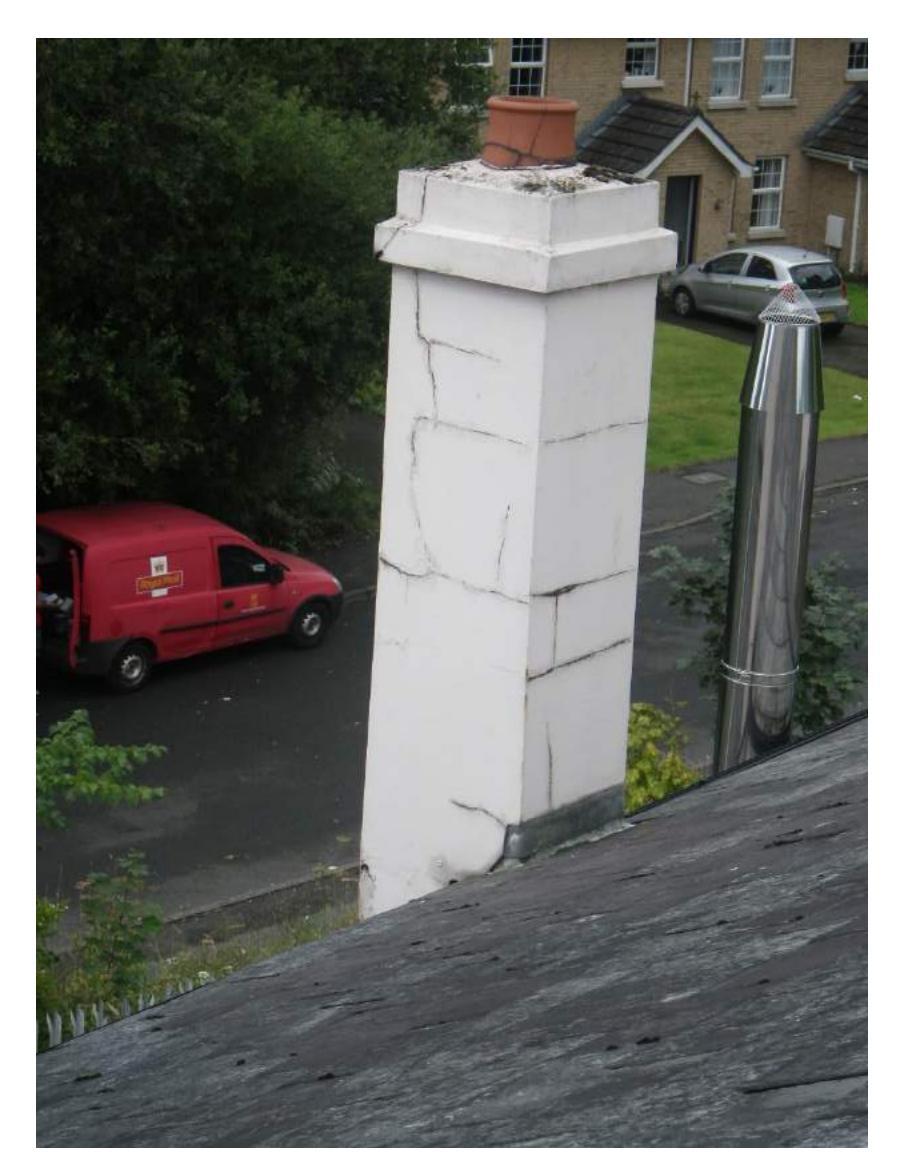
Cracking to Rear Chimney

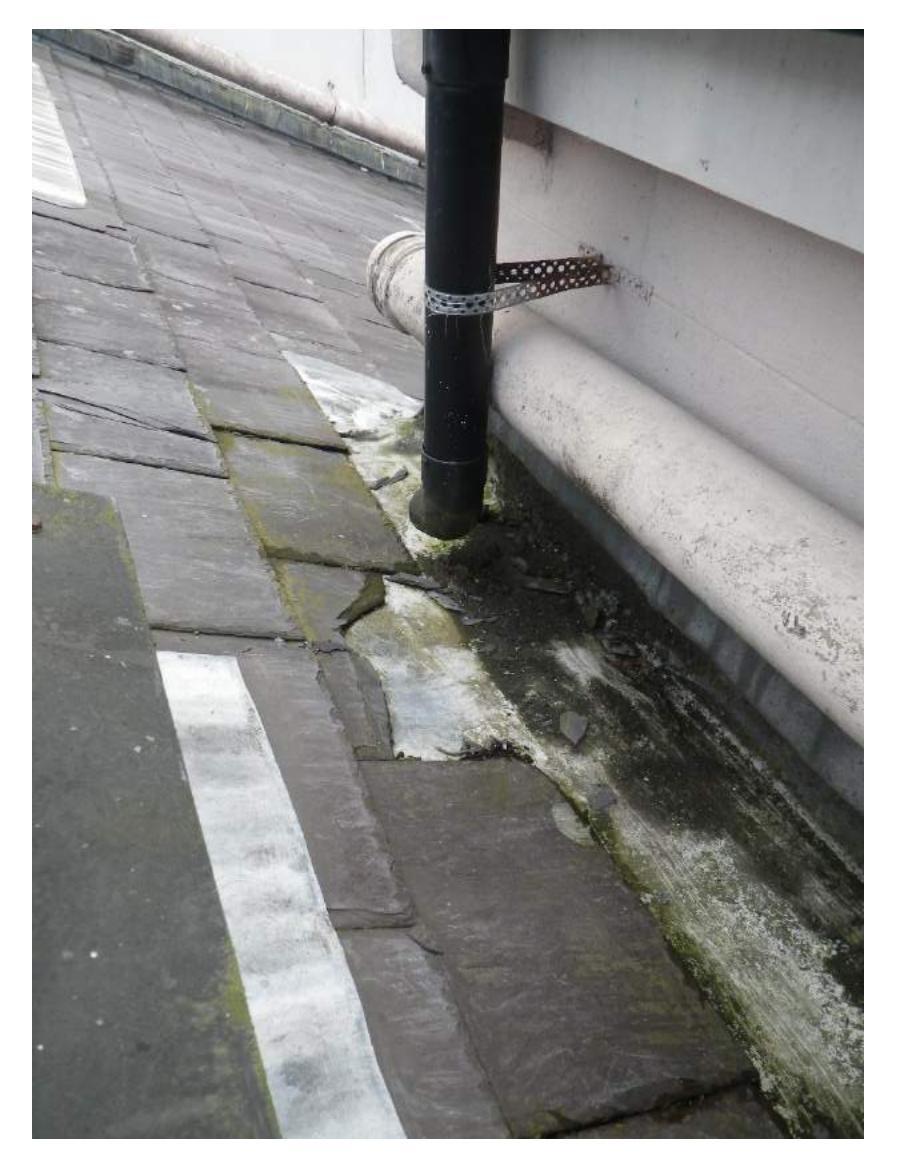
- RS14 Pitched roof overlaid with even coursed, even sized, smaller gauge, Welsh slate. Slating in poor condition with heavy and unsightly repairs around its roof light and with upwards of fifteen broken and cracked slates across its slope. Colour clouding to repairs reflects poor slating practice. One slate broken where the downpipe from the roof above discharges, allowing rainwater to penetrate.

Roof RS14 – Missing Slate at Critical Gutter Detail

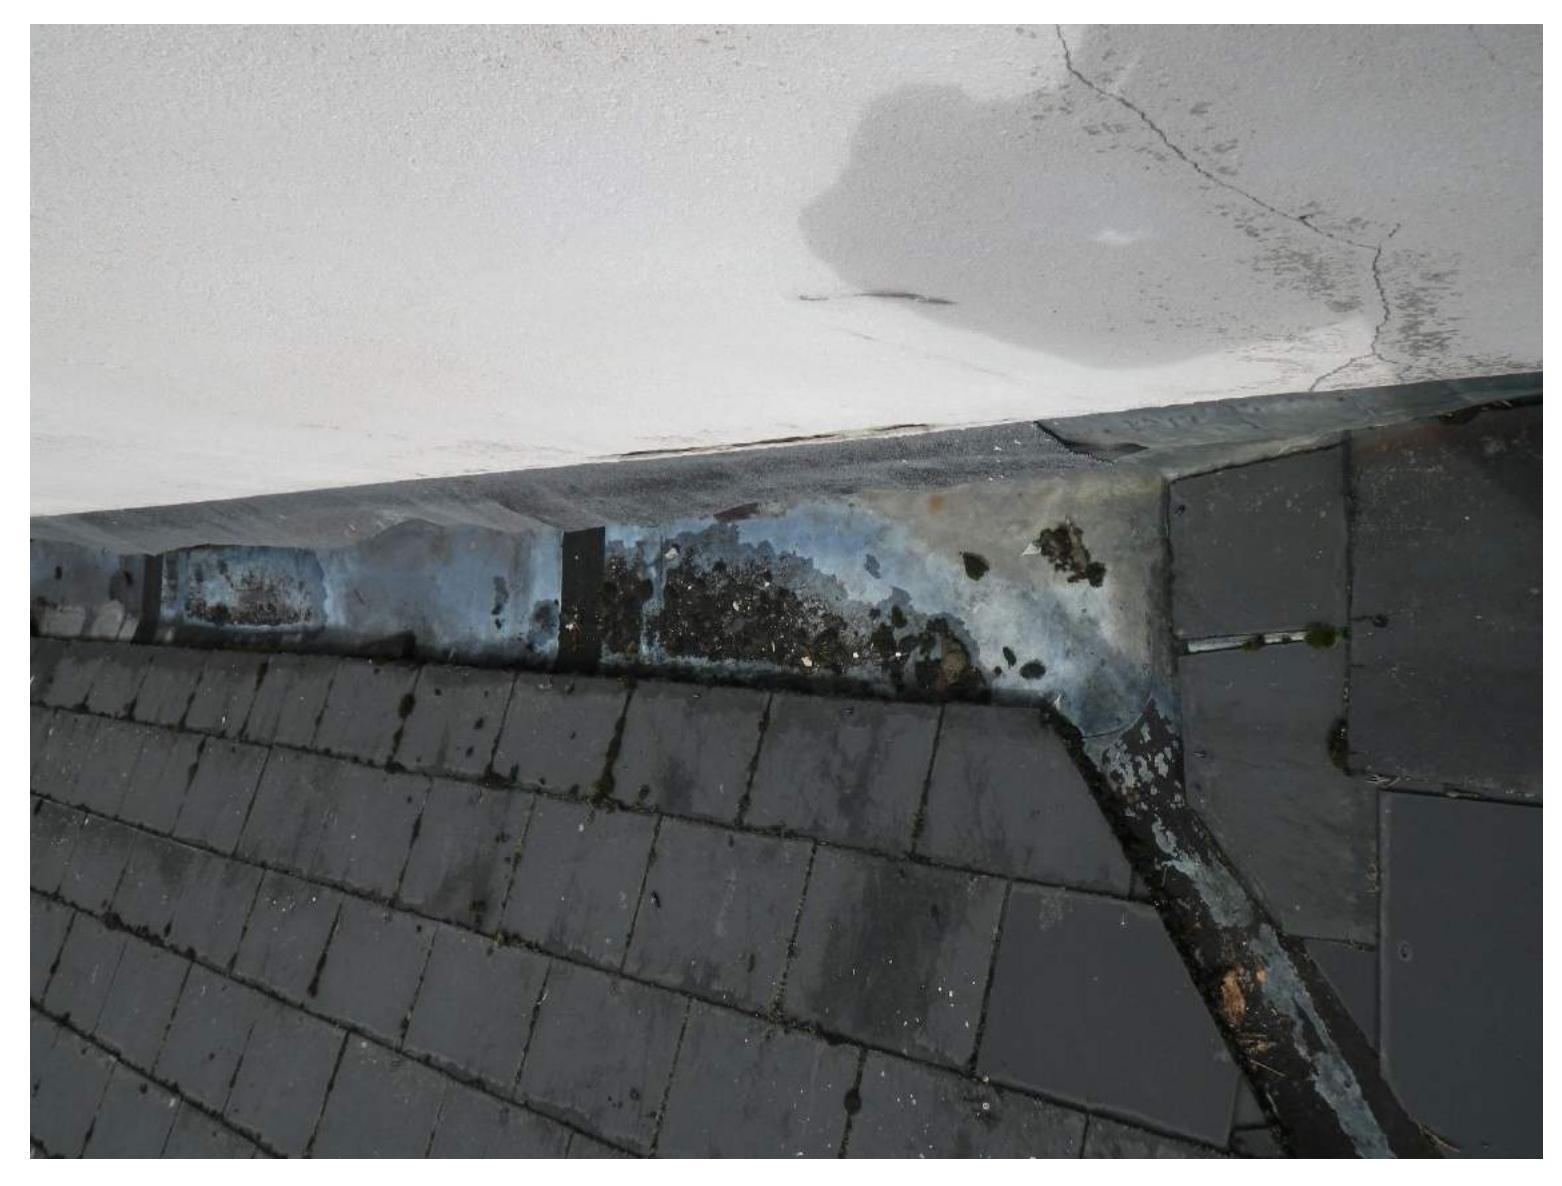
- RS18 Tapered gutter is lead lined and in a single bay. The lead is over spanned and as a result there are Bitumen strap repairs where the lead has cracked in two locations.

Roof RS18 – Temporary Patches to Lead Tapered Gutter

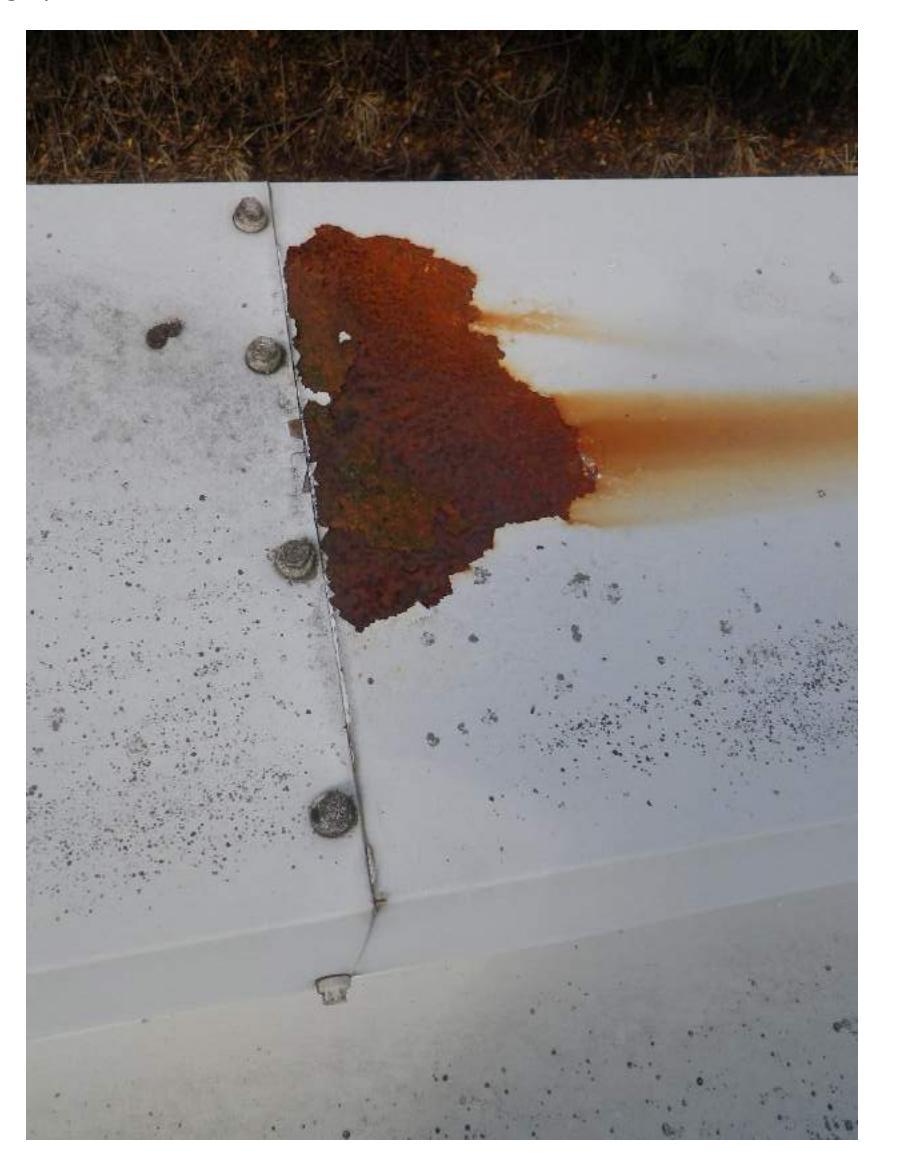
Roof RS19 – Corrosion to Parapet Capping

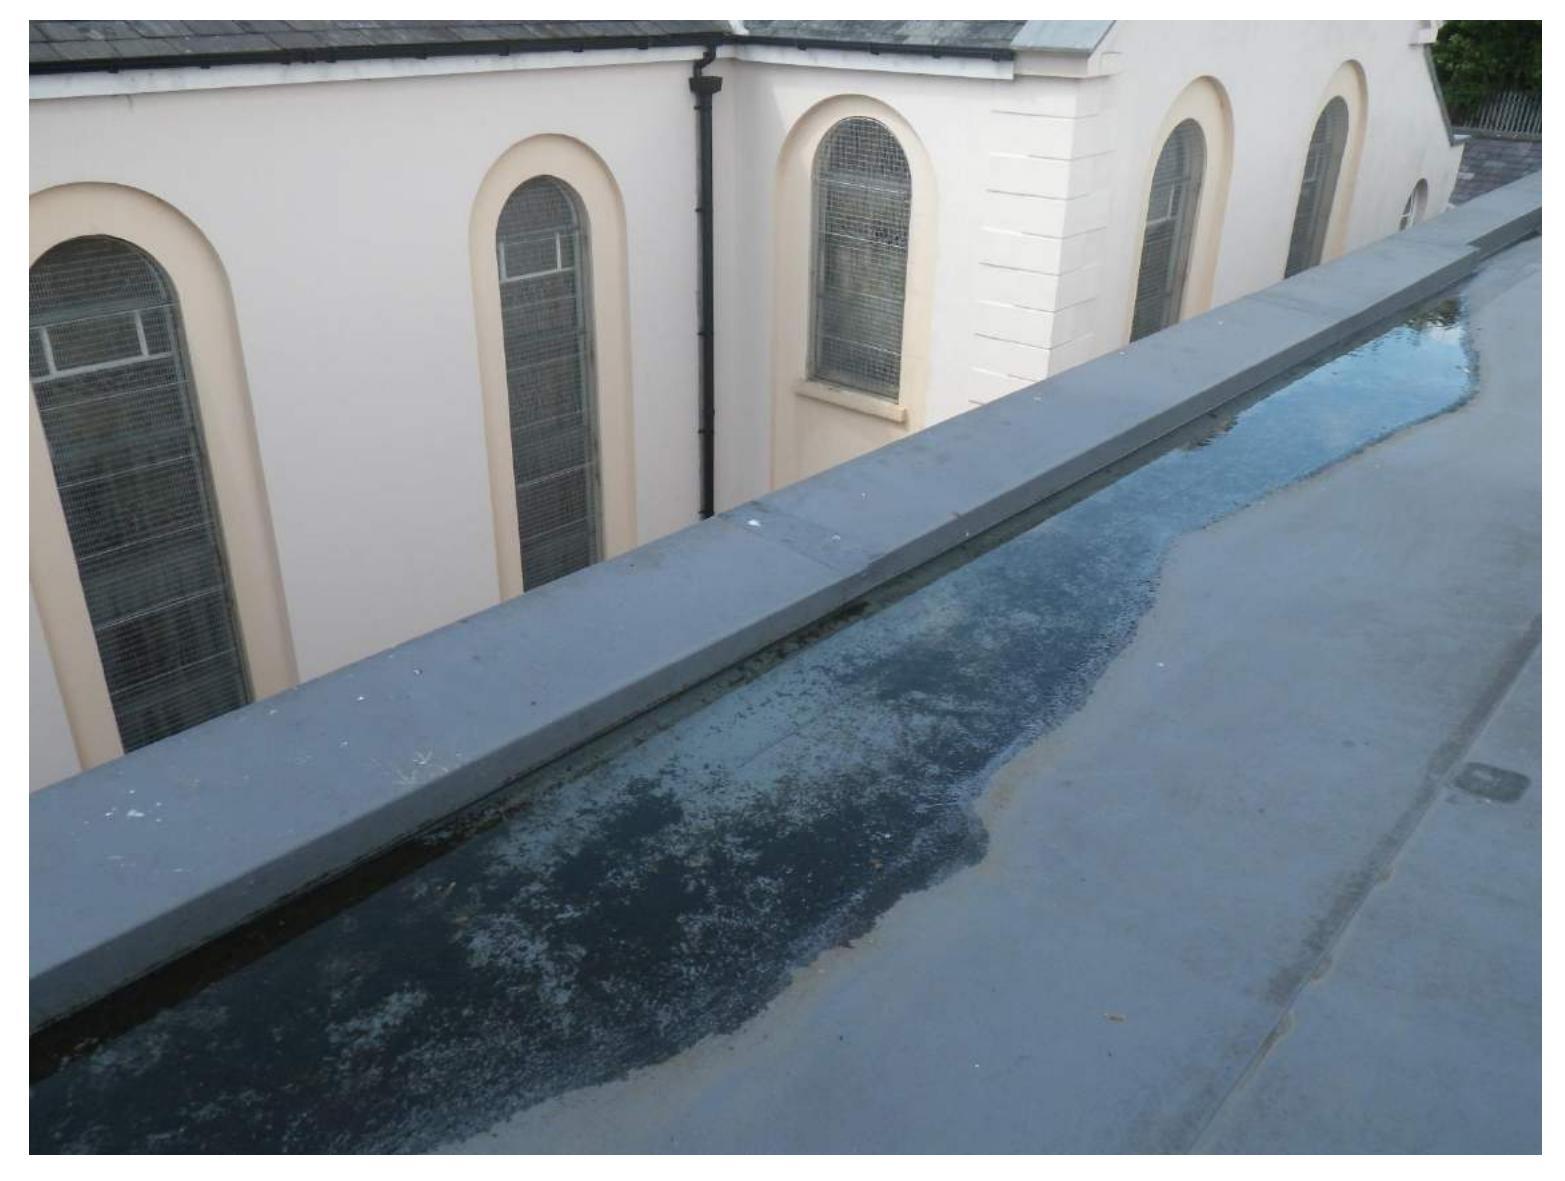
- RS19 uPVC oversized pipe and hopper in good condition but with vegetation growing. Butyl lined parapet gutter in reasonable condition, but with poor falls allowing rainwater to pond above outlet.

Roof RS19 – Water Ponding

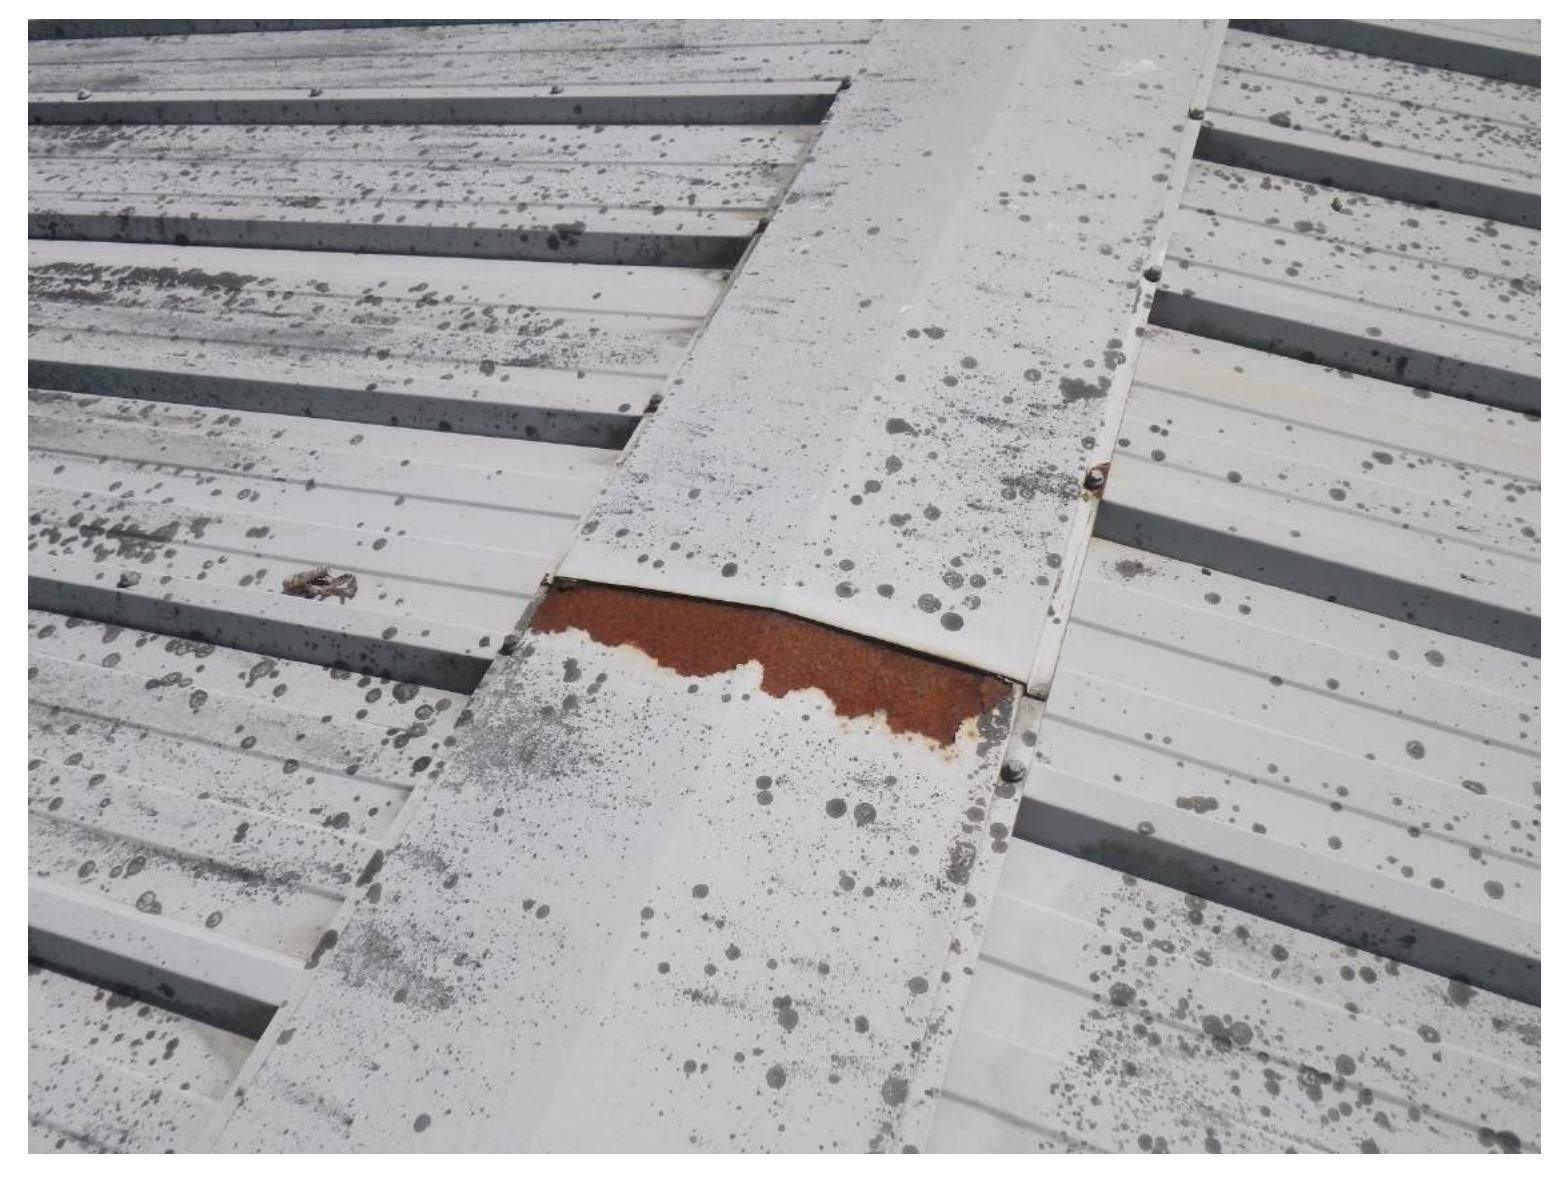
• RS21/RS22 – Metal profiled ridge generally sound, but with one joint corroded. This failure should be arrested by cleaning and sealing.

Roof RS21/RS22 – Corrosion to Ridge

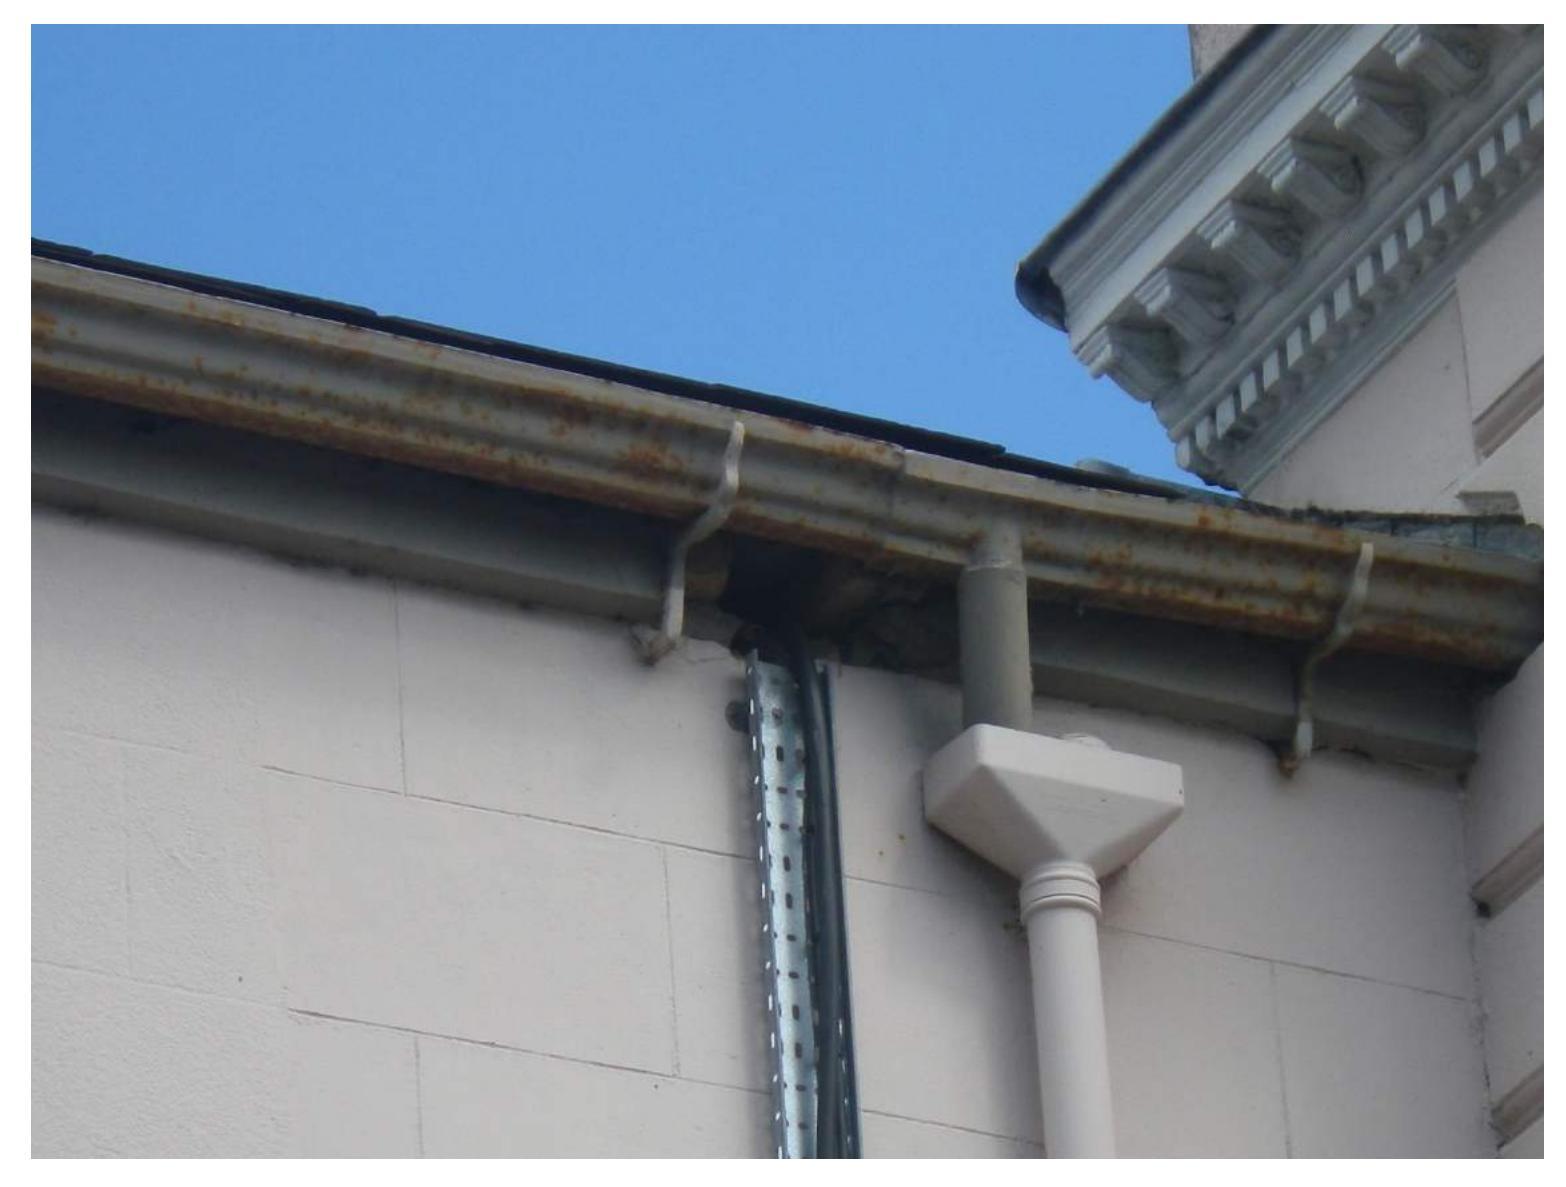
- RS01 Eaves gutters are moulded cast iron gutter with uPVC downpipe. Gutters falling into poor condition with evidence of metal corrosion to the underside generally and leaking joints and a Belly towards the outlet. This gutter should be repaired and re-set for now and then renewed as part of a wider scheme of repair.
- RS02 uPVC moulded gutter is inappropriate and now with vegetation gathering at stop ends and valley base. Two large diameter plastic downpipes with hoppers are also inappropriate, but are in reasonable condition.

Roof RS01 – Corrosion to Rainwater Goods

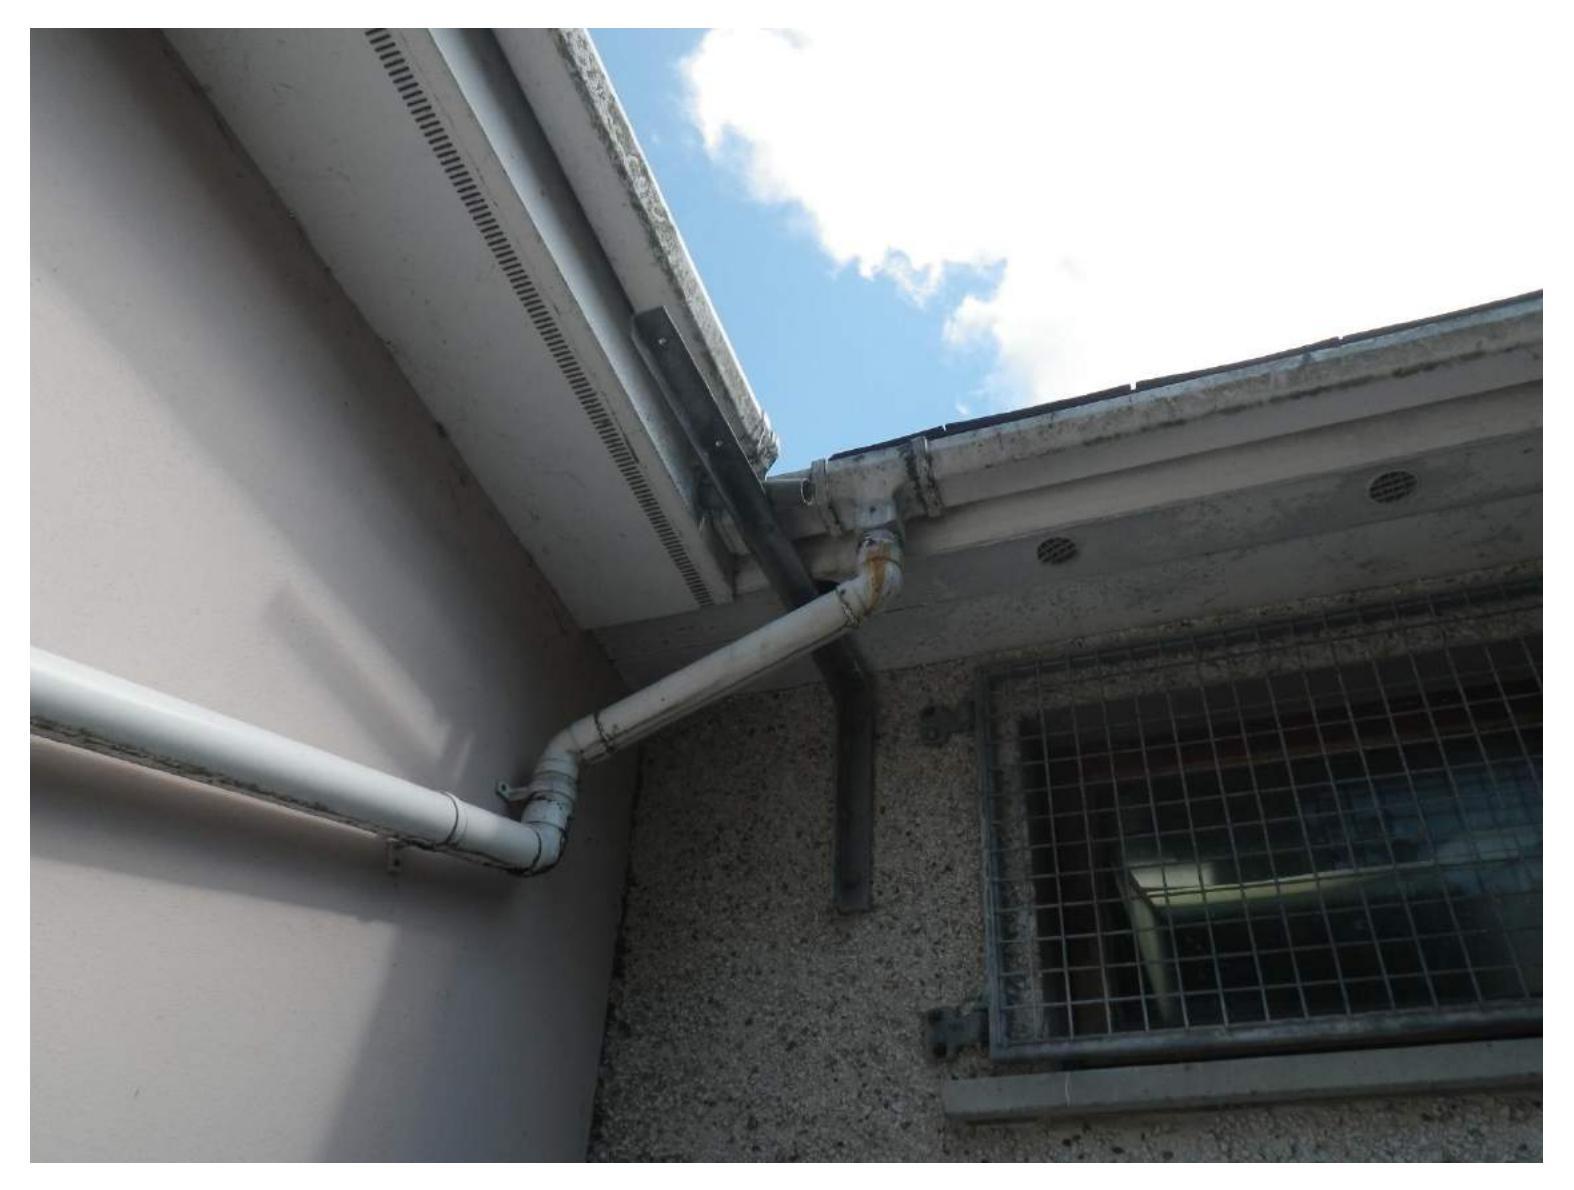
- RS15 Square section uPVC with round downpipes, dirty, but serviceable with repairs needed where leaking at swan neck.
- RS16 Square section uPVC with round downpipes, dirty, but serviceable with repairs needed where leaking at swan neck.
- RS17 Square section uPVC with round downpipes, dirty, but serviceable with repairs needed where leaking at swan neck.

Roof RS15 – Leaking Gutters

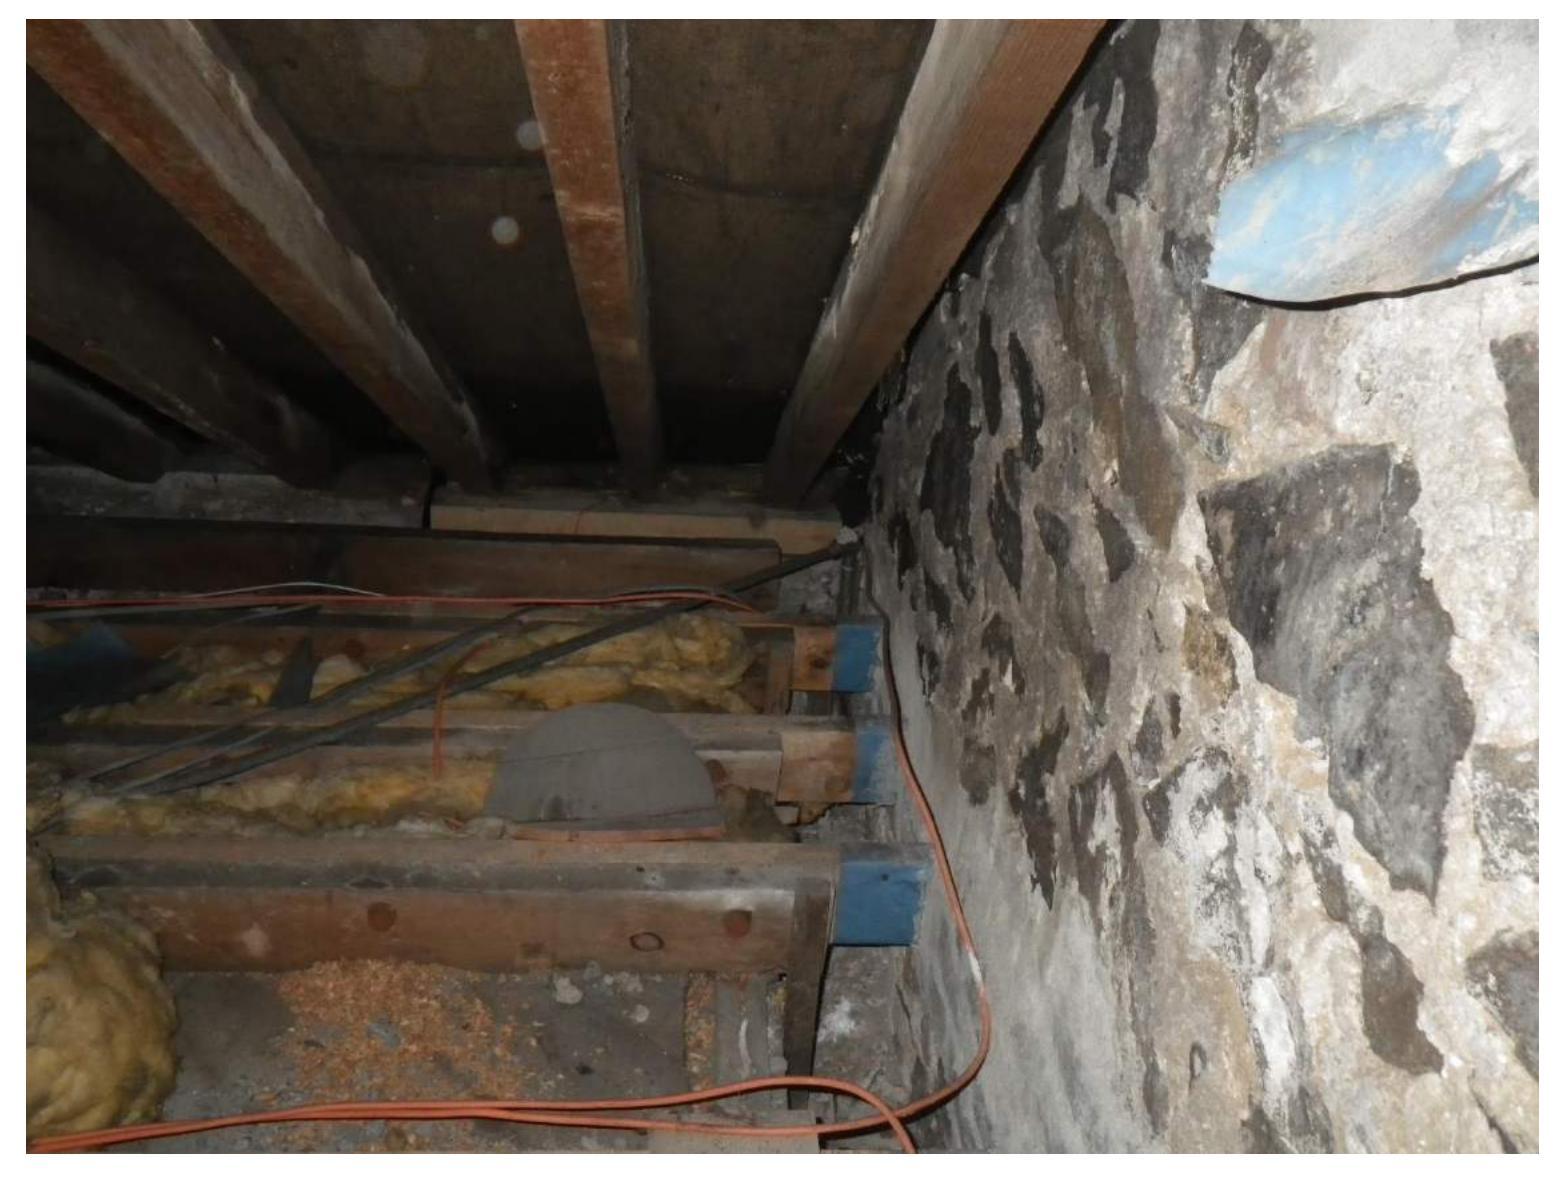
Past Repairs to Previously Rotten Timbers within Main Roof Space
