Whiteabbey Presbyterian Church 602 Shore Road Newtownabbey

Detailed Condition Report (Church)

August 2022

McCOLLUM CONSERVATION

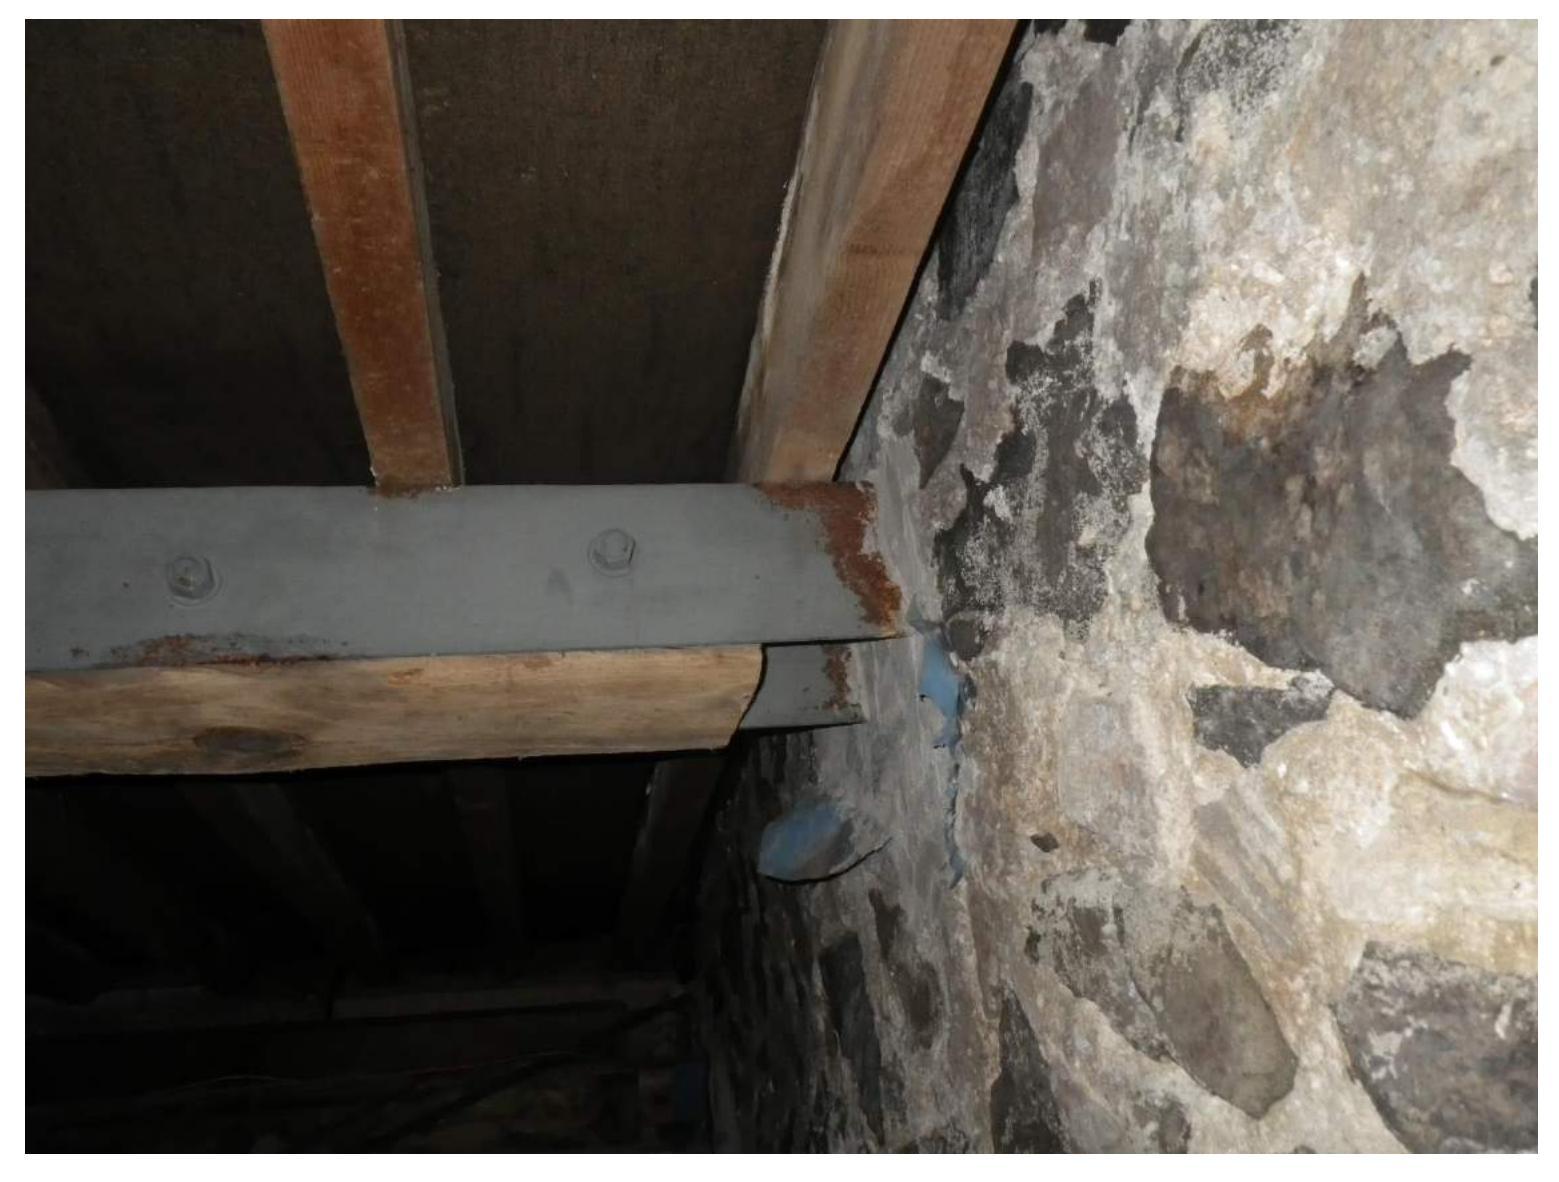
Past Steel Repairs to Previously Rotten Timbers, now with Corrosion to Metal

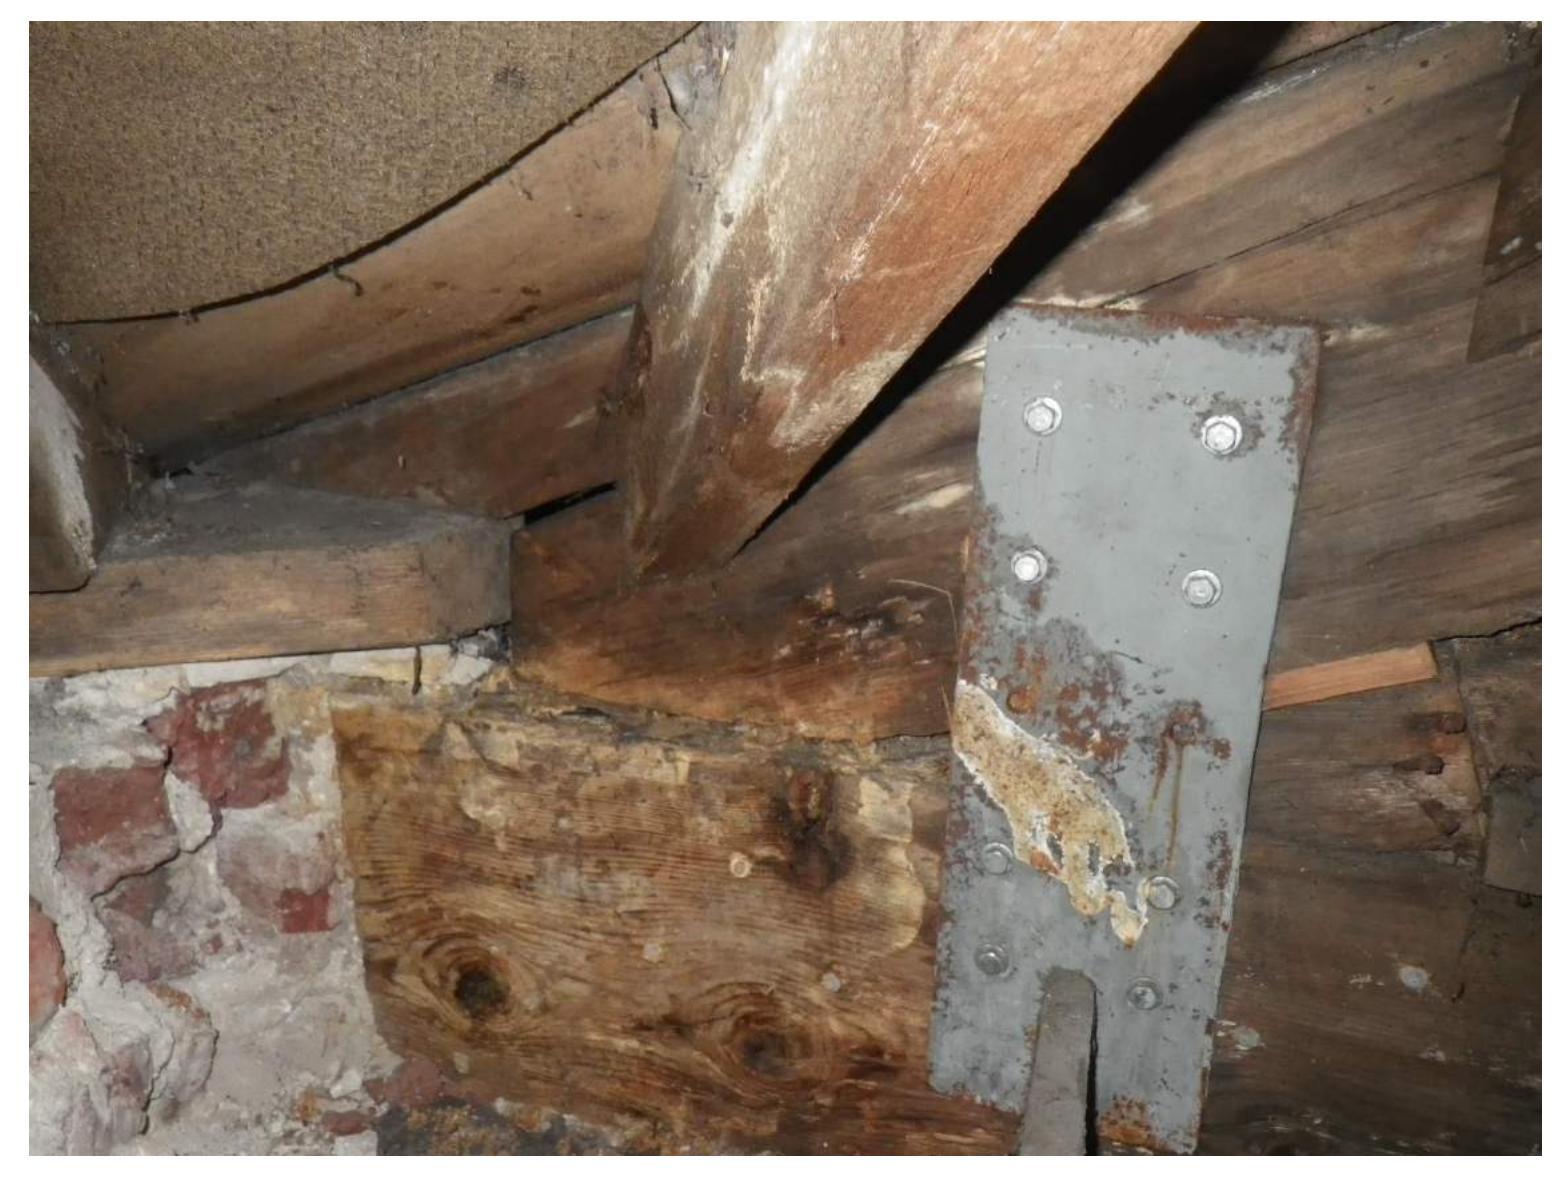
Evidence of Past Repairs to Valley Bases within Main Roof Space

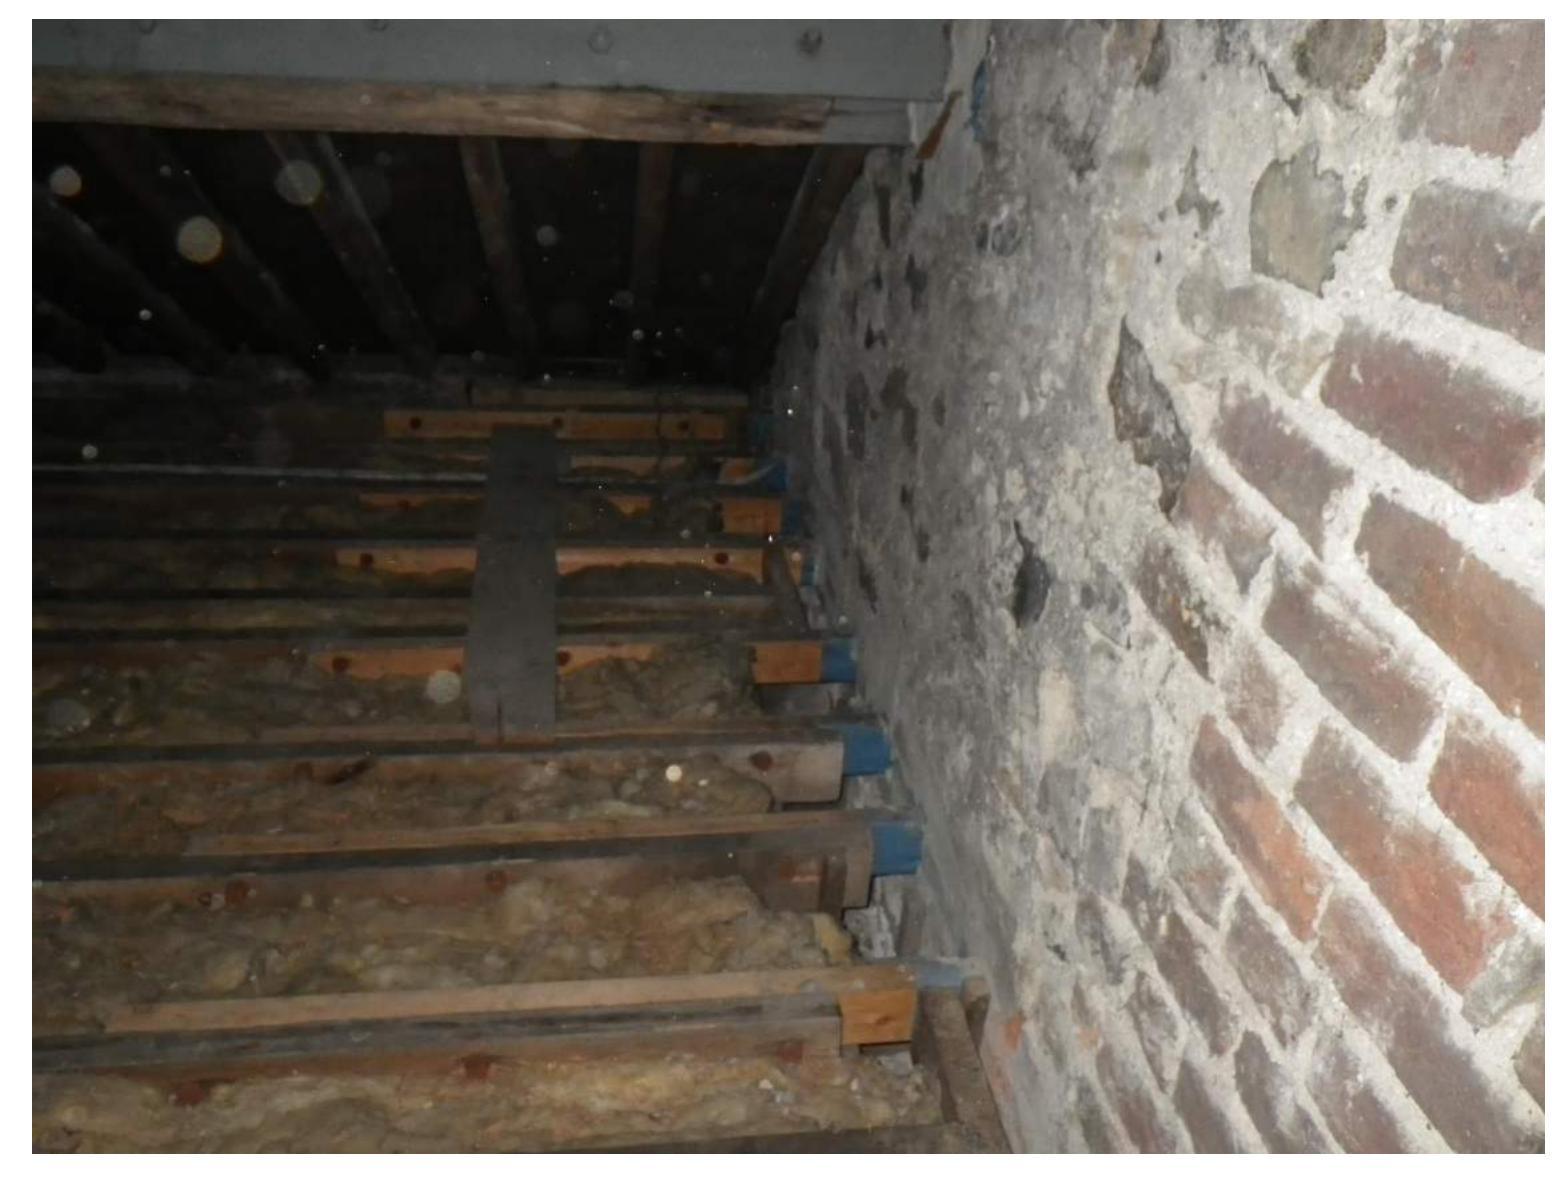
Further Examples of Previous Repairs to Main Roof

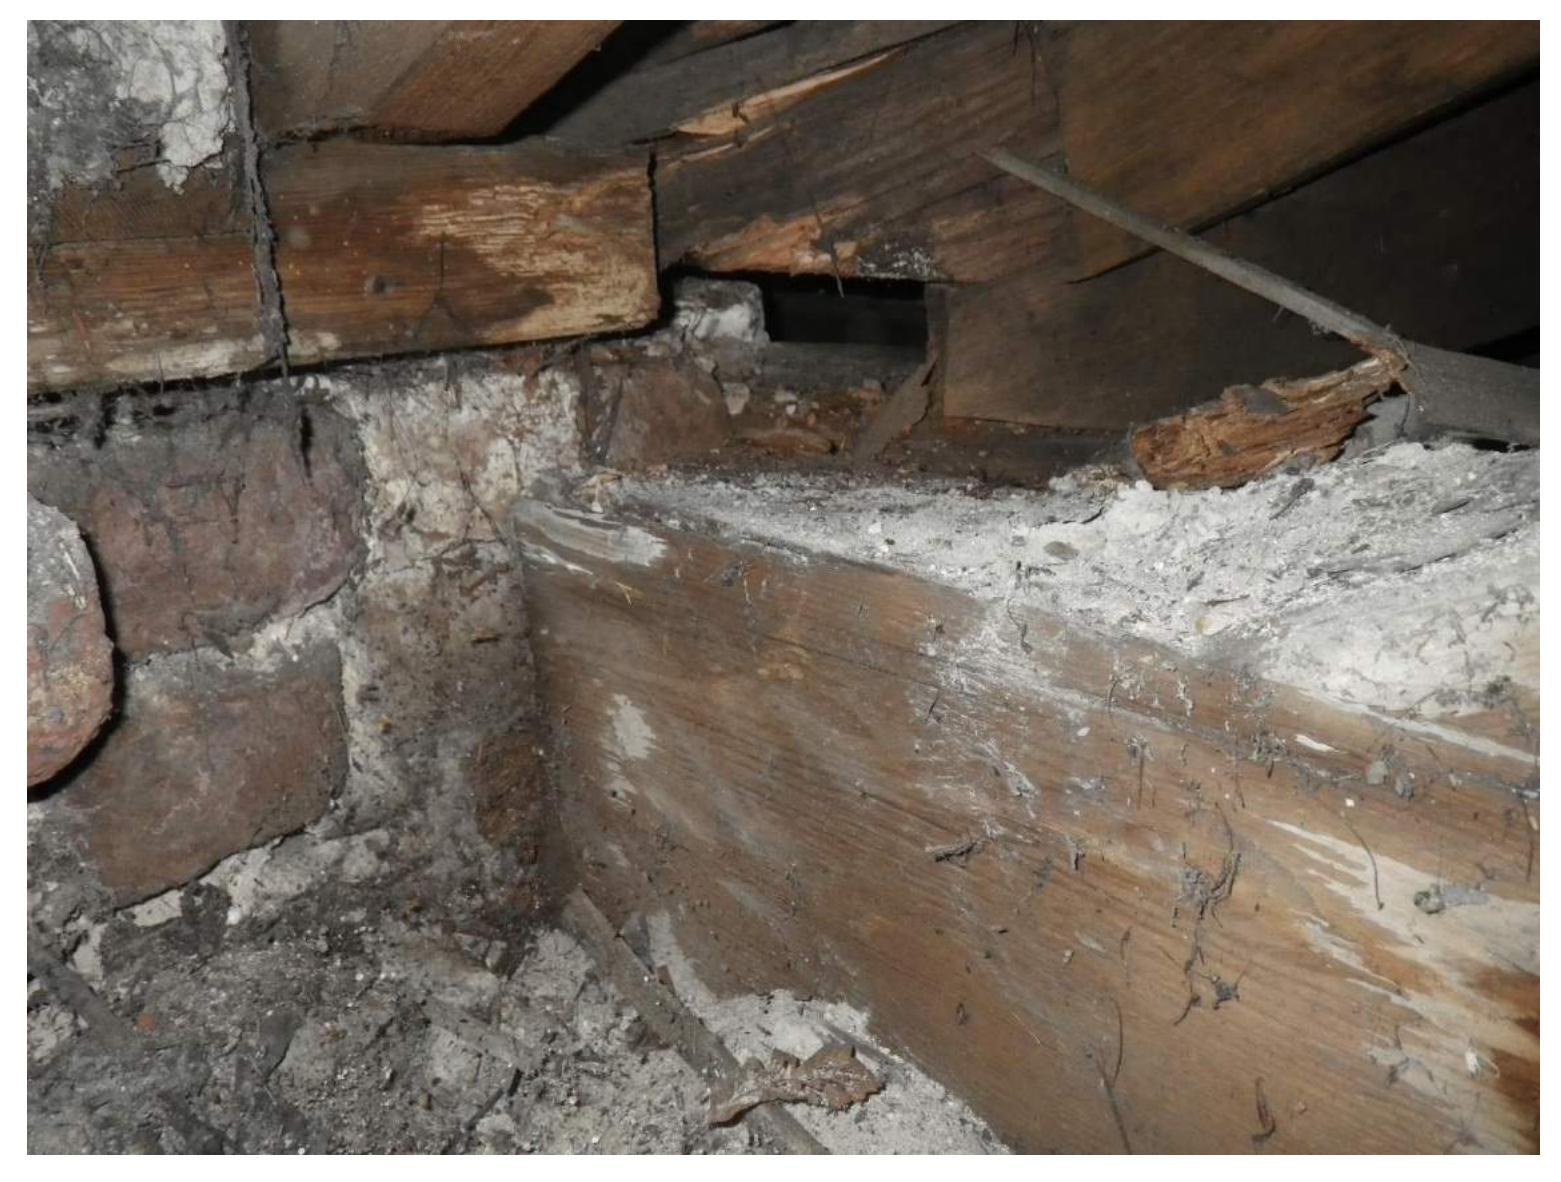
Minor Timber Decay at Base of Valley to Main Roof

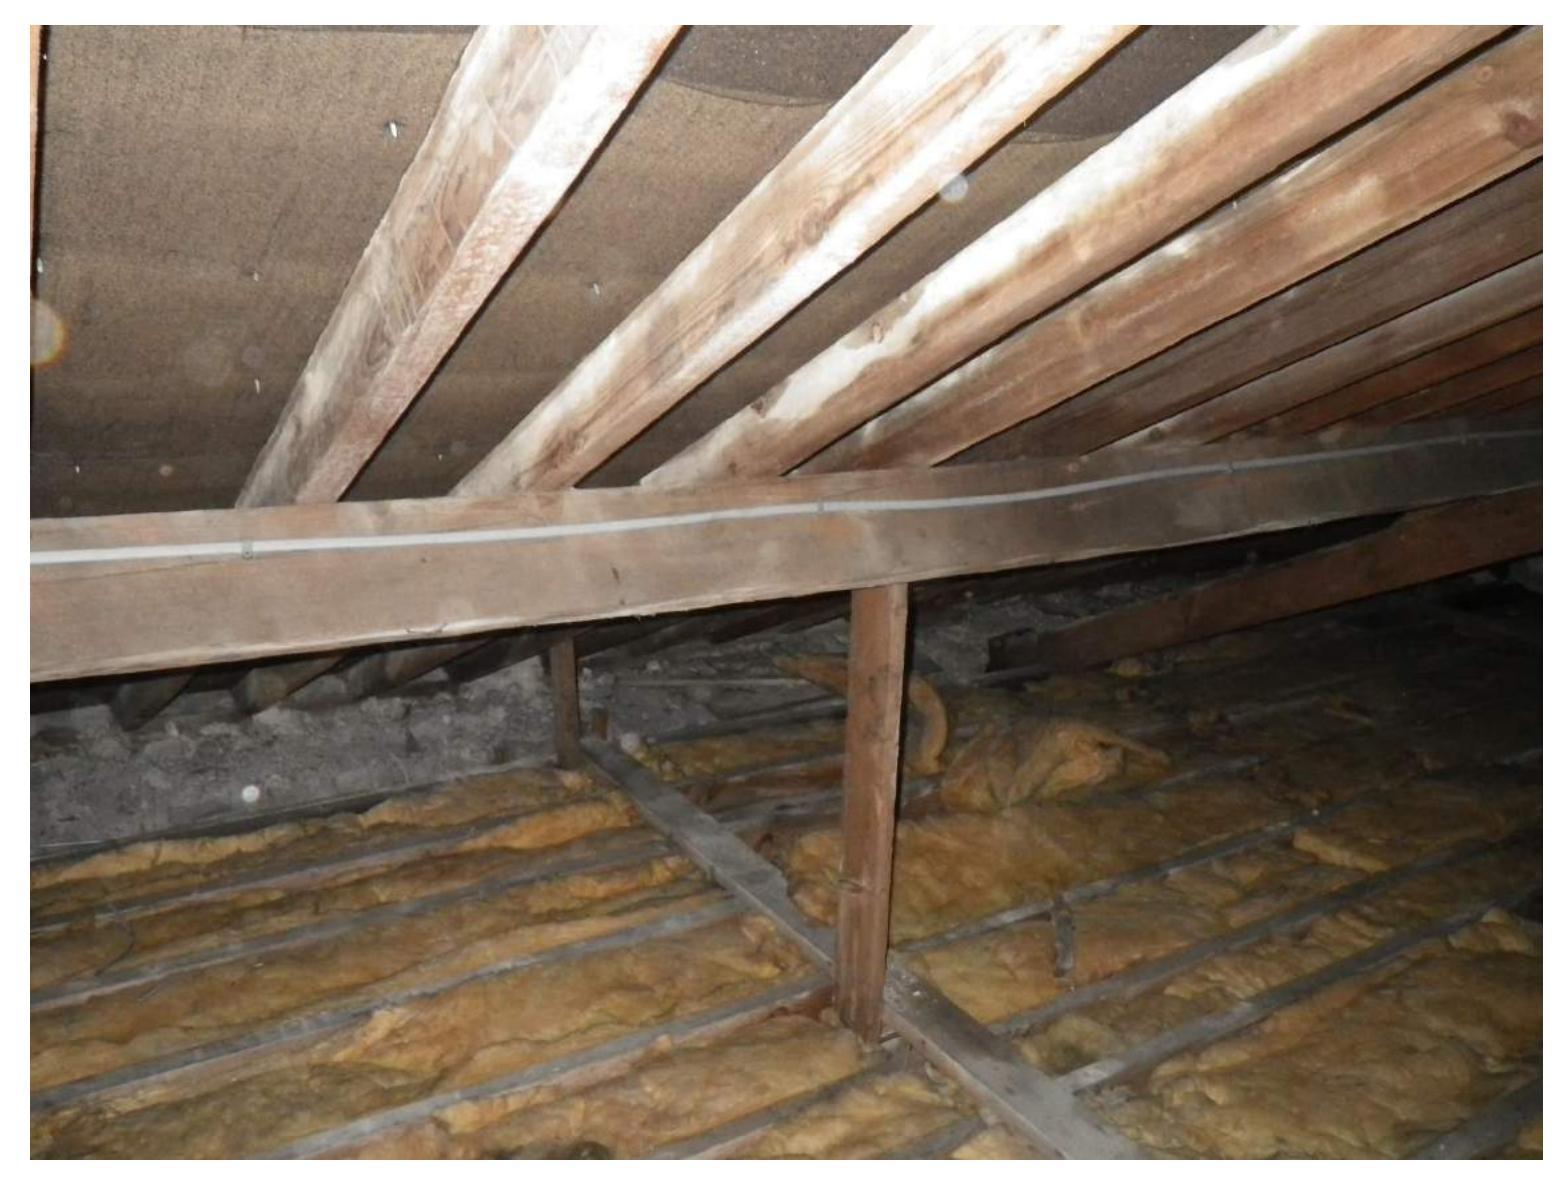
Bowing Purlin Main Roof

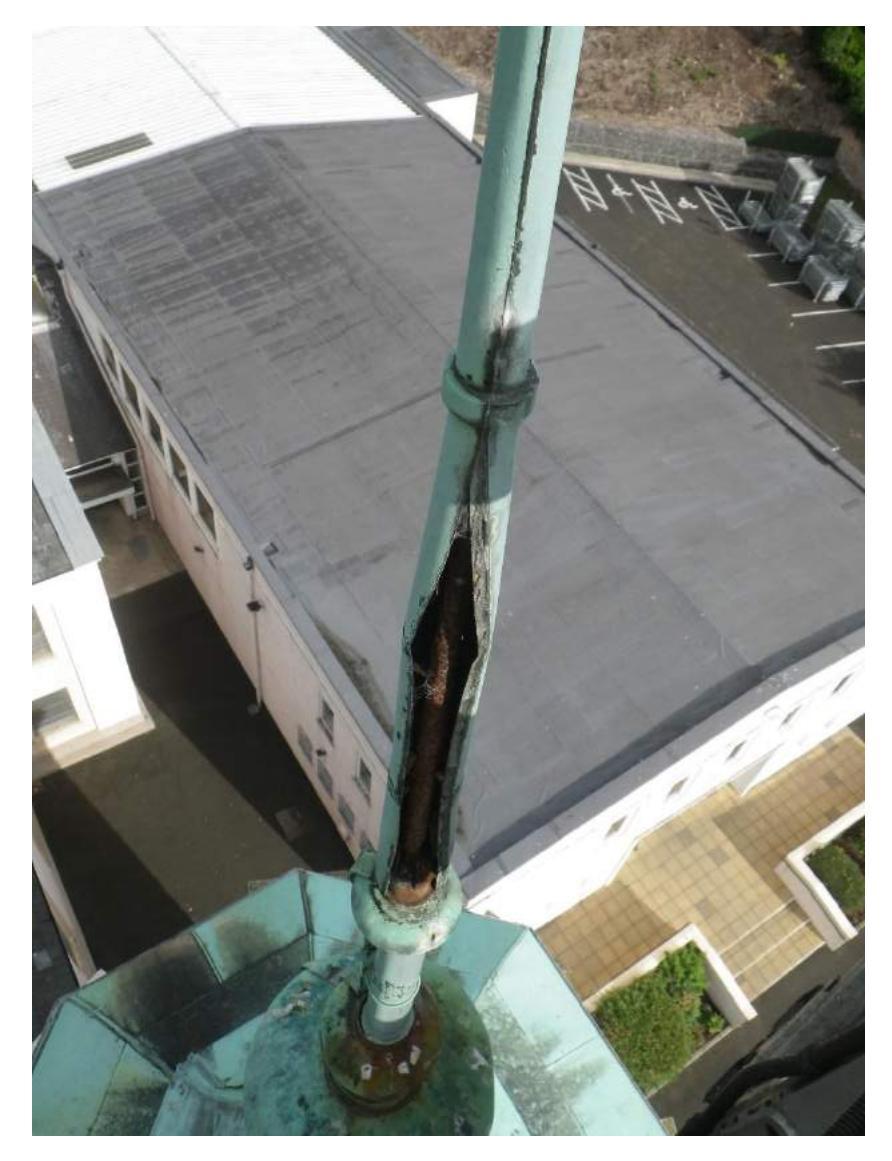
Failure of Copper and Corroding Metal Spike Behind

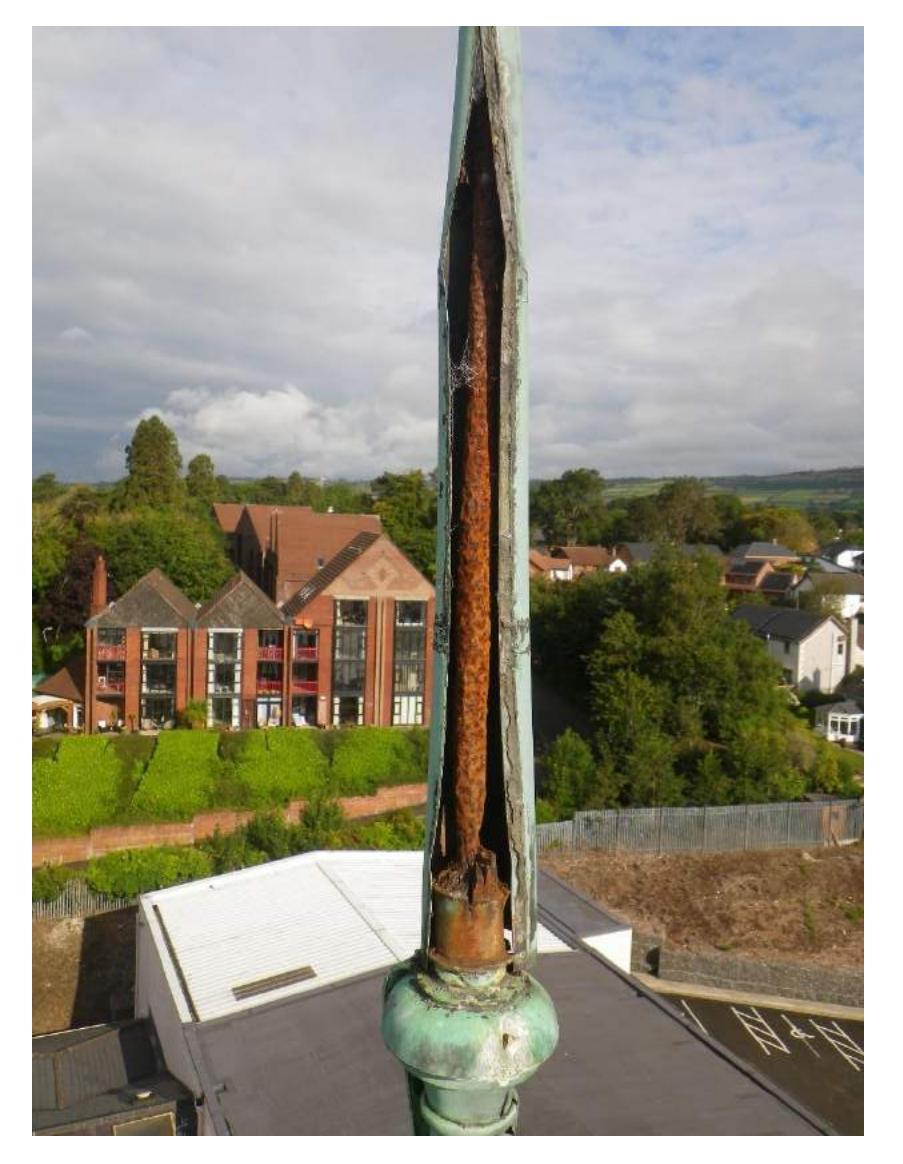
Corroding Metal behind Copper with corrosion at its Base

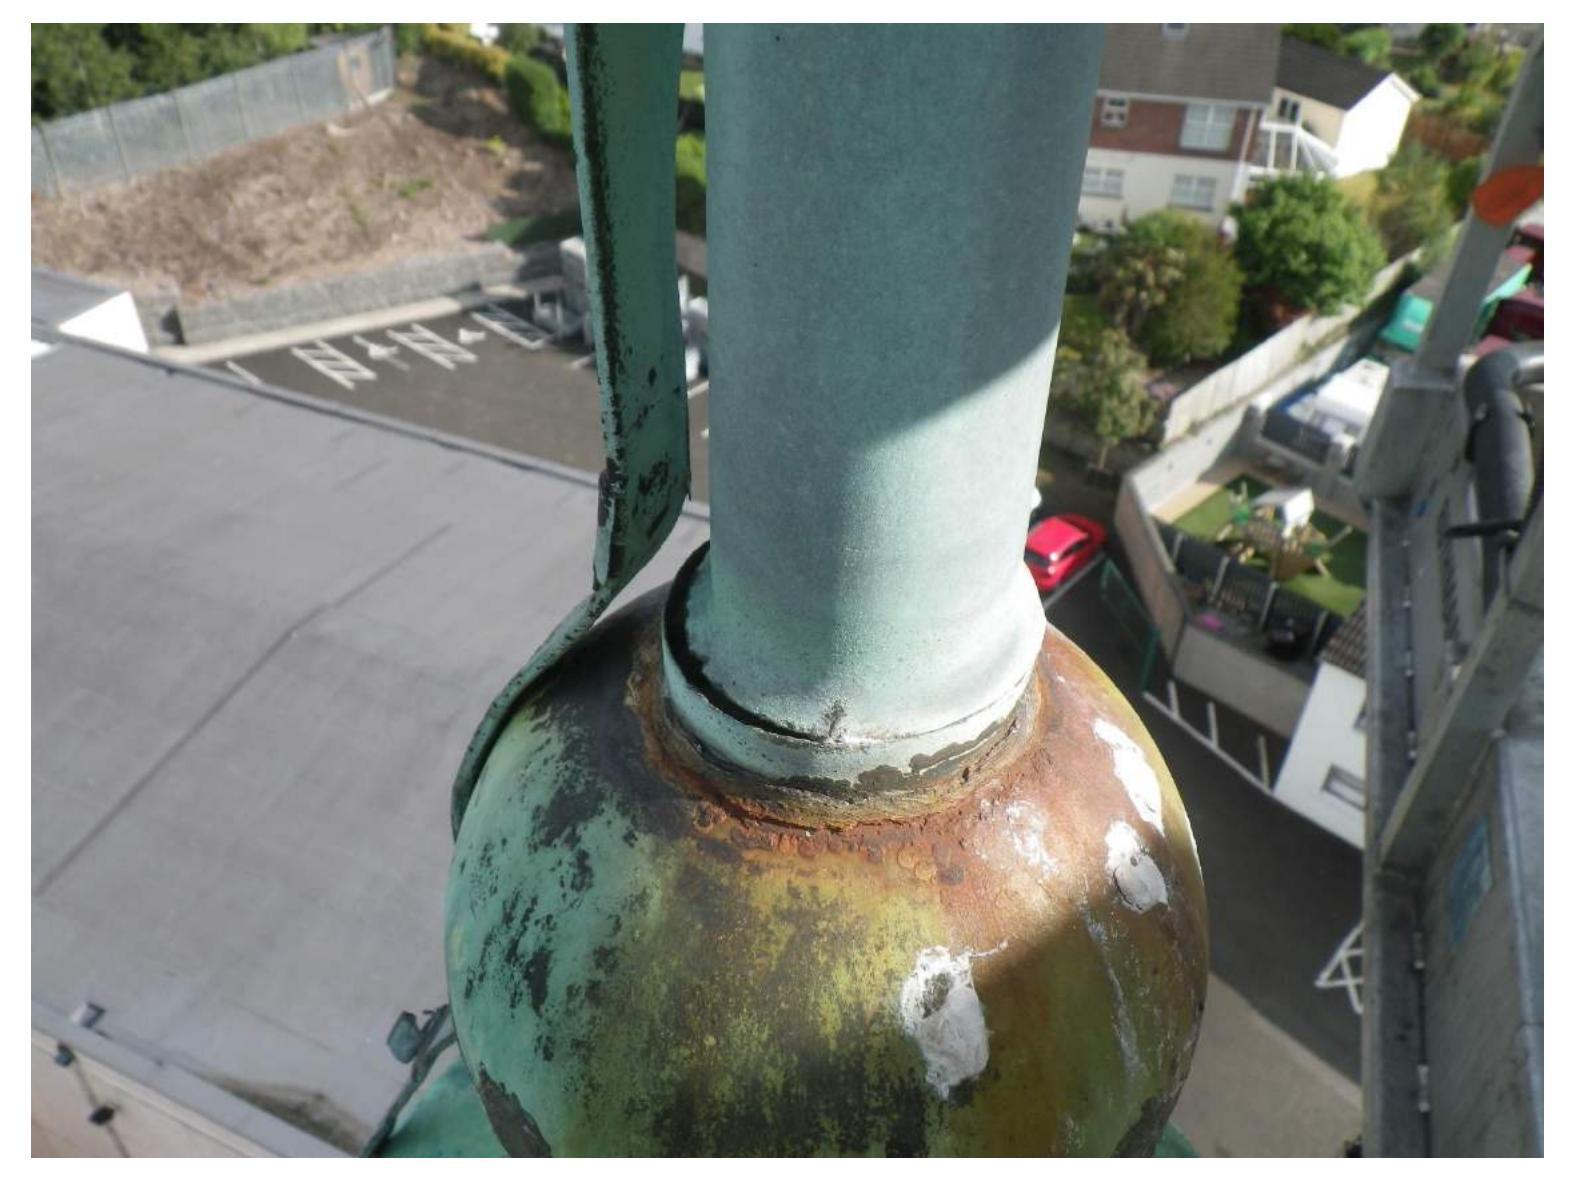
Open Collars Allowing Water Penetration to Weather Spike

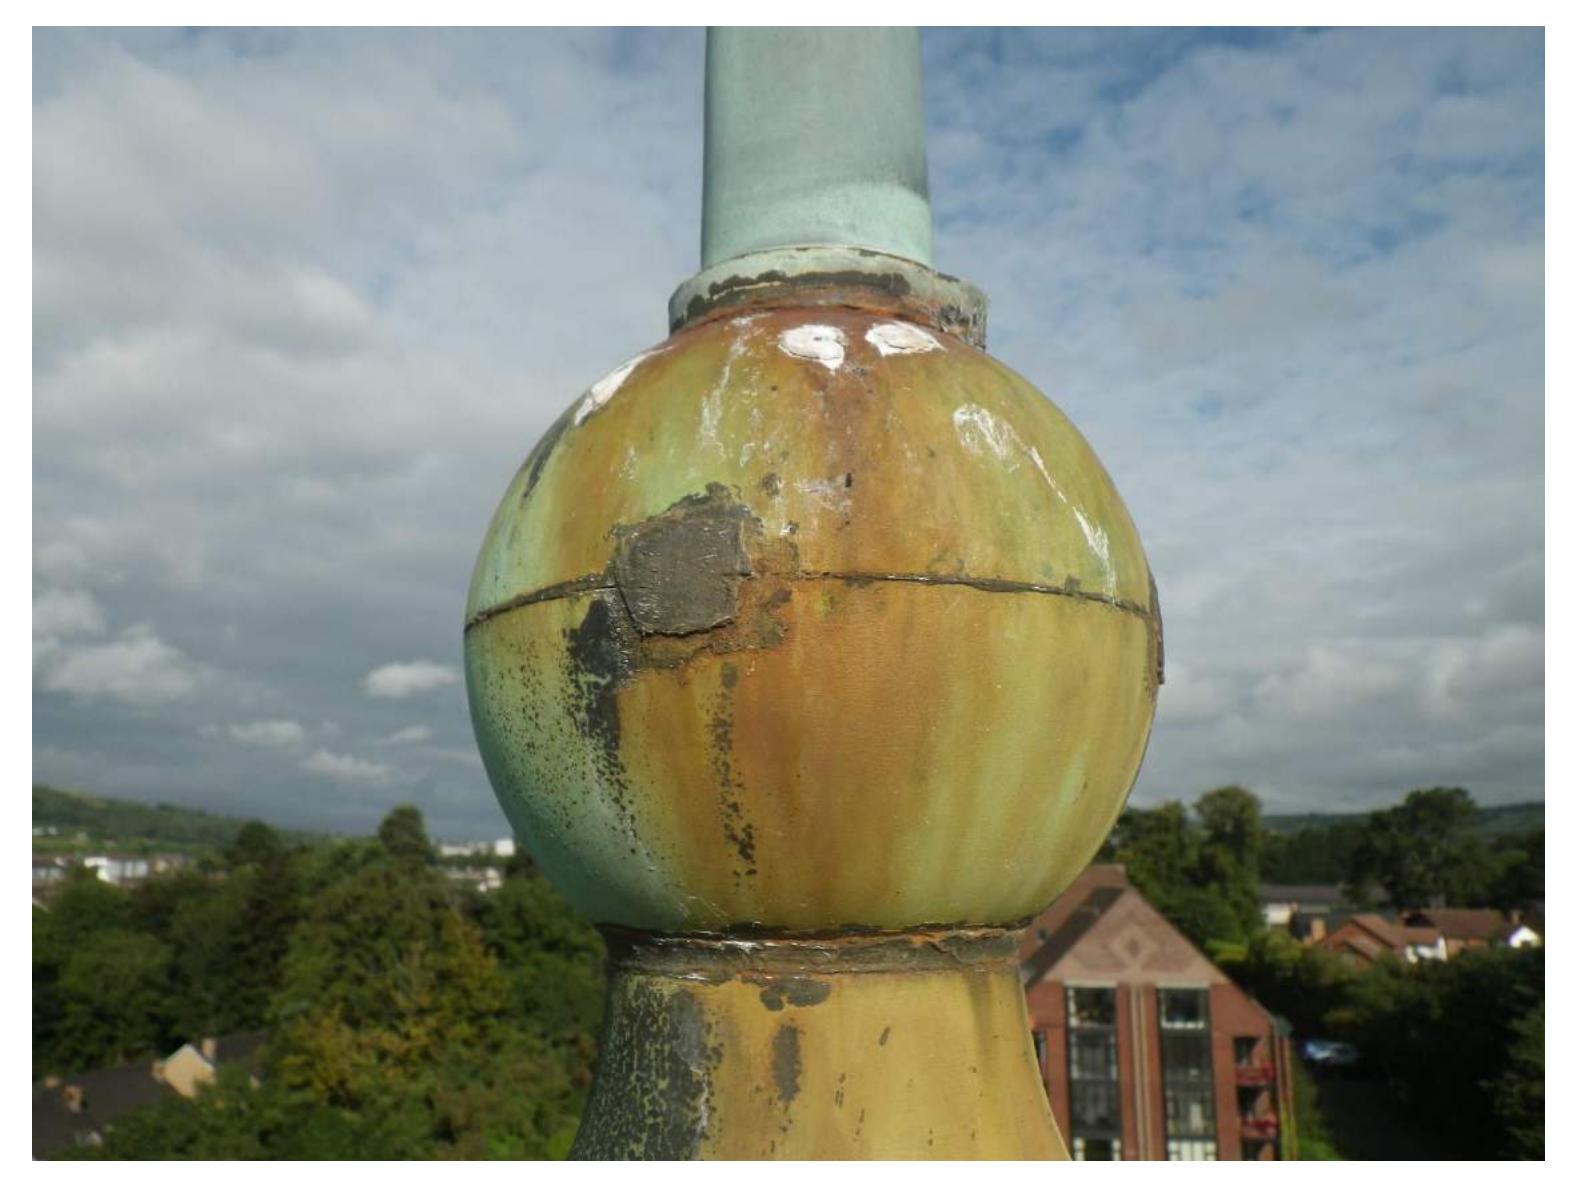
Past Repairs to Copper Finial

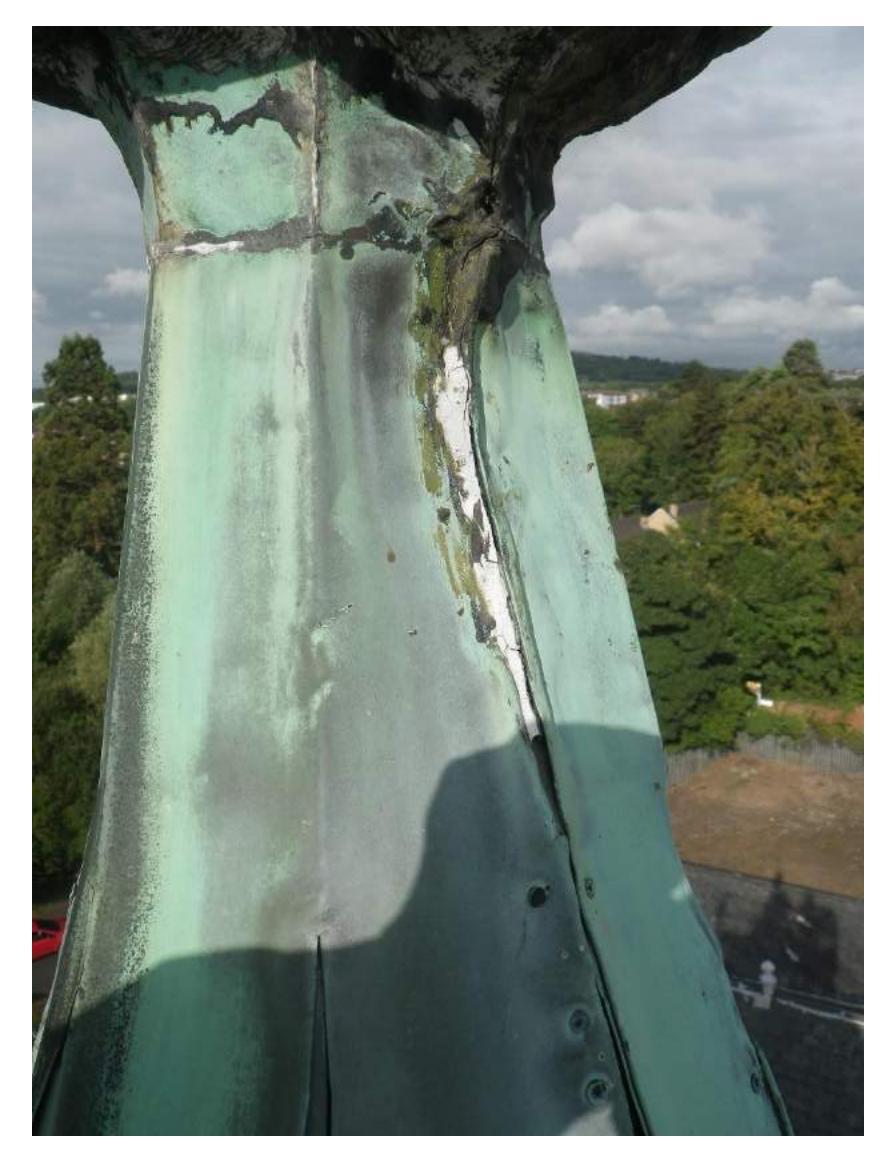
Splitting of Upper Reaches of Copper Cladding and Evidence of Past Repairs

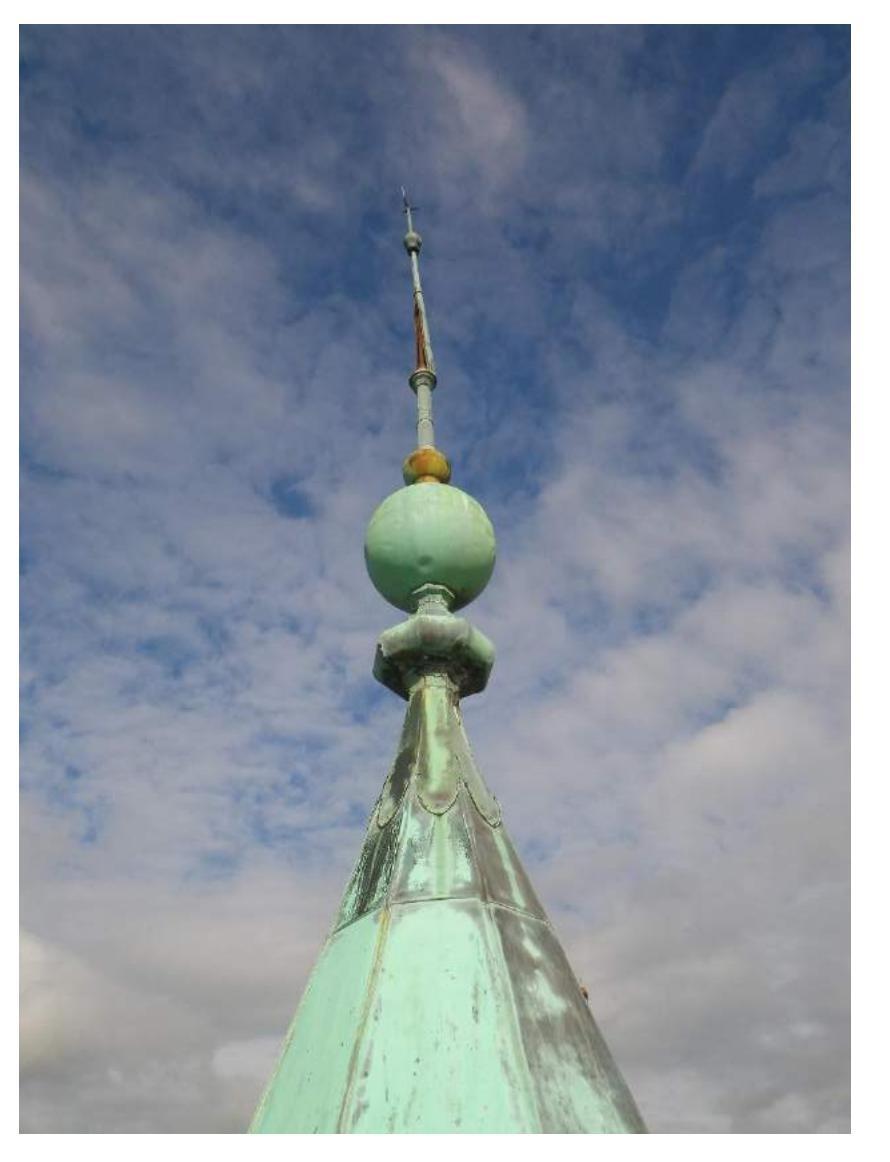
Overview of Metal Spike to Tower – Notice Leaning of Top Section

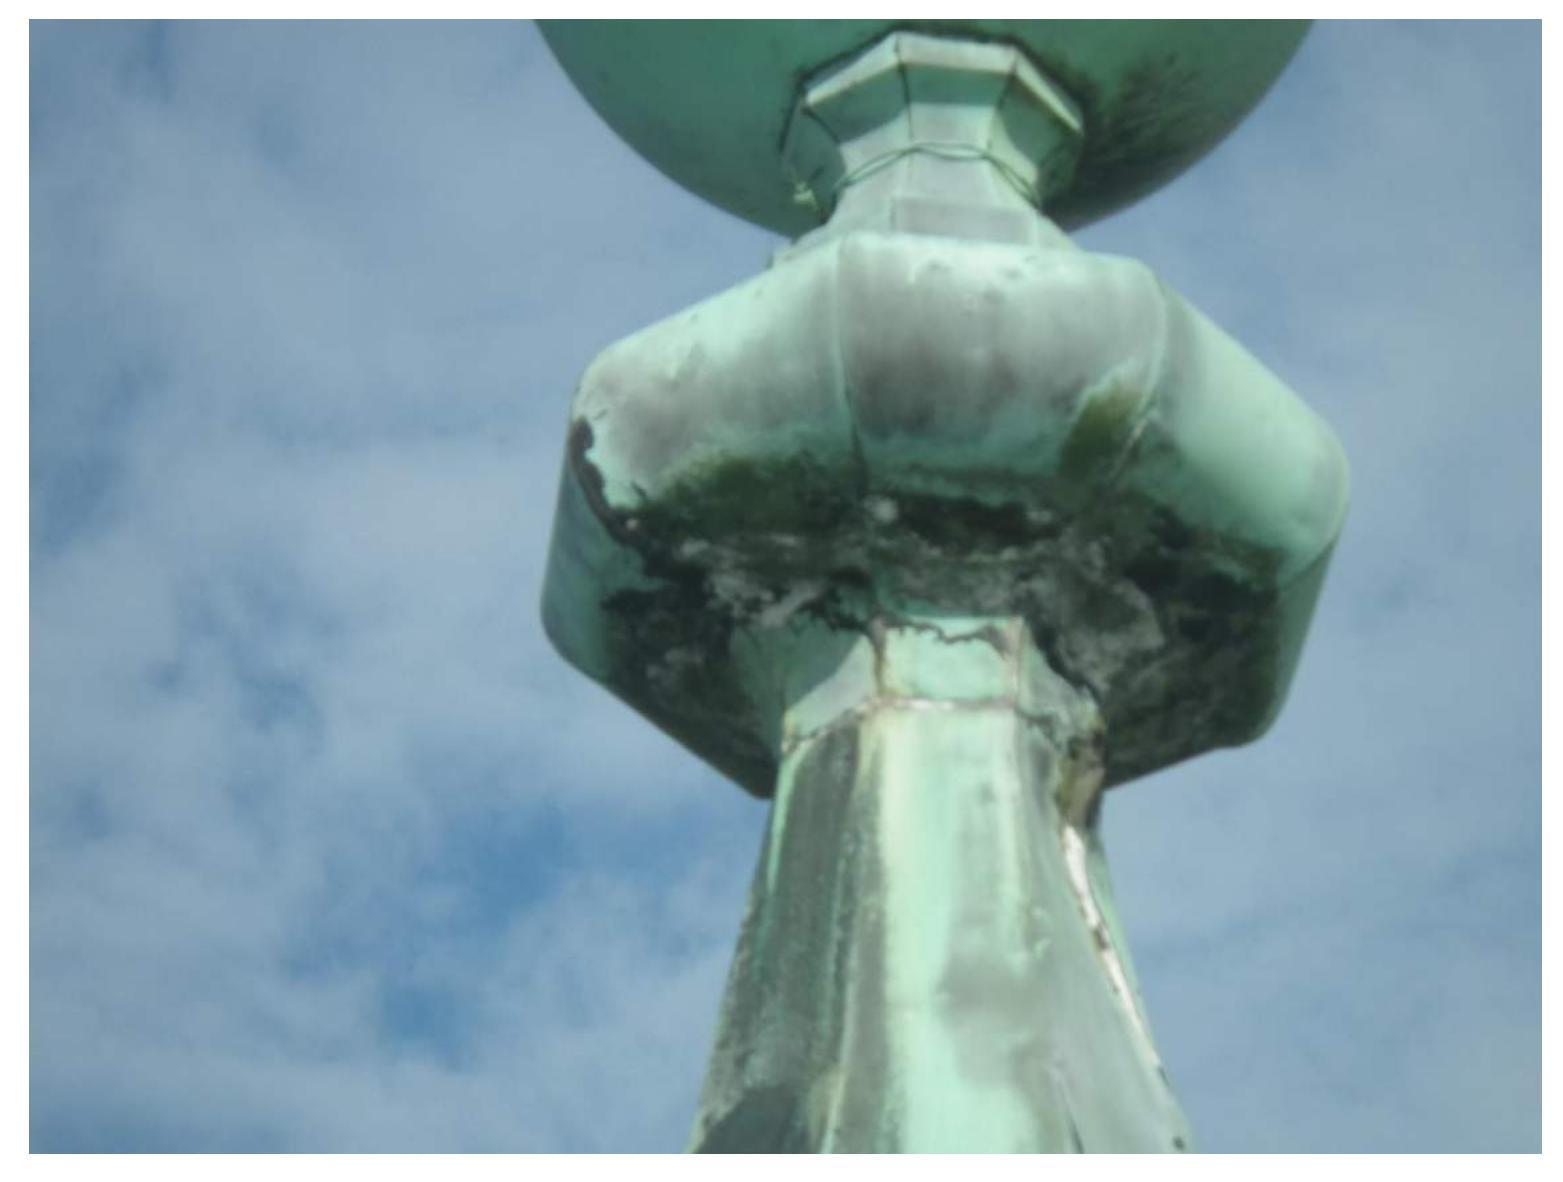
Past Repairs to Copper Boss

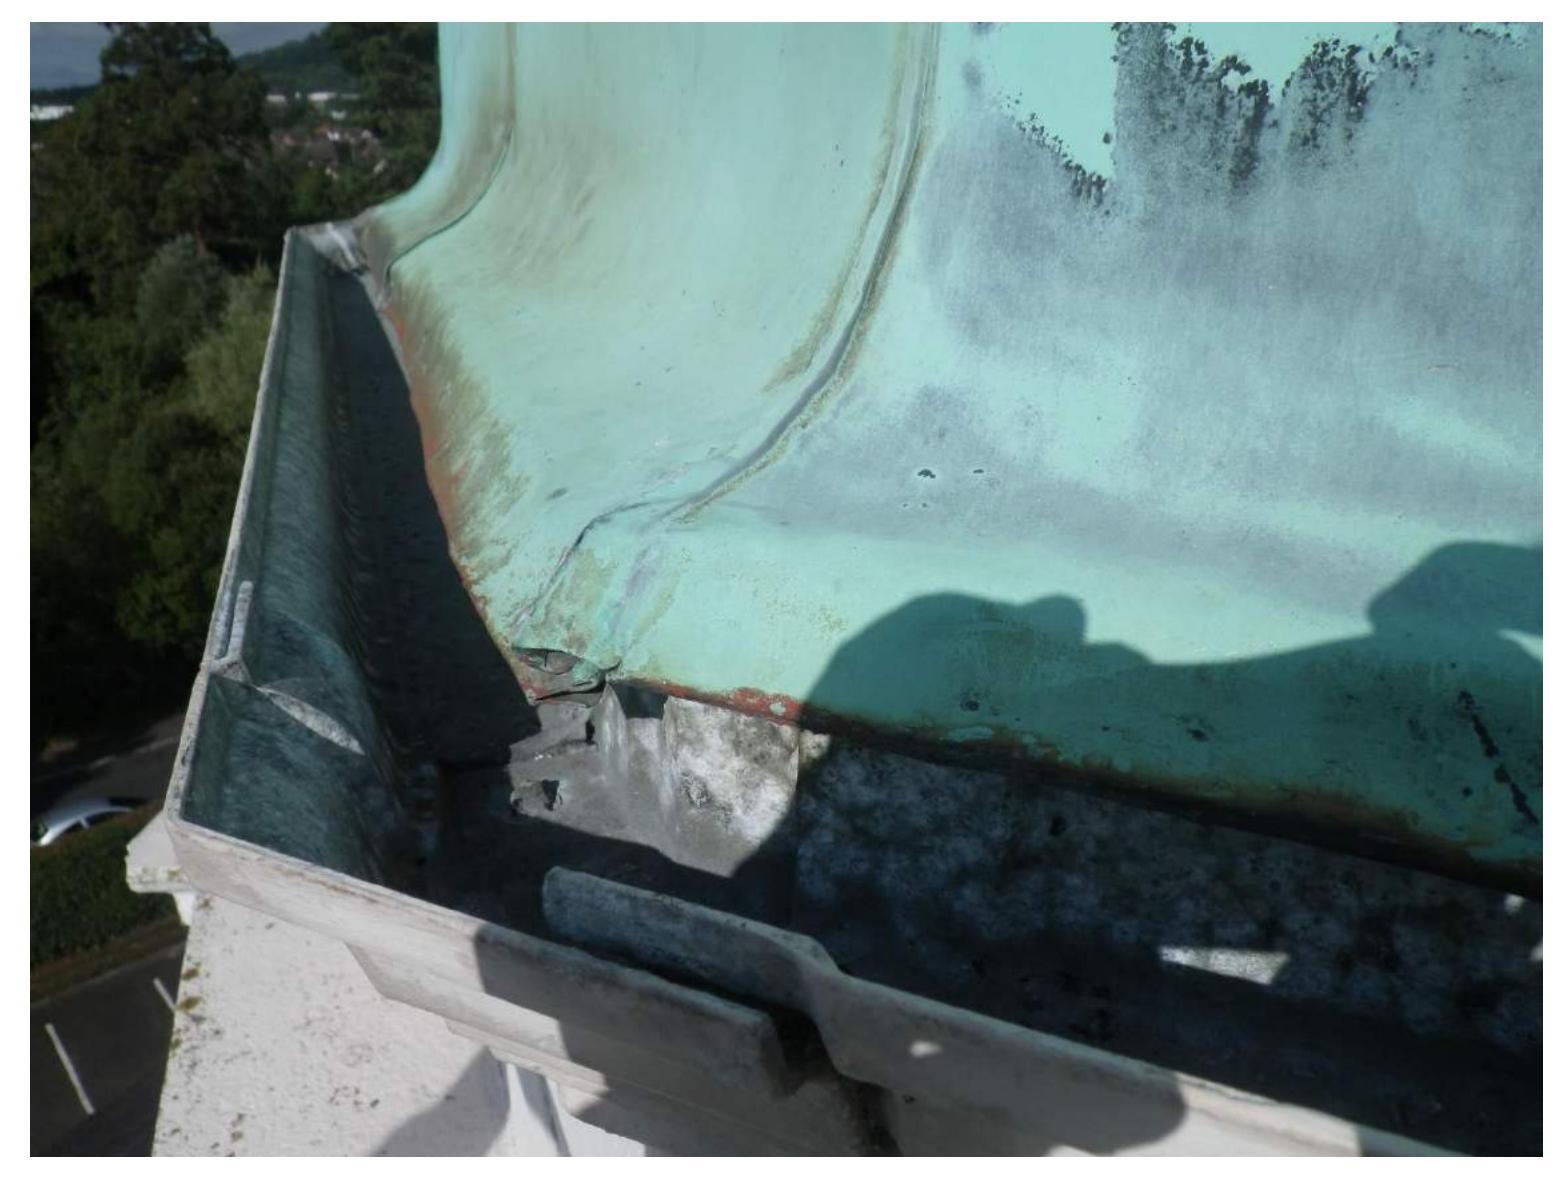
Welted Joints Beginning to Open and some Corrosion at Base of Copper Roof. Open Joints to Aluminium Gutters.

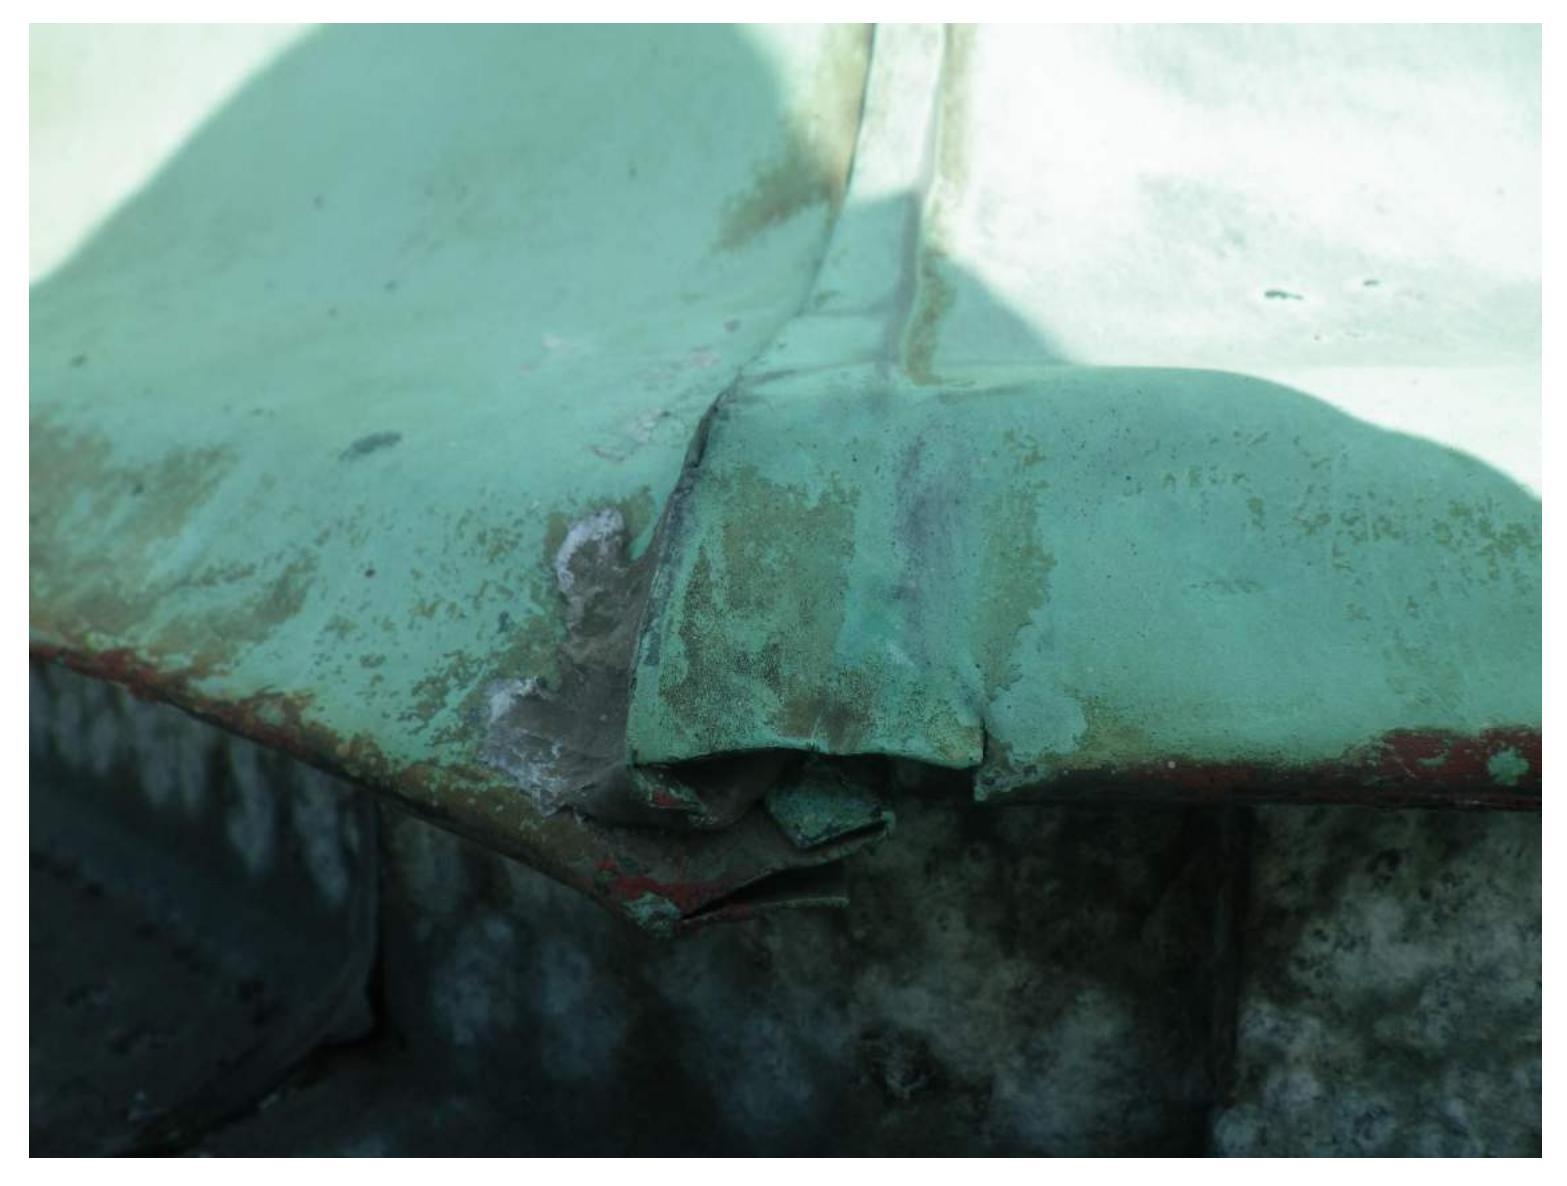
Welted Joints with Past Repairs
