Whiteabbey Presbyterian Church 602 Shore Road Newtownabbey

Detailed Condition Report (Church)

August 2022

McCOLLUM CONSERVATION

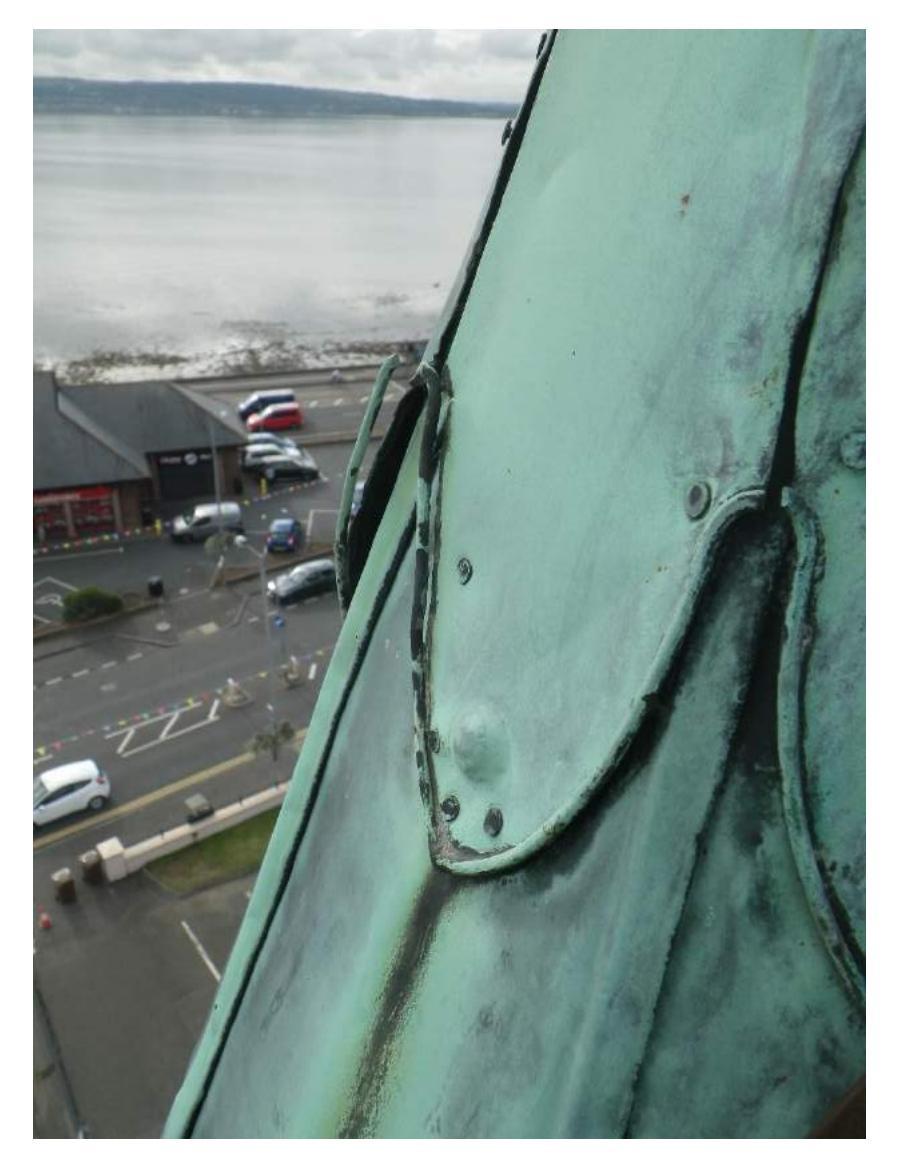
Copper Detailing Working Loose

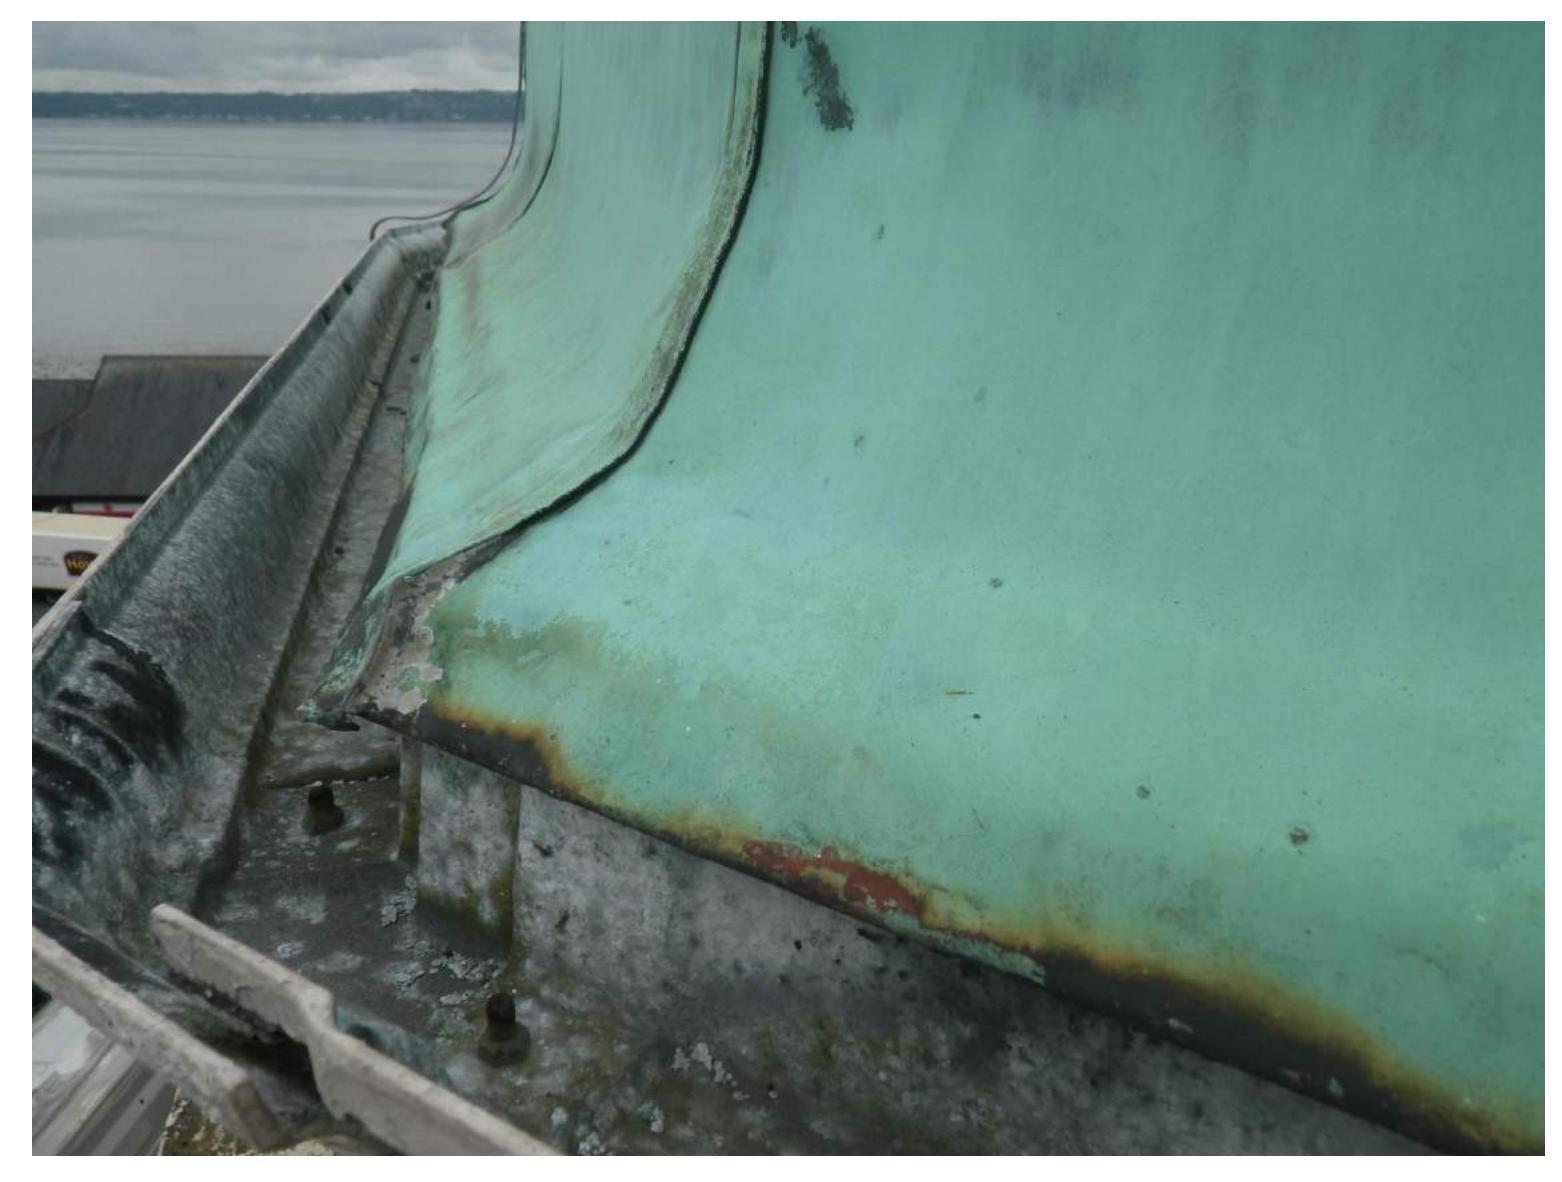
Past Repairs and Some Corrosion to the Base of the Copper Roof

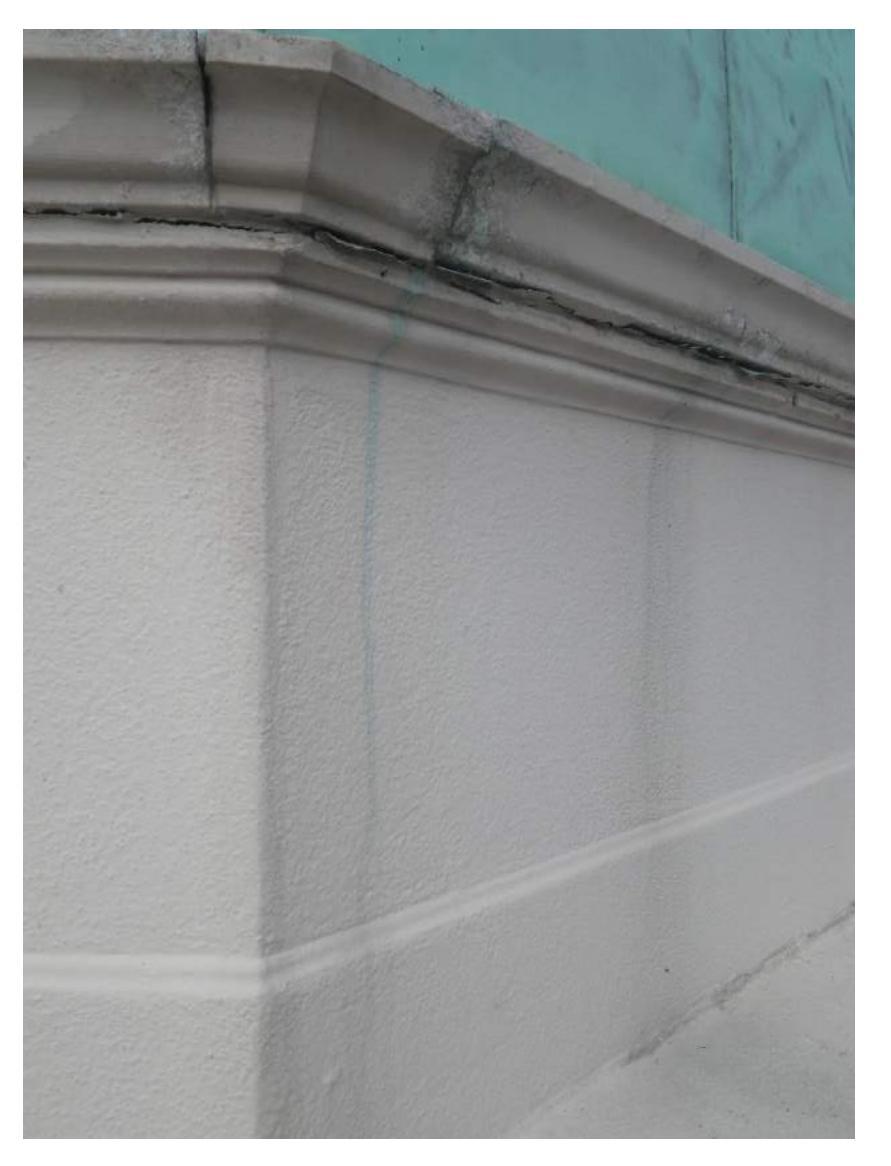
Leaking Tower Gutters

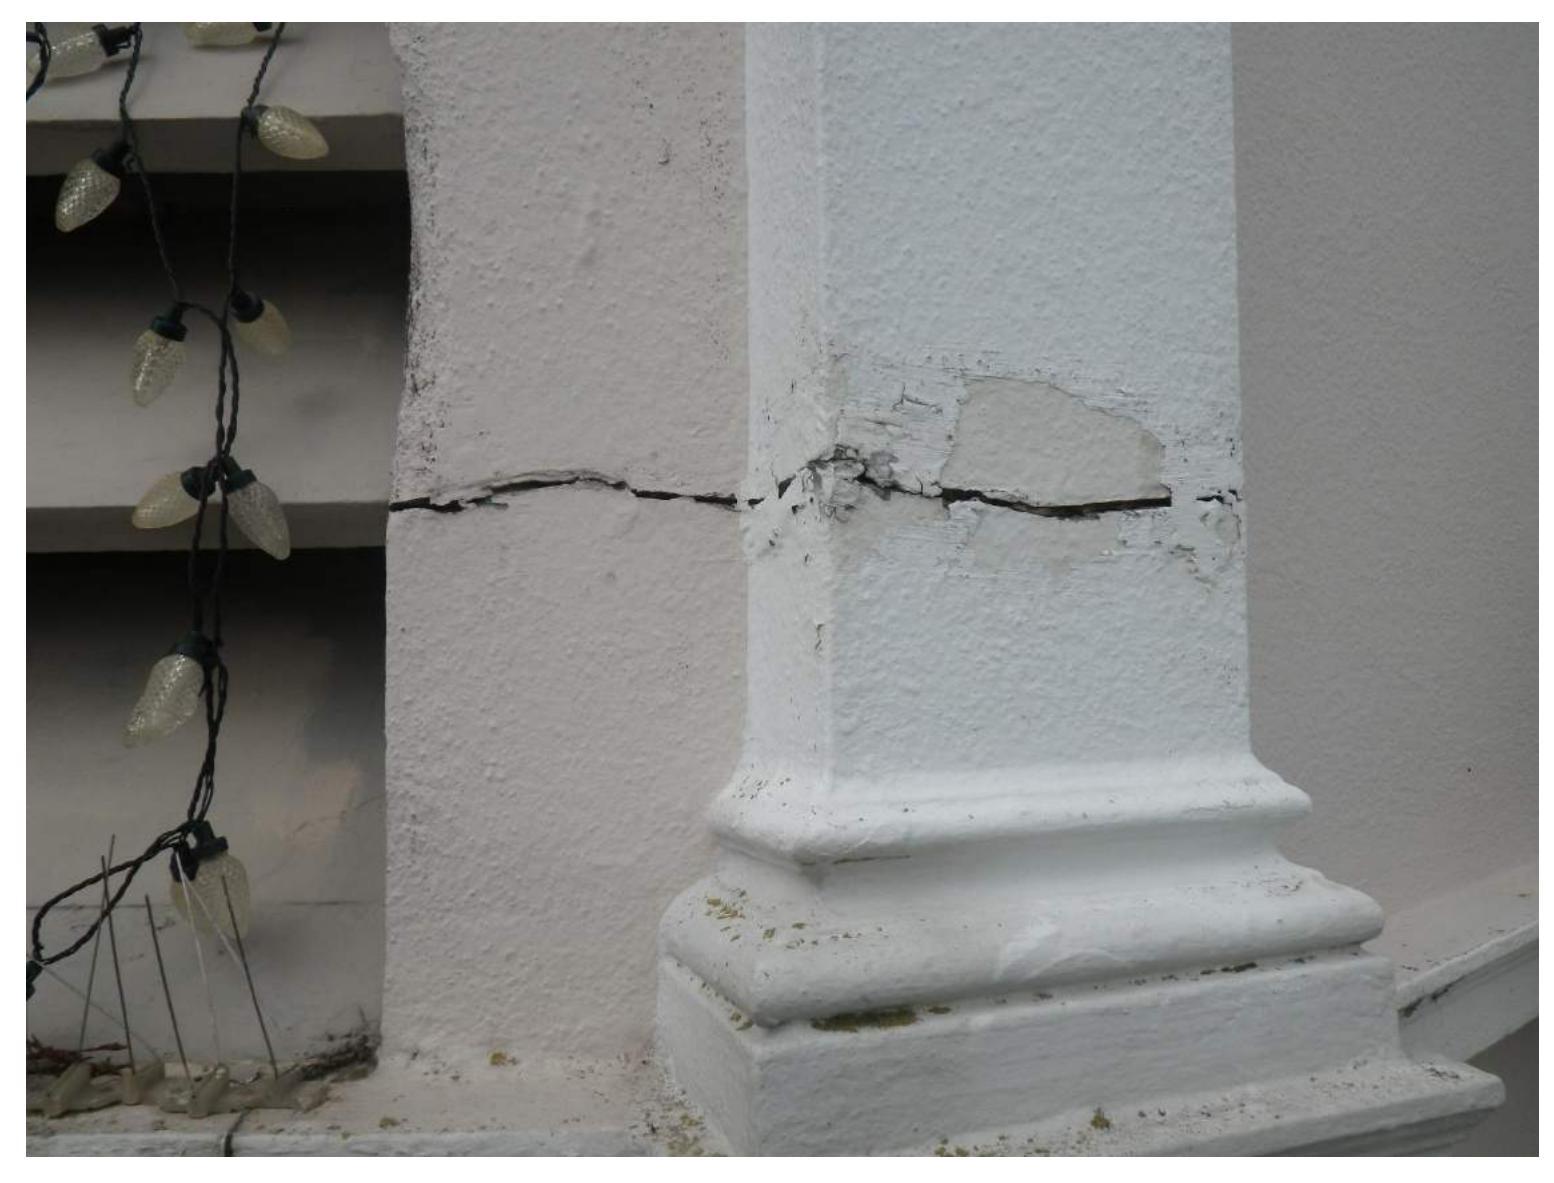
Horizontal Cracking to Bell Louvre Section of Tower

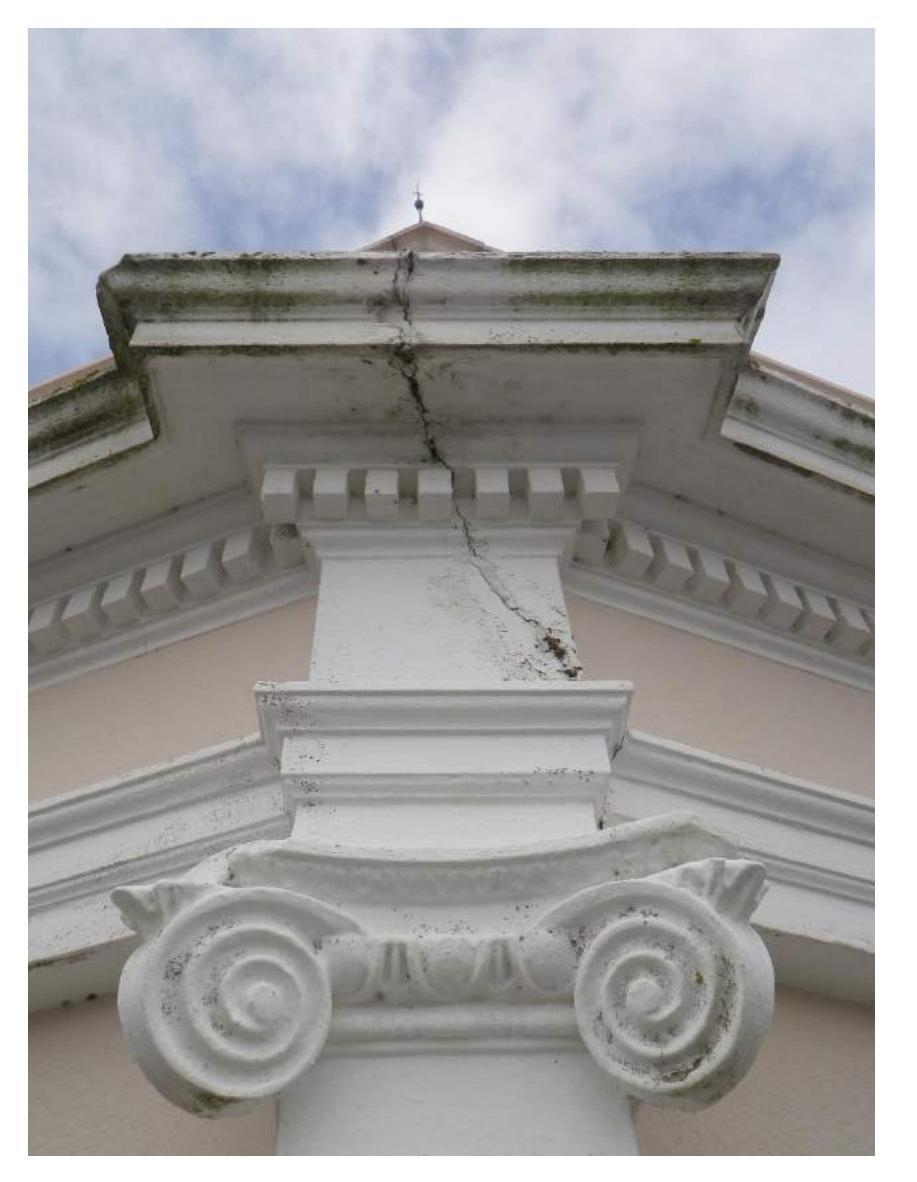
Further Cracking to Upper Reaches of Tower

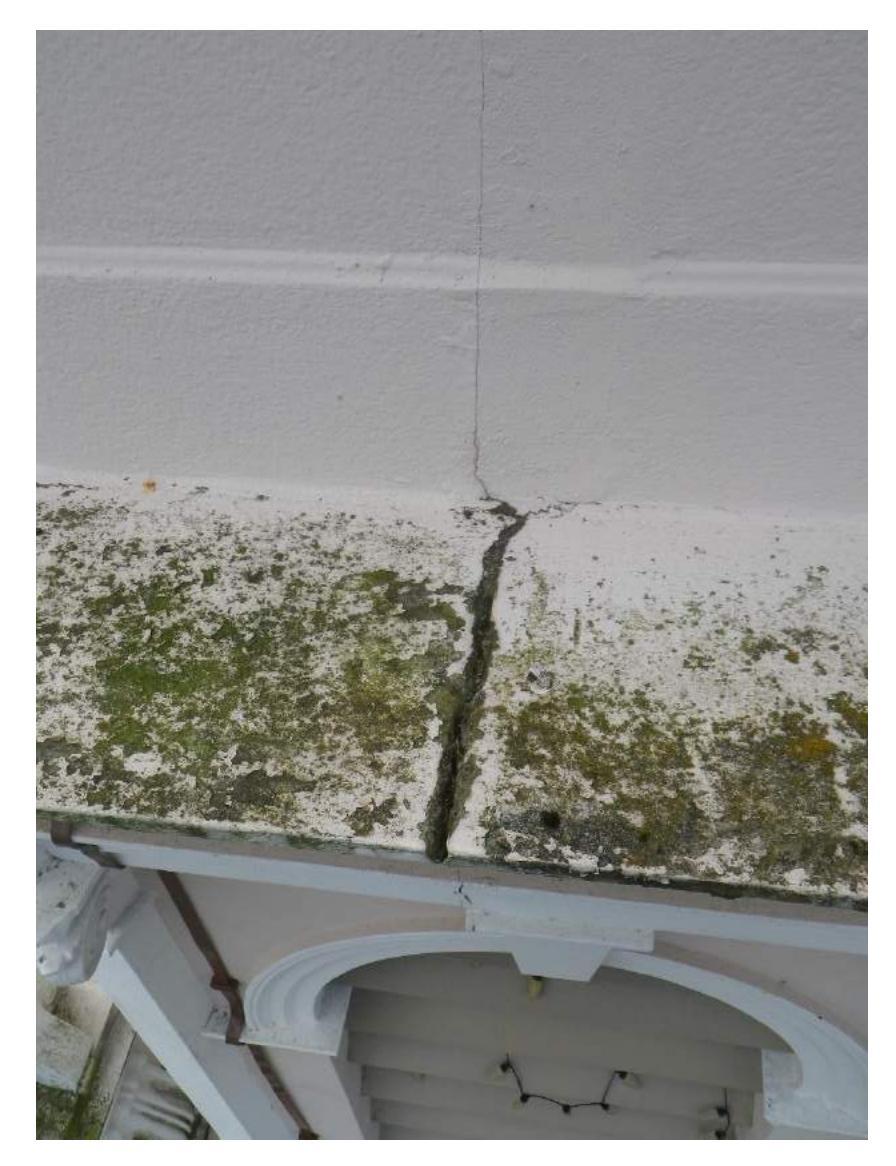
Cracking to Overhangs of Tower

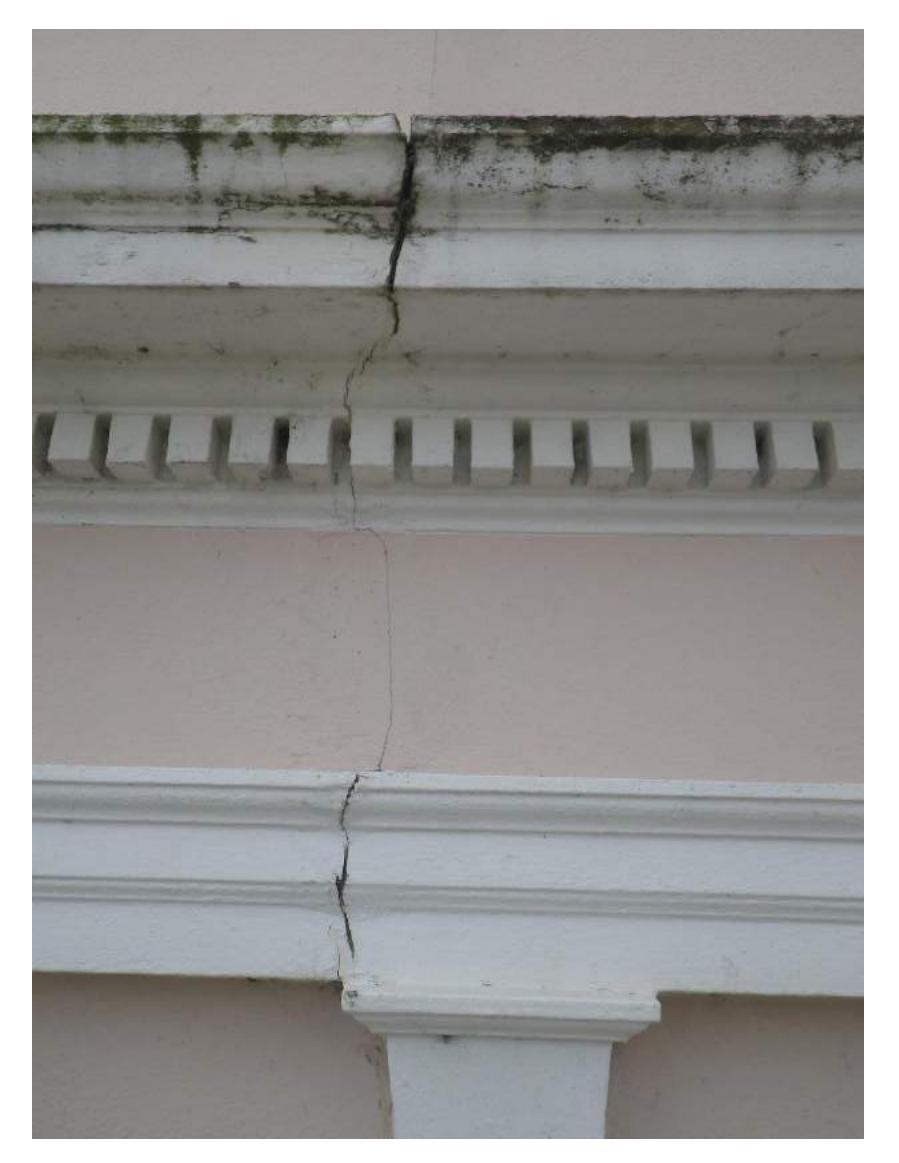
Cracking to Upper Reaches of Tower

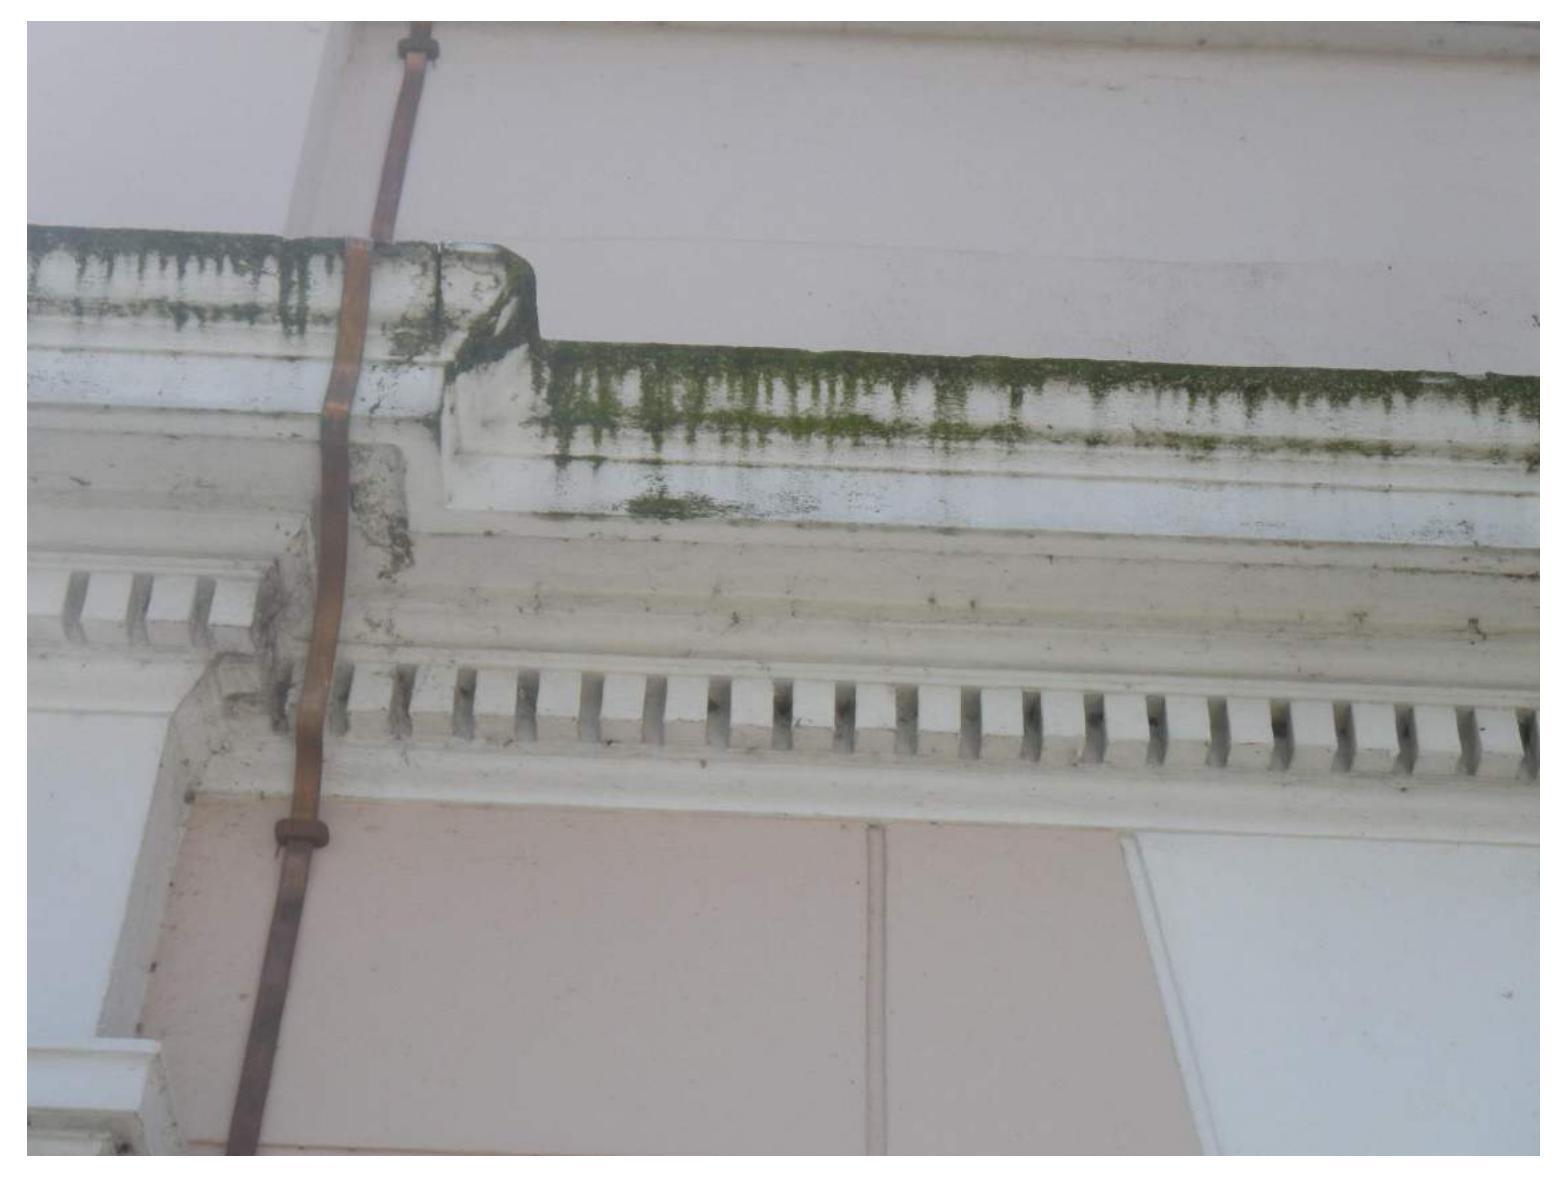
Prolonged Water Spilling Over Projections to Tower

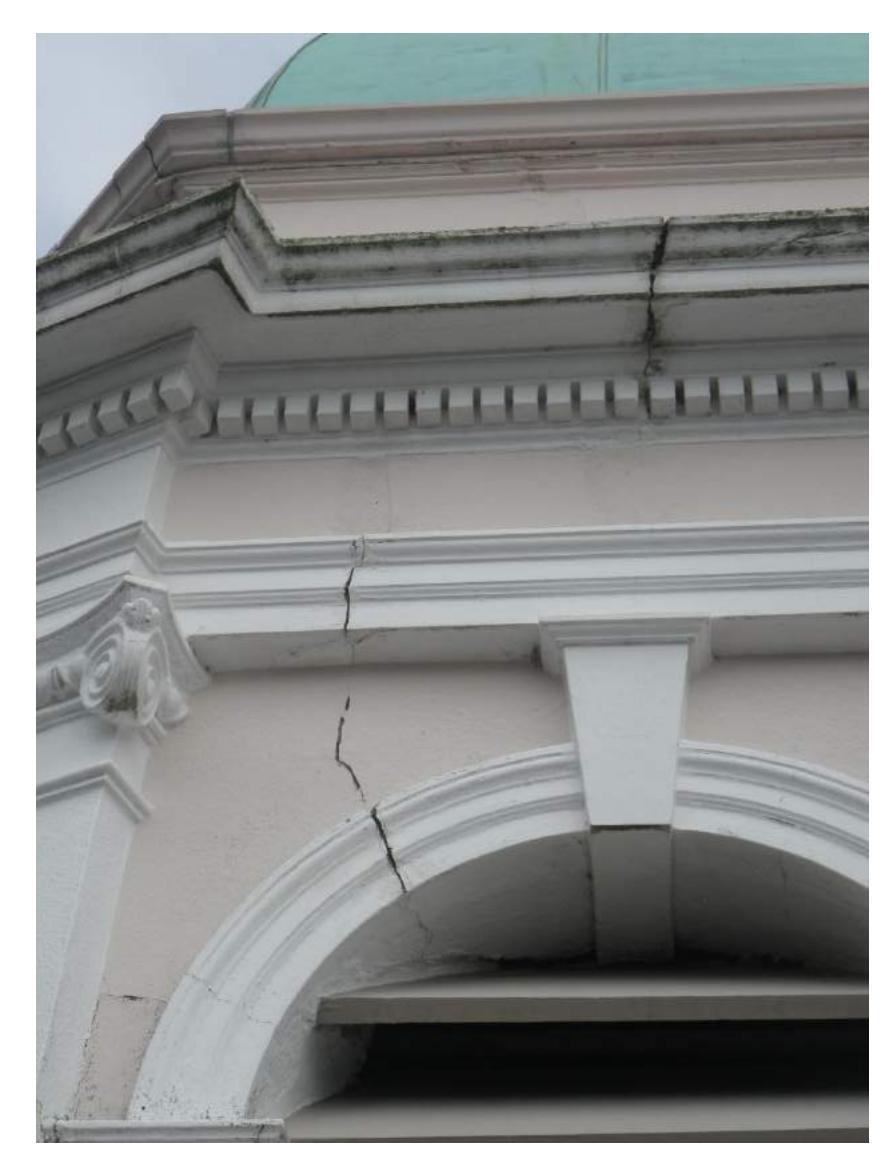
Cracking to Upper Reaches of Tower

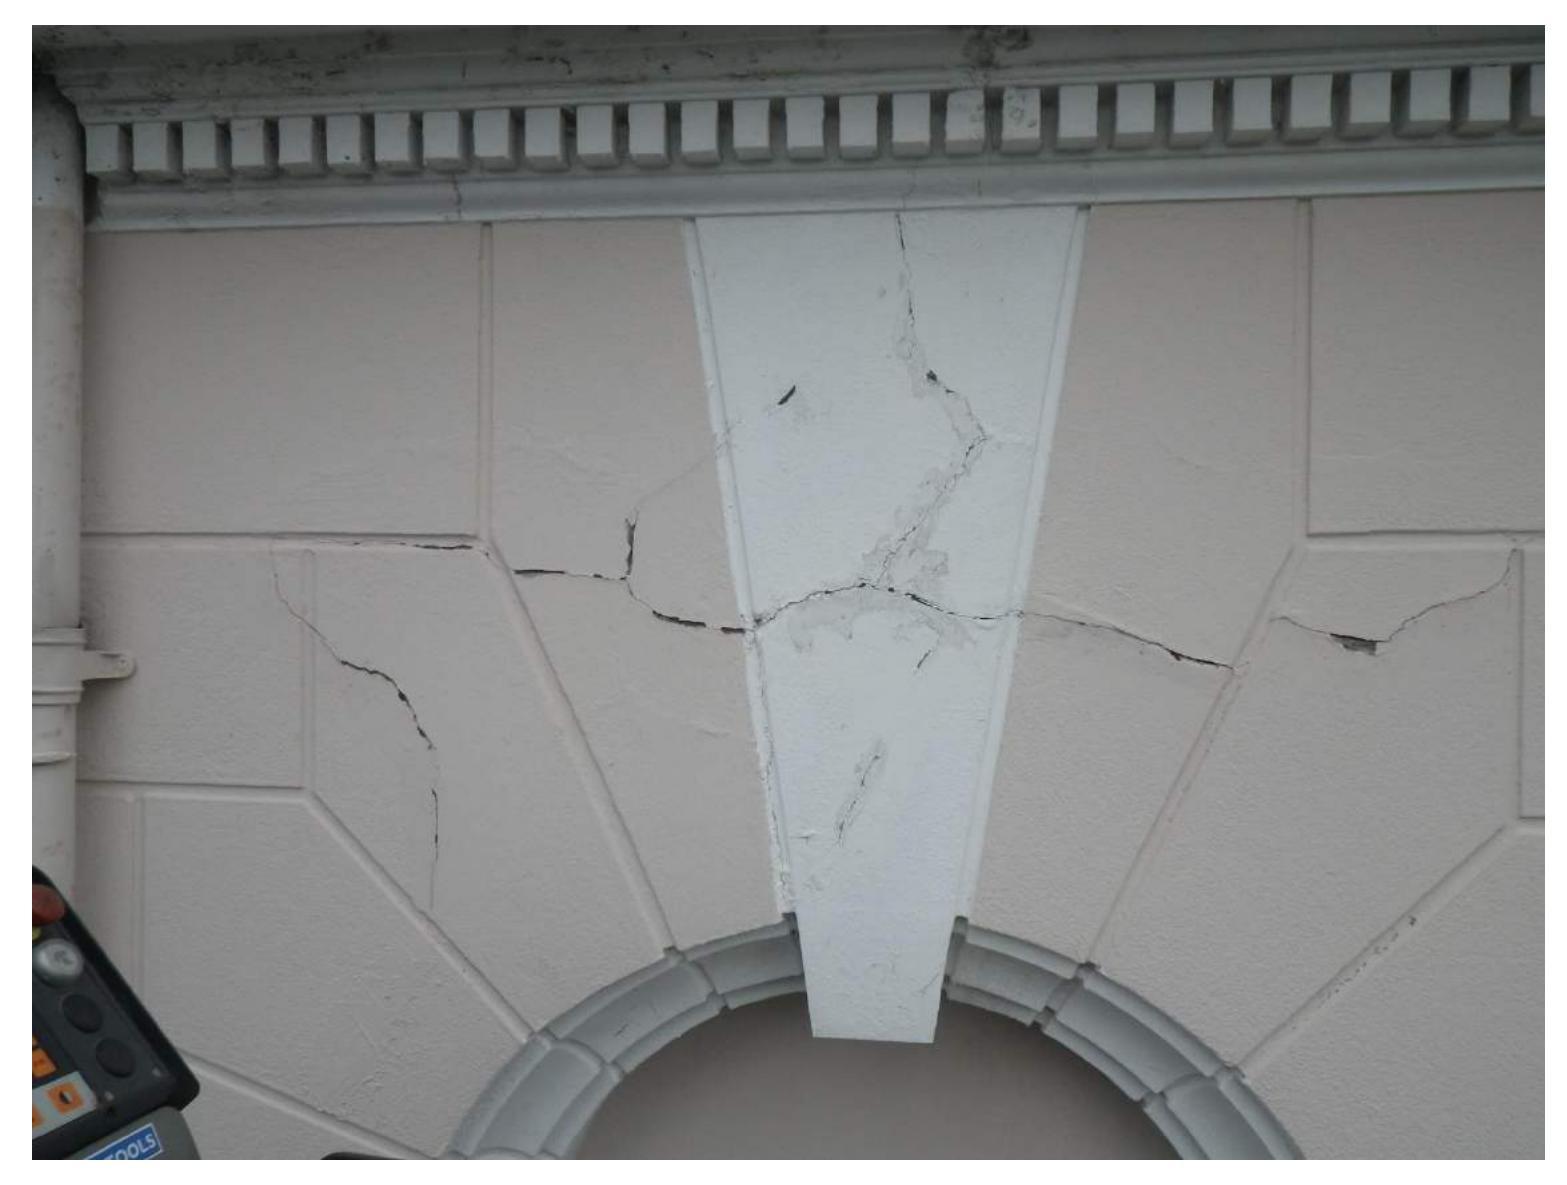
Cracking Above Openings to Tower

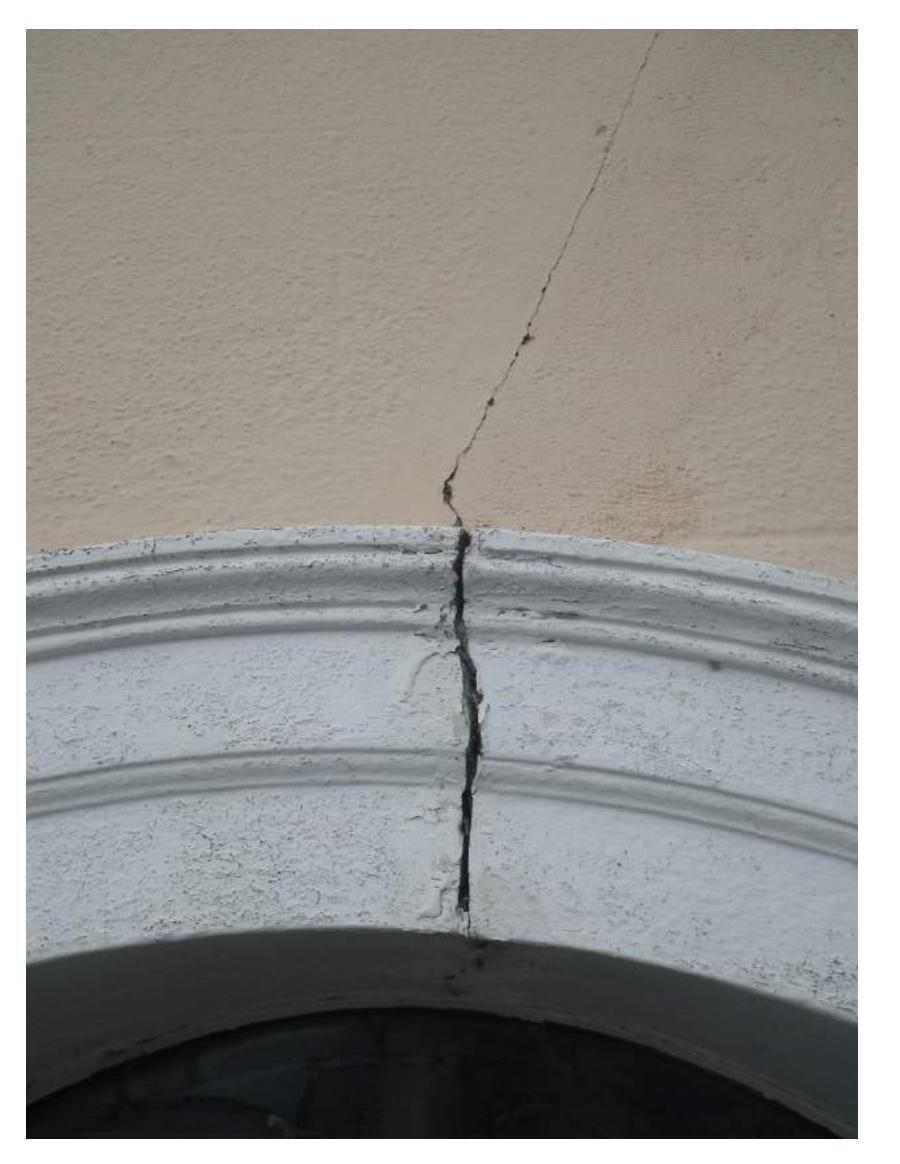
Cracking at Opening Architrave to Tower

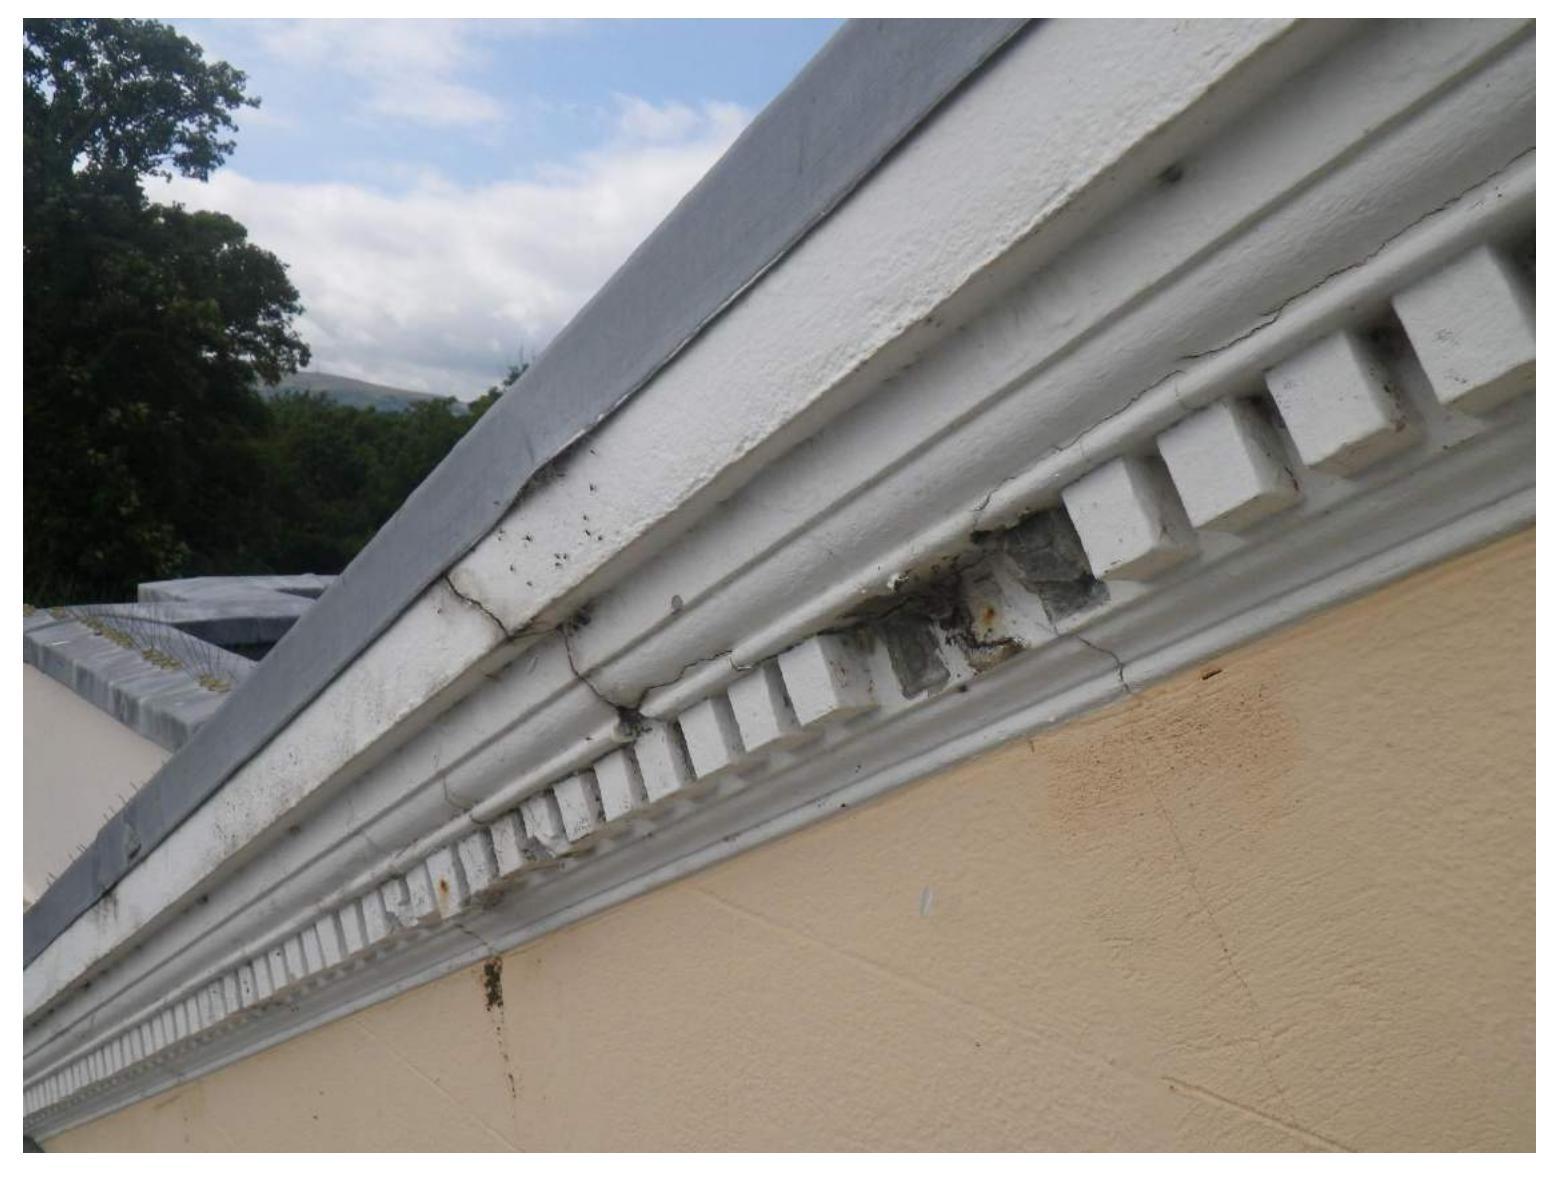
Missing Dentils Front Elevation of Church

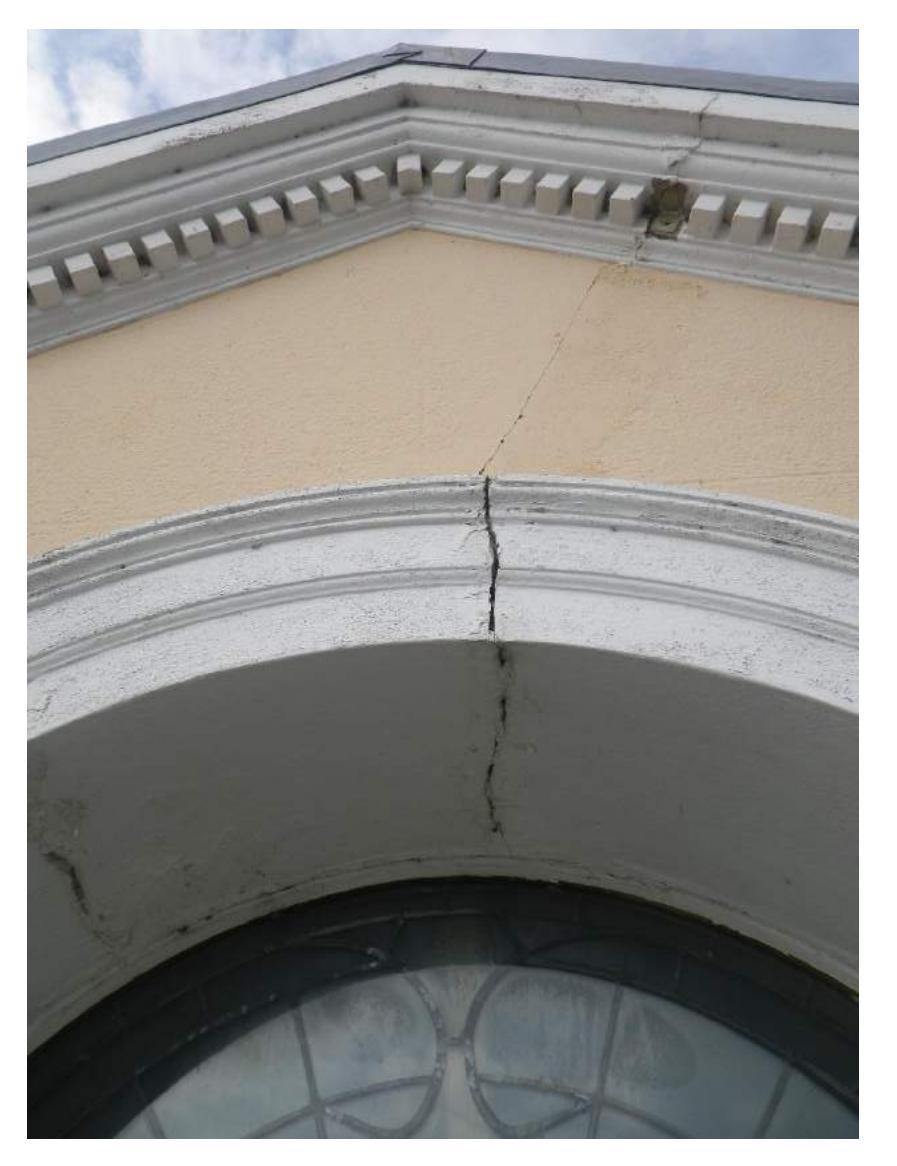
Missing Dentil and Cracks to Front Elevation of Church

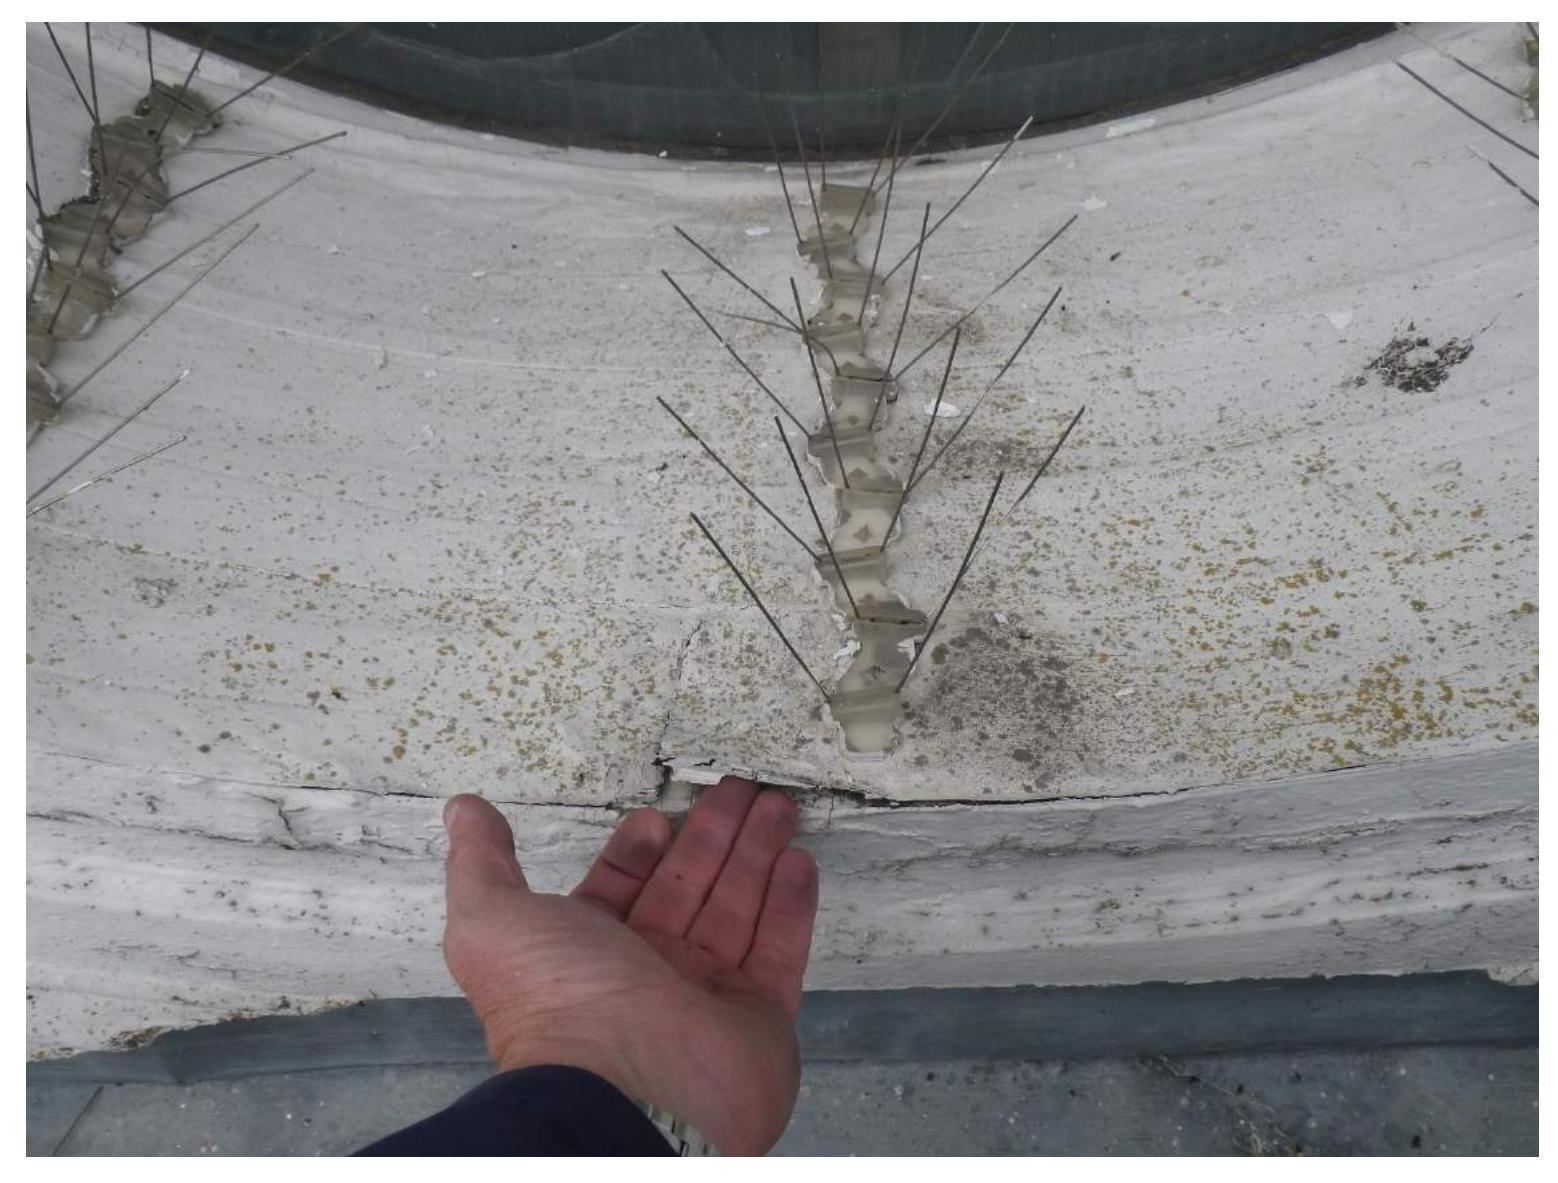
Failing Liners to Oculi Window at Front Elevation of Church

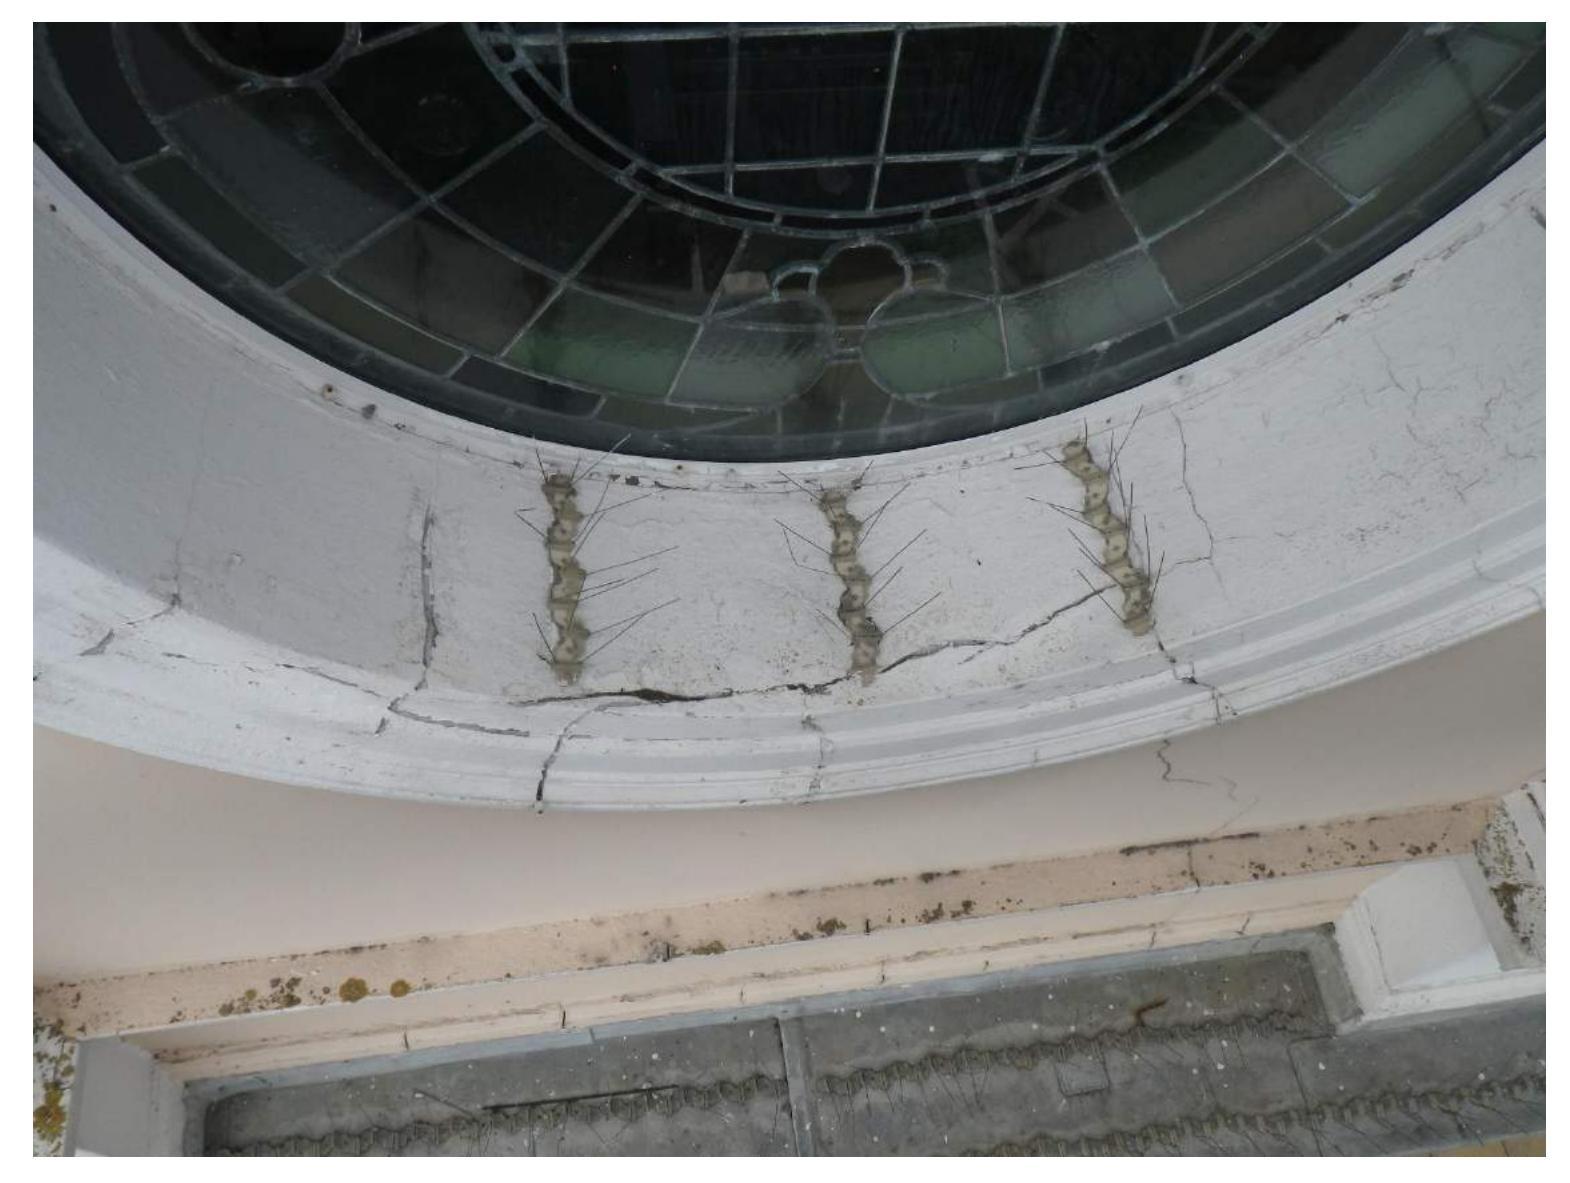
Cracking to Oculi Window Liners Front Elevation of Church

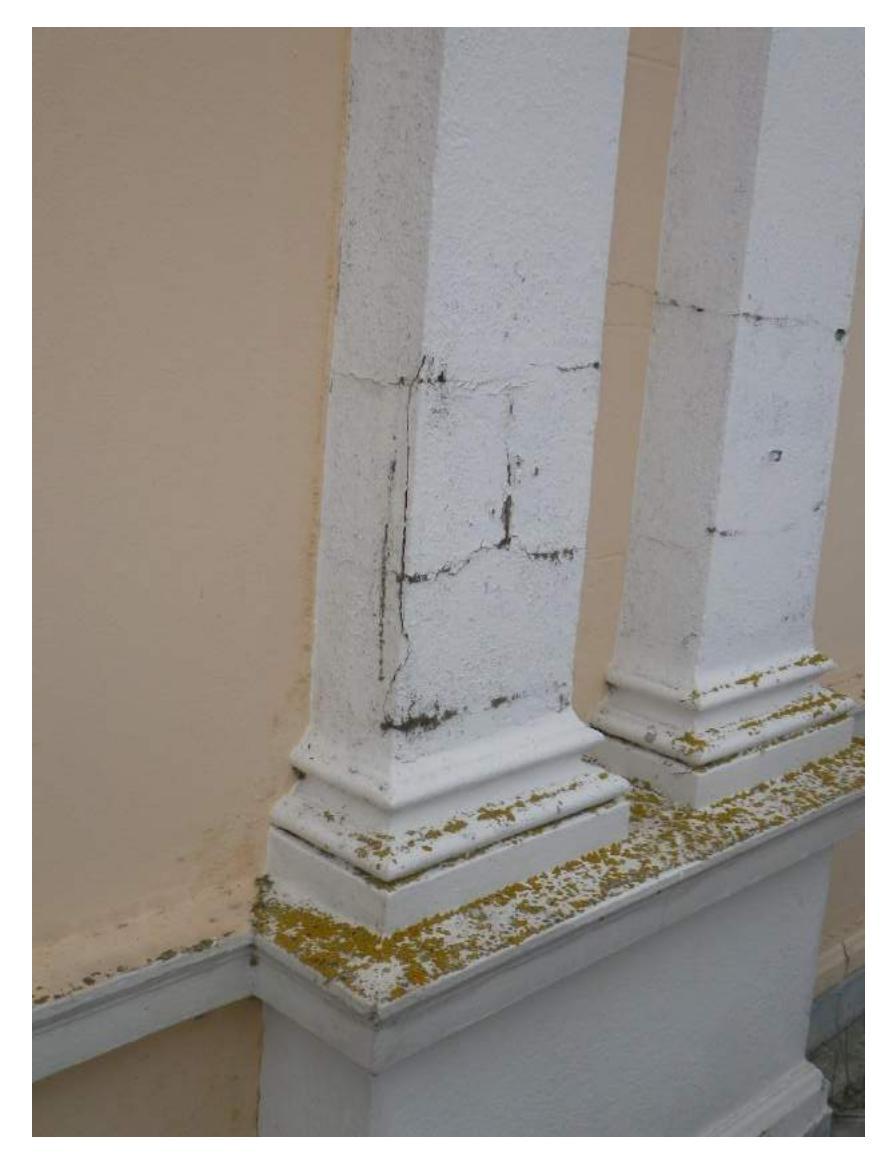
Cracking to Pilasters at Front Elevation of Church
