Whiteabbey Presbyterian Church 602 Shore Road Newtownabbey

Detailed Condition Report (Church)

August 2022

McCOLLUM CONSERVATION

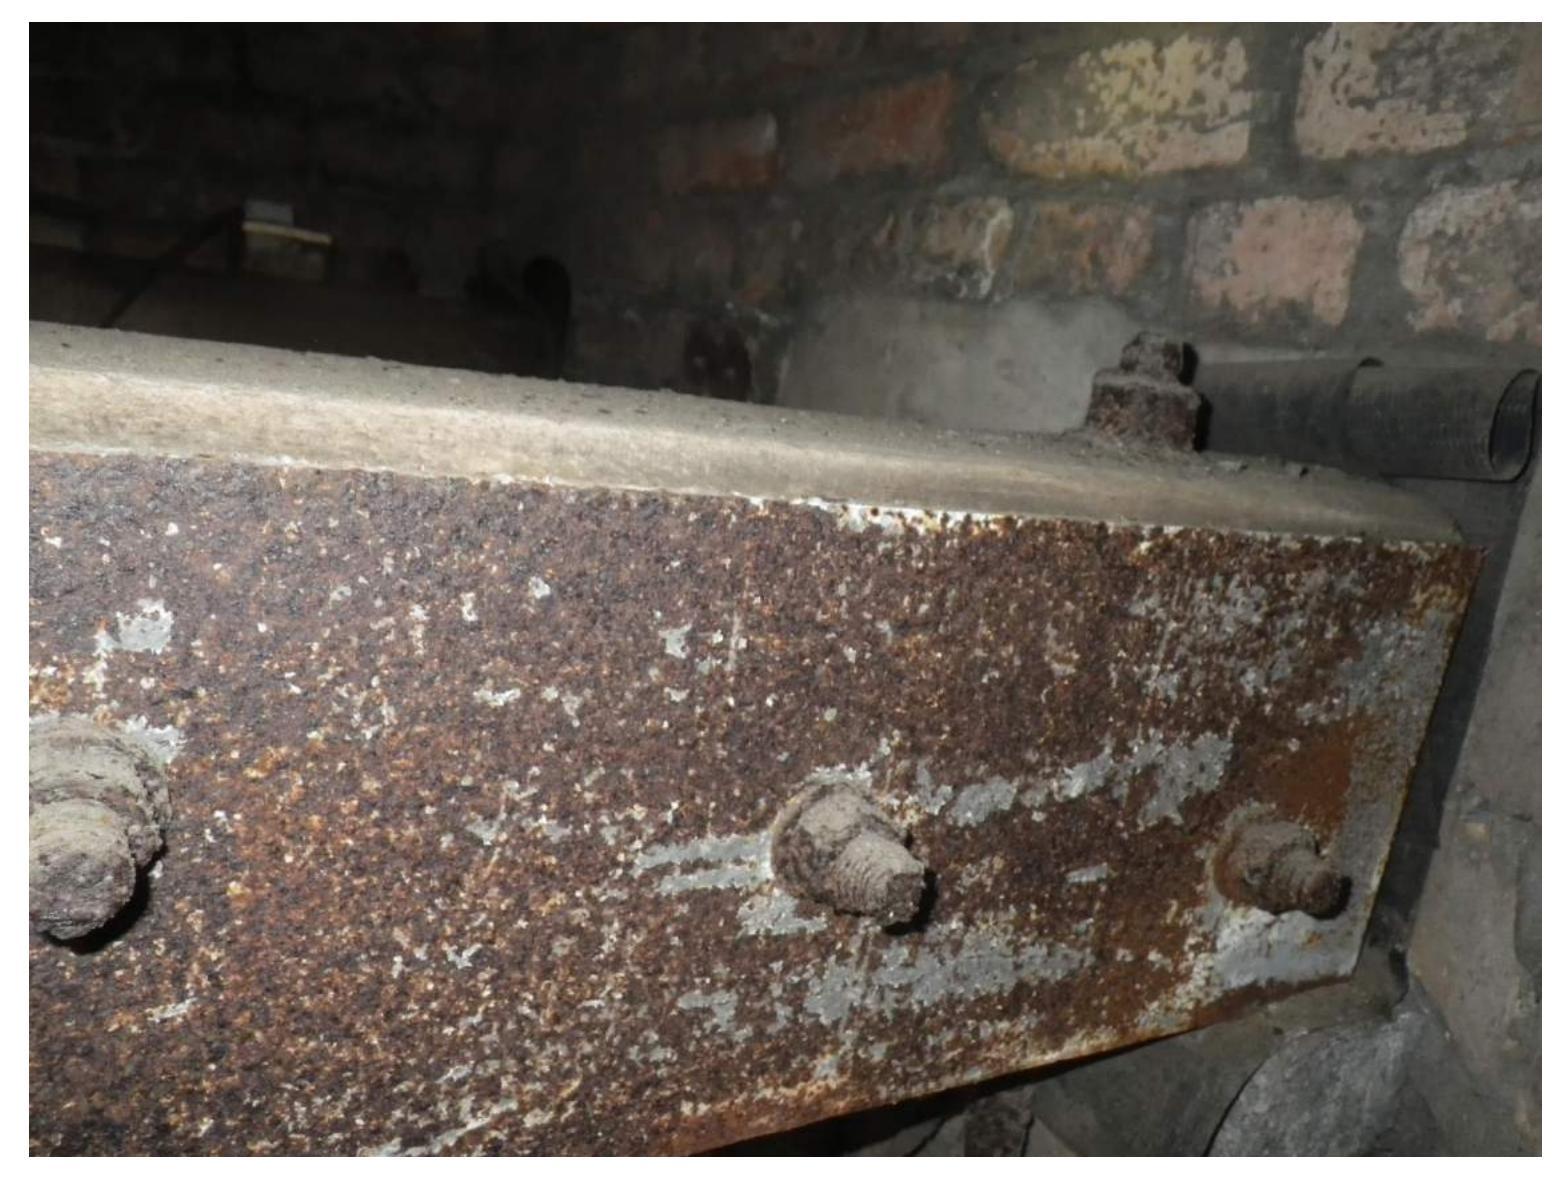
Slight Corrosion to Metal Supports of Bell Carriage

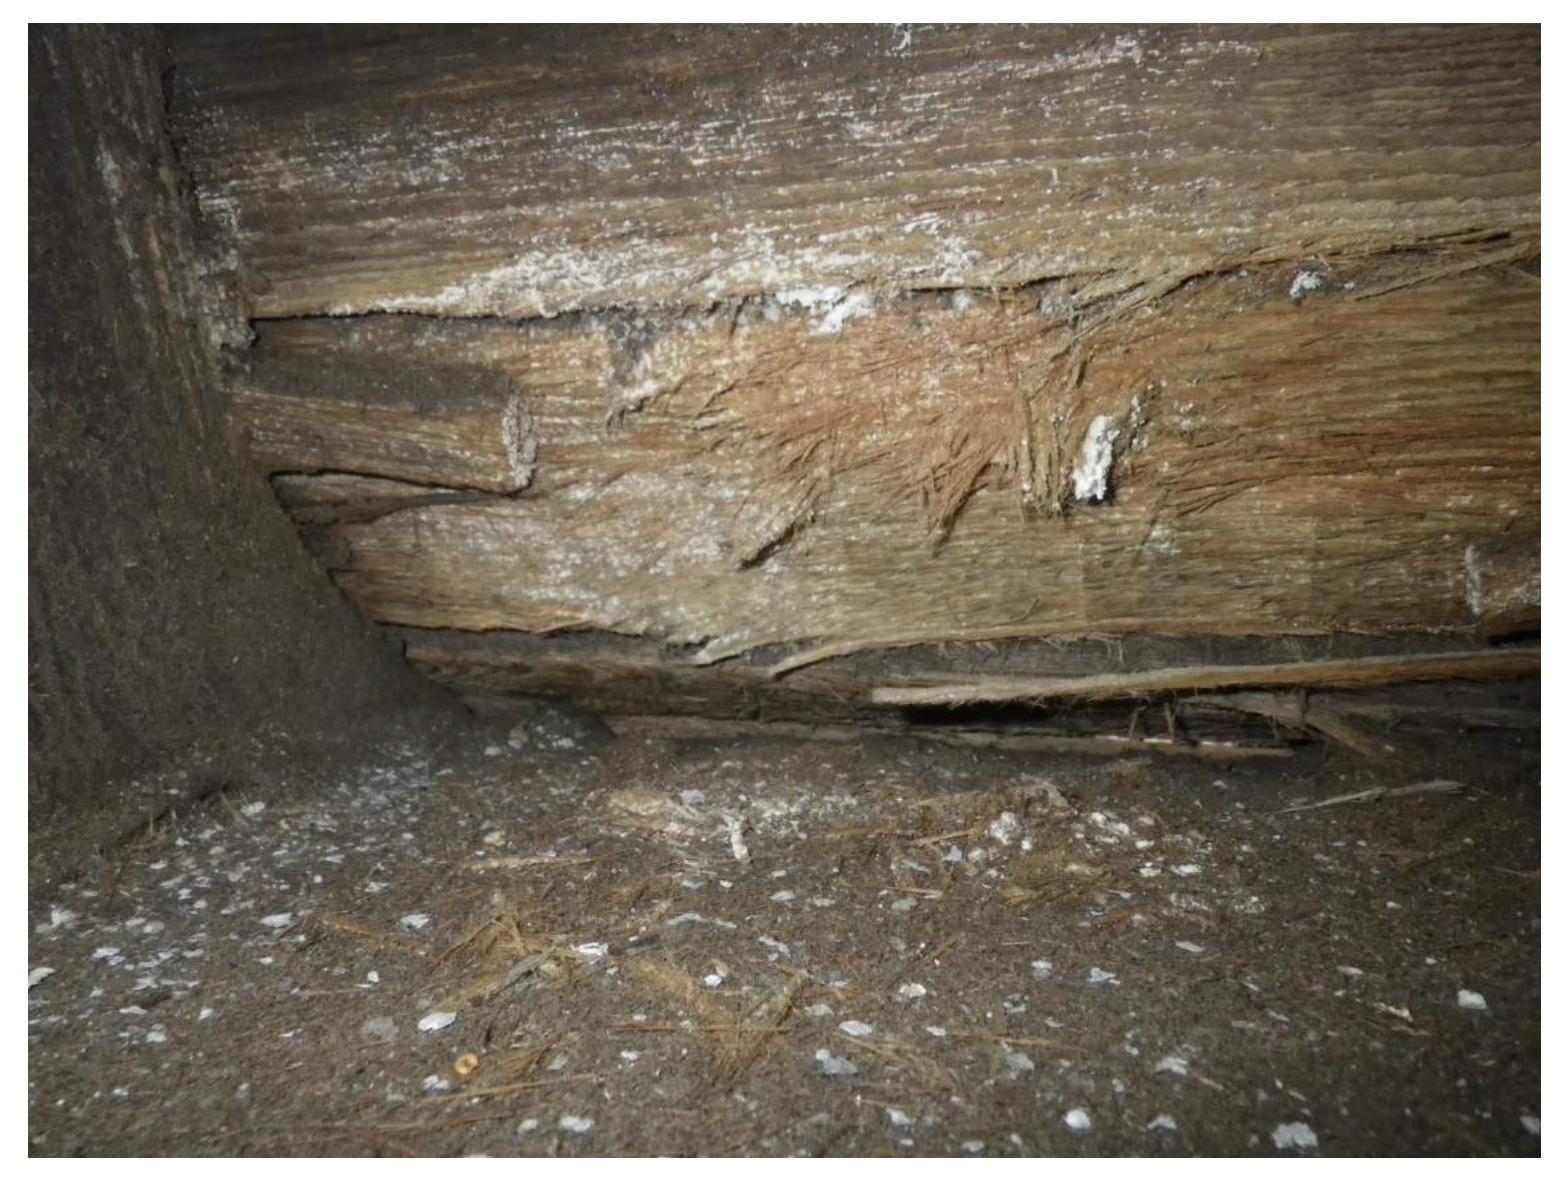
Further Softening of Timbers at Base of Copper Roof

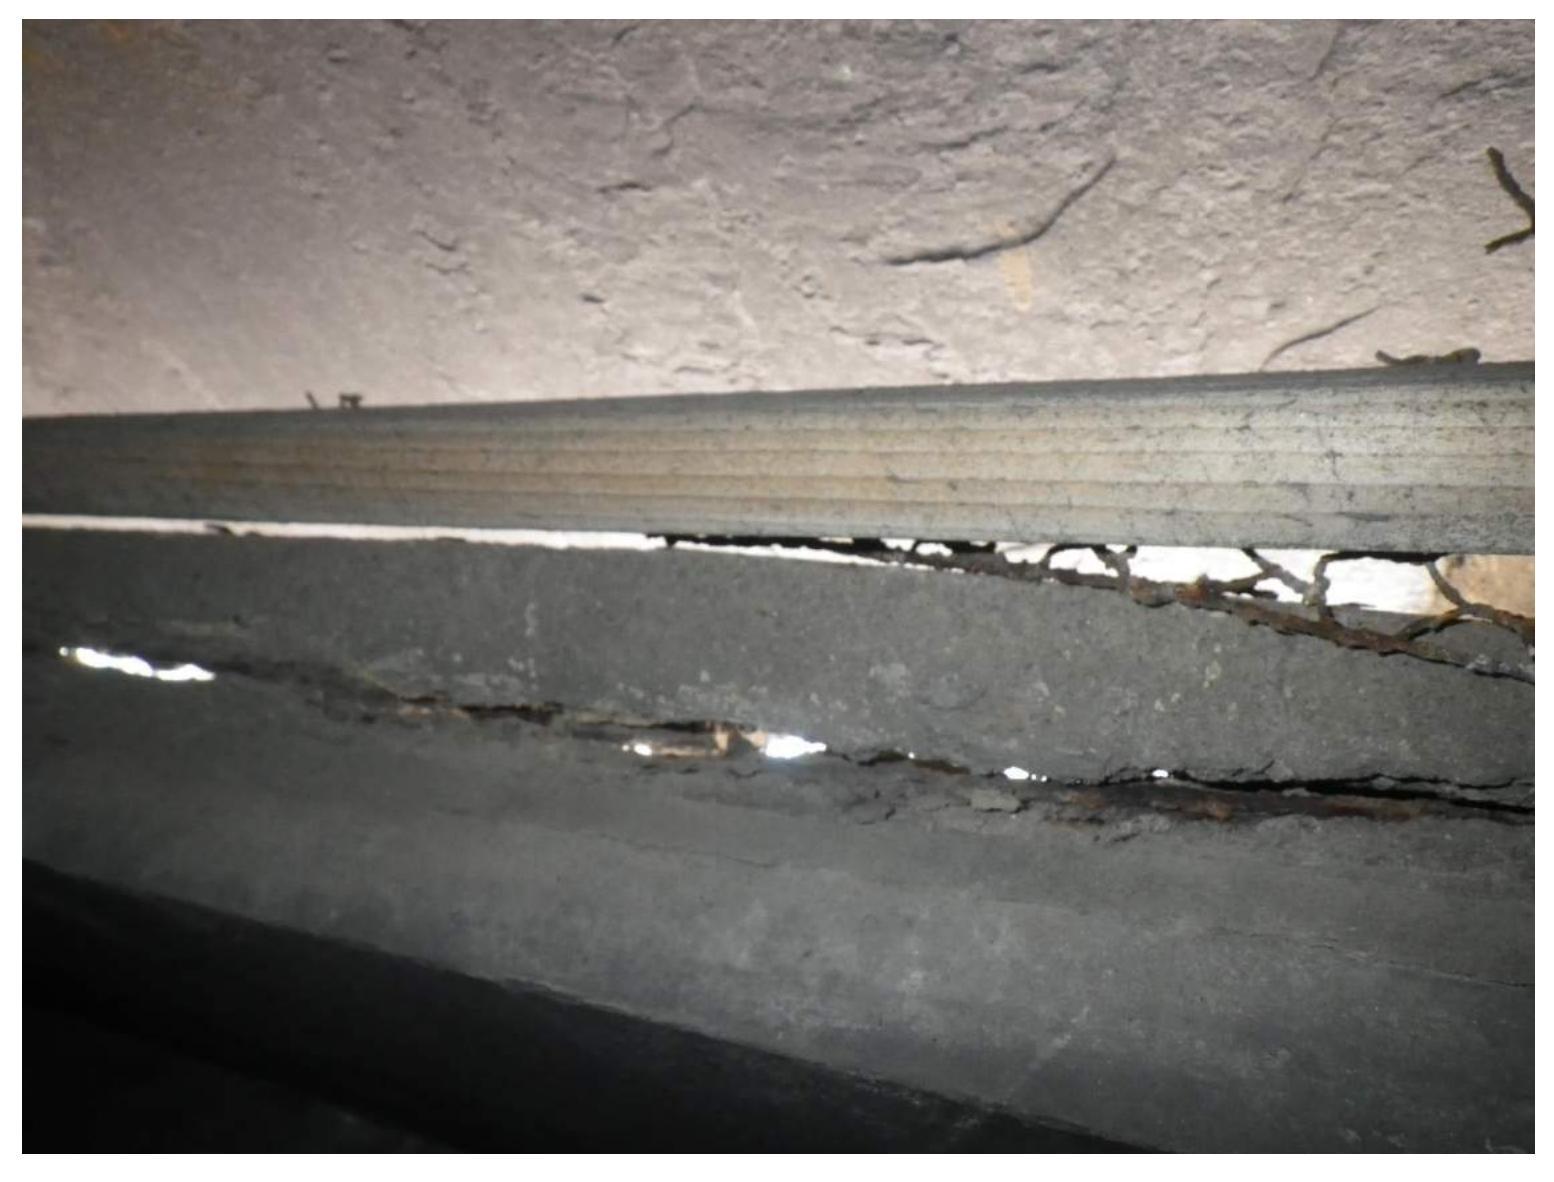
Cement Patching to Bell Louvres Now Loose and with Corroding Supports

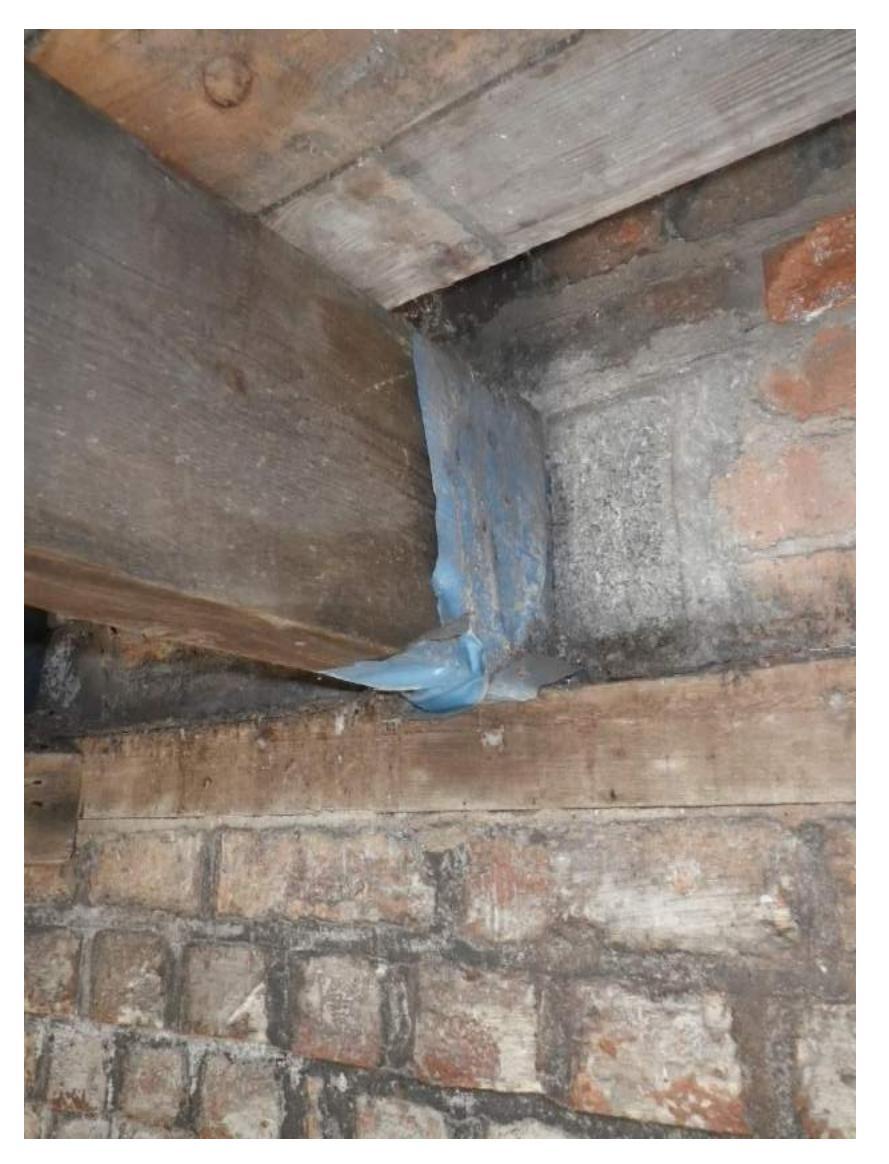
Past Repairs to Timbers within Tower

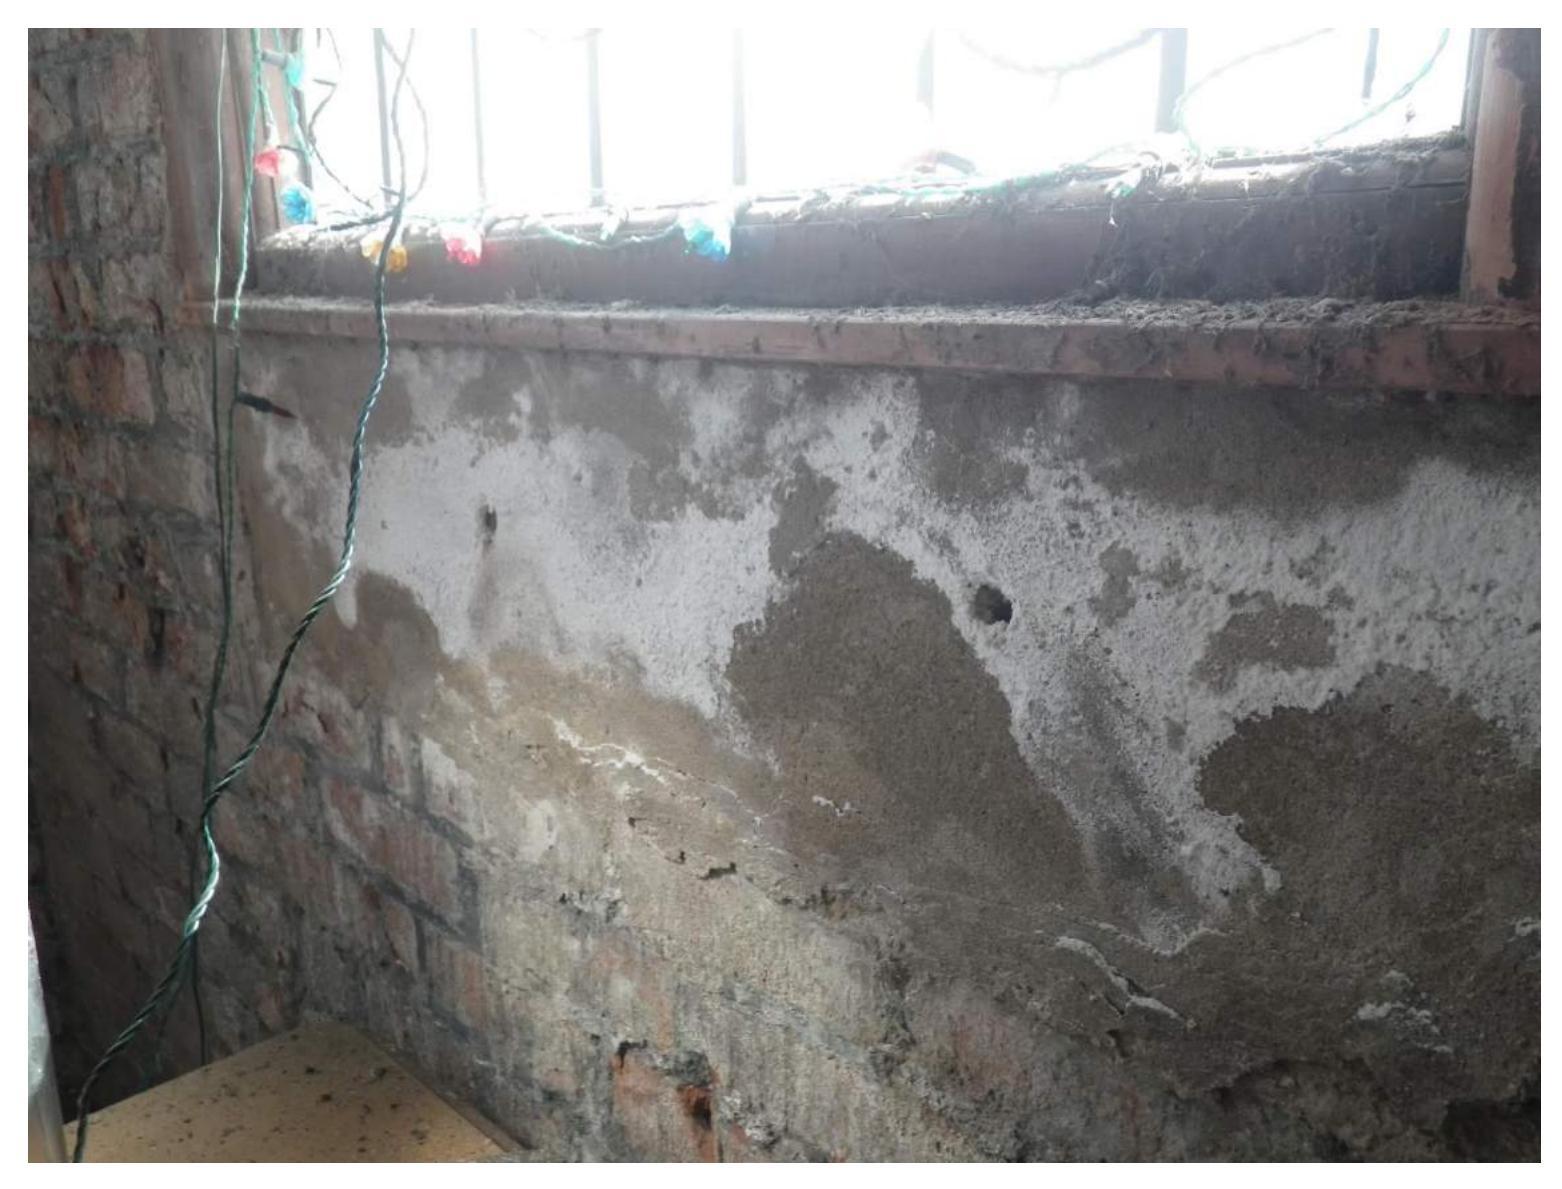
Penetrating Damp around Windows to Tower

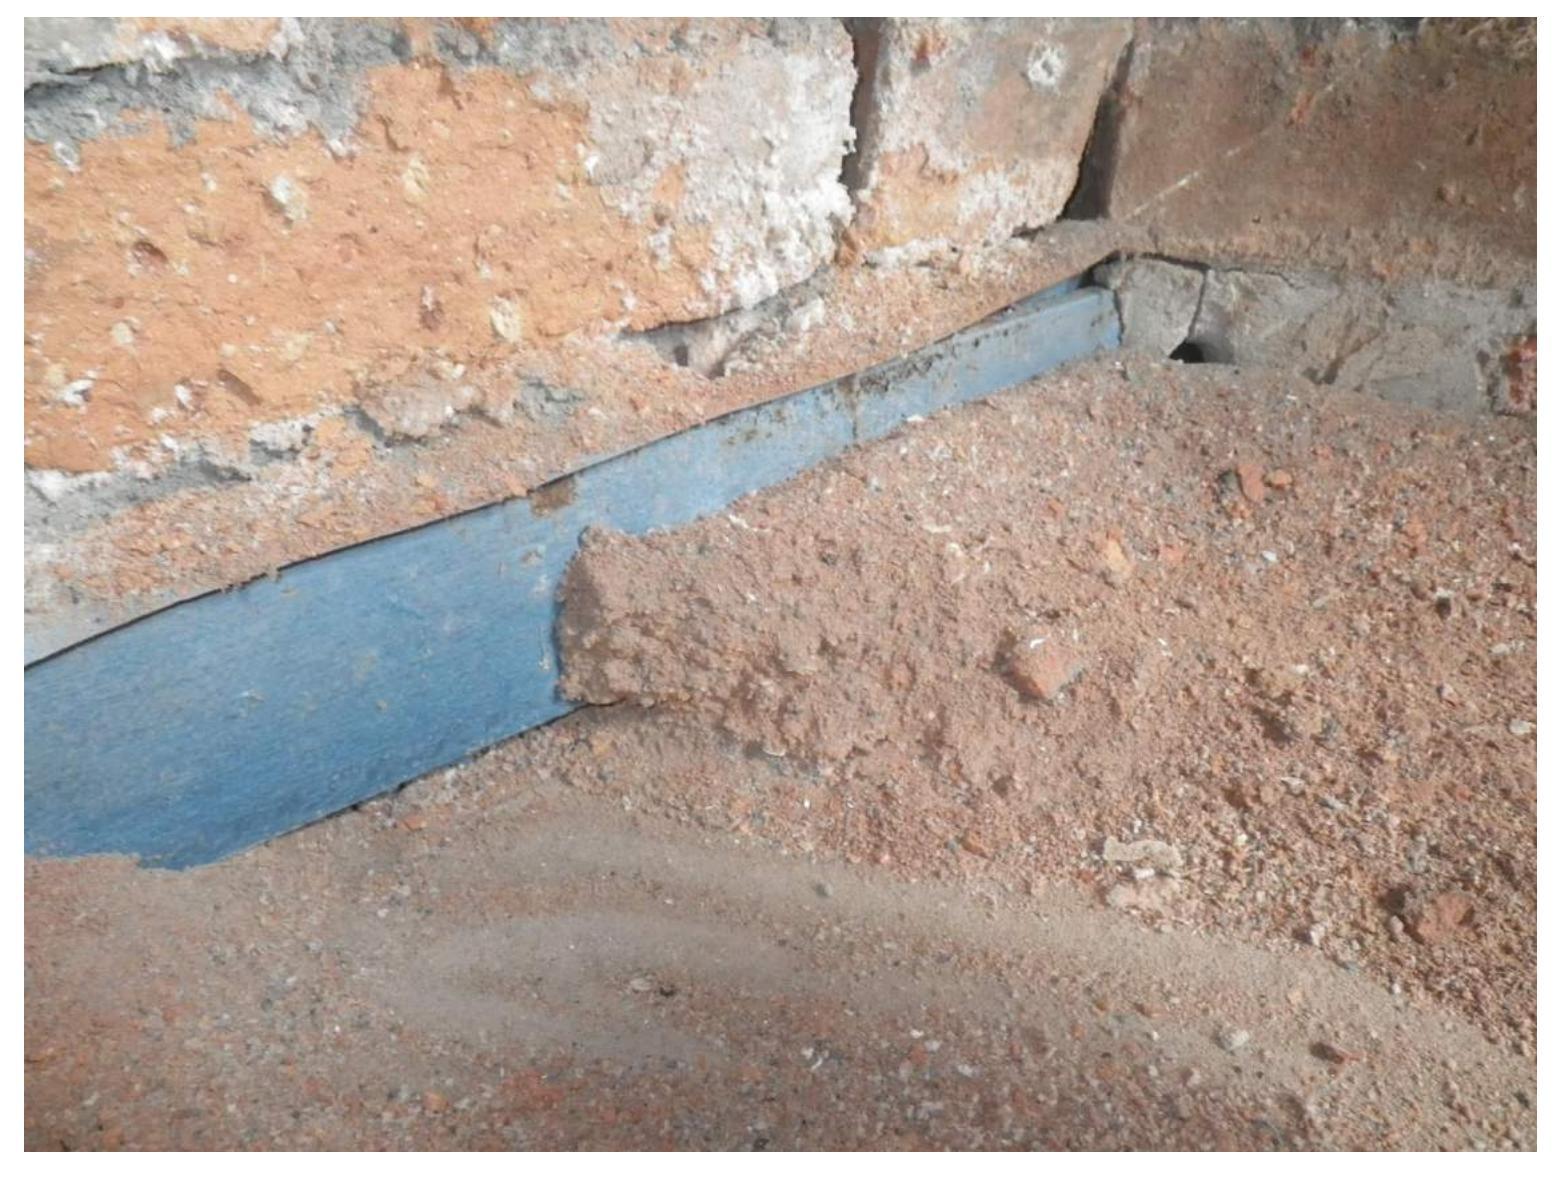
Extent of Loss of Brick Faces within Tower (since the previous scheme of repairs)

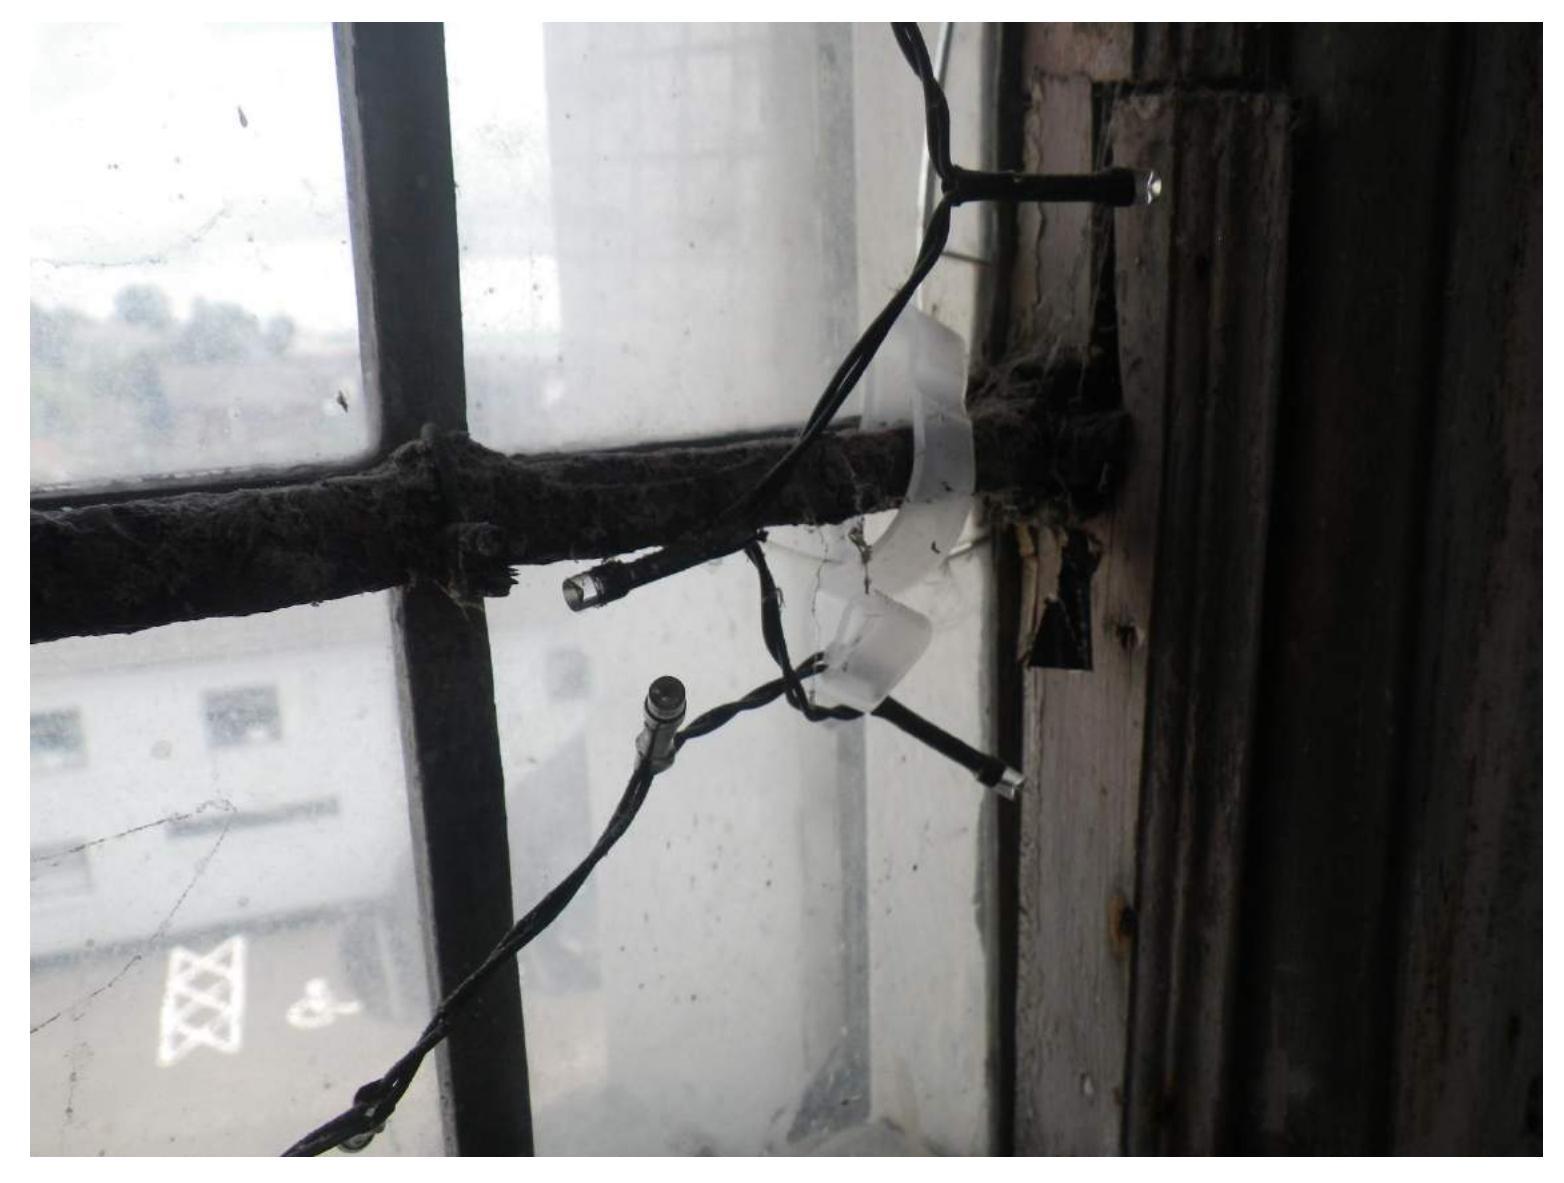
Corroding Ferramenta to Tower Window

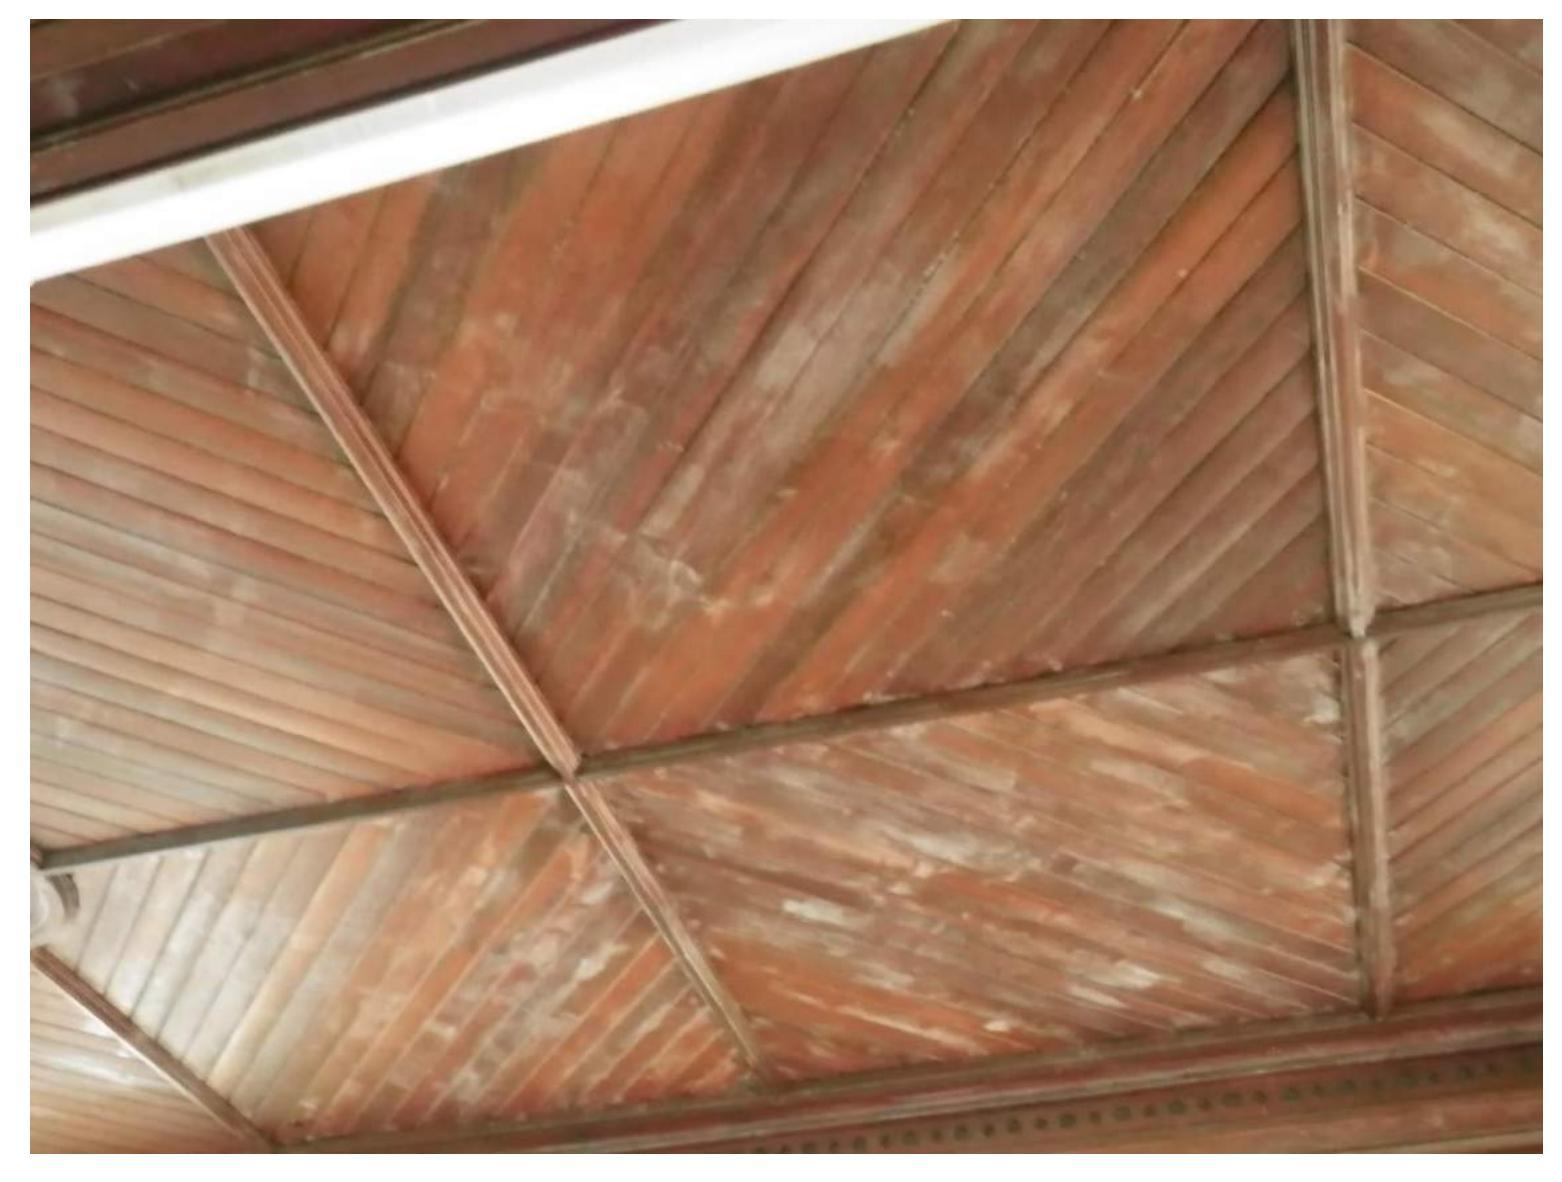
Staining to Main Ceiling of Church due to previous dampness

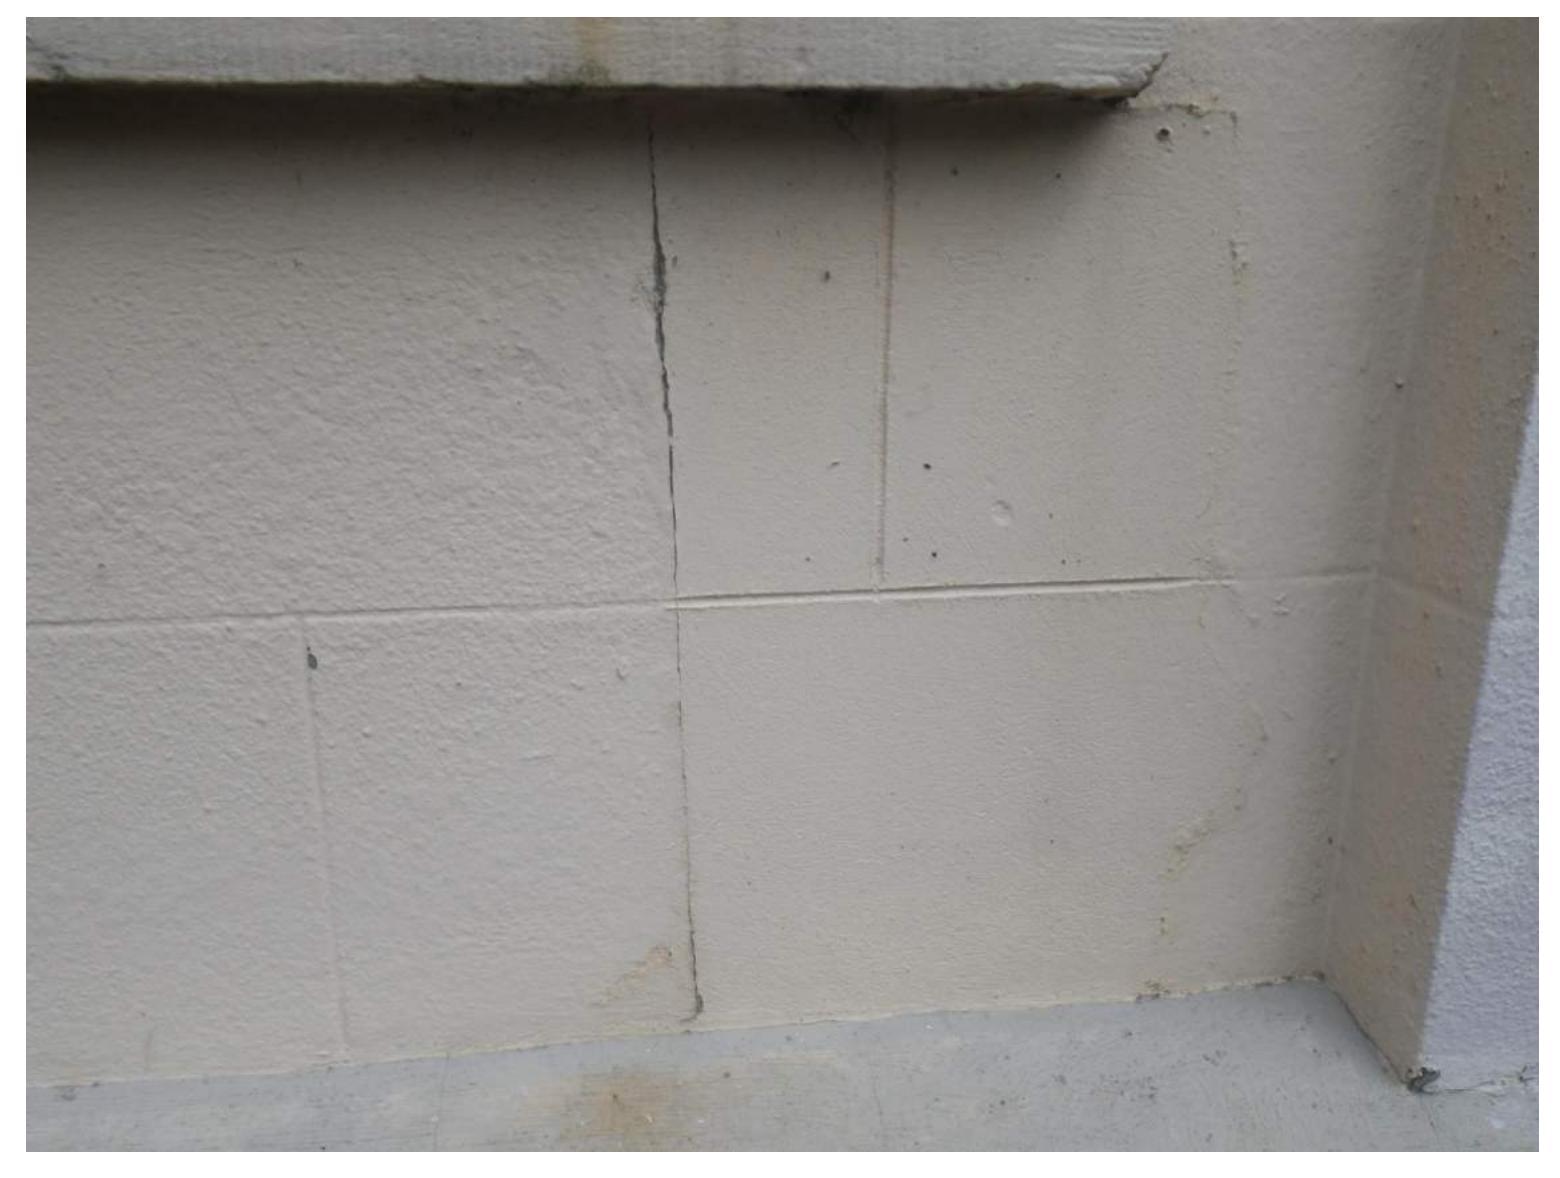
Evidence of Previous Repairs Main Church Render

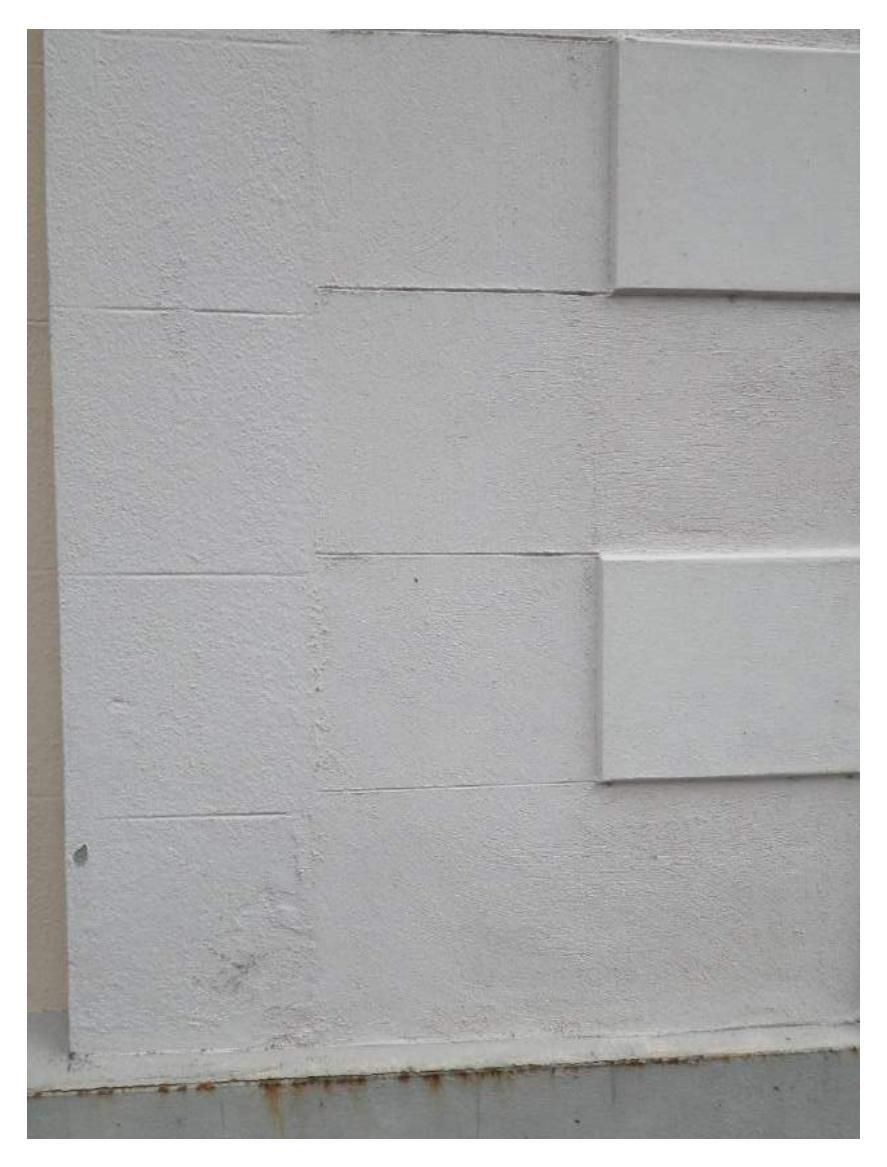
Evidence of Previous Repairs Main Church Render

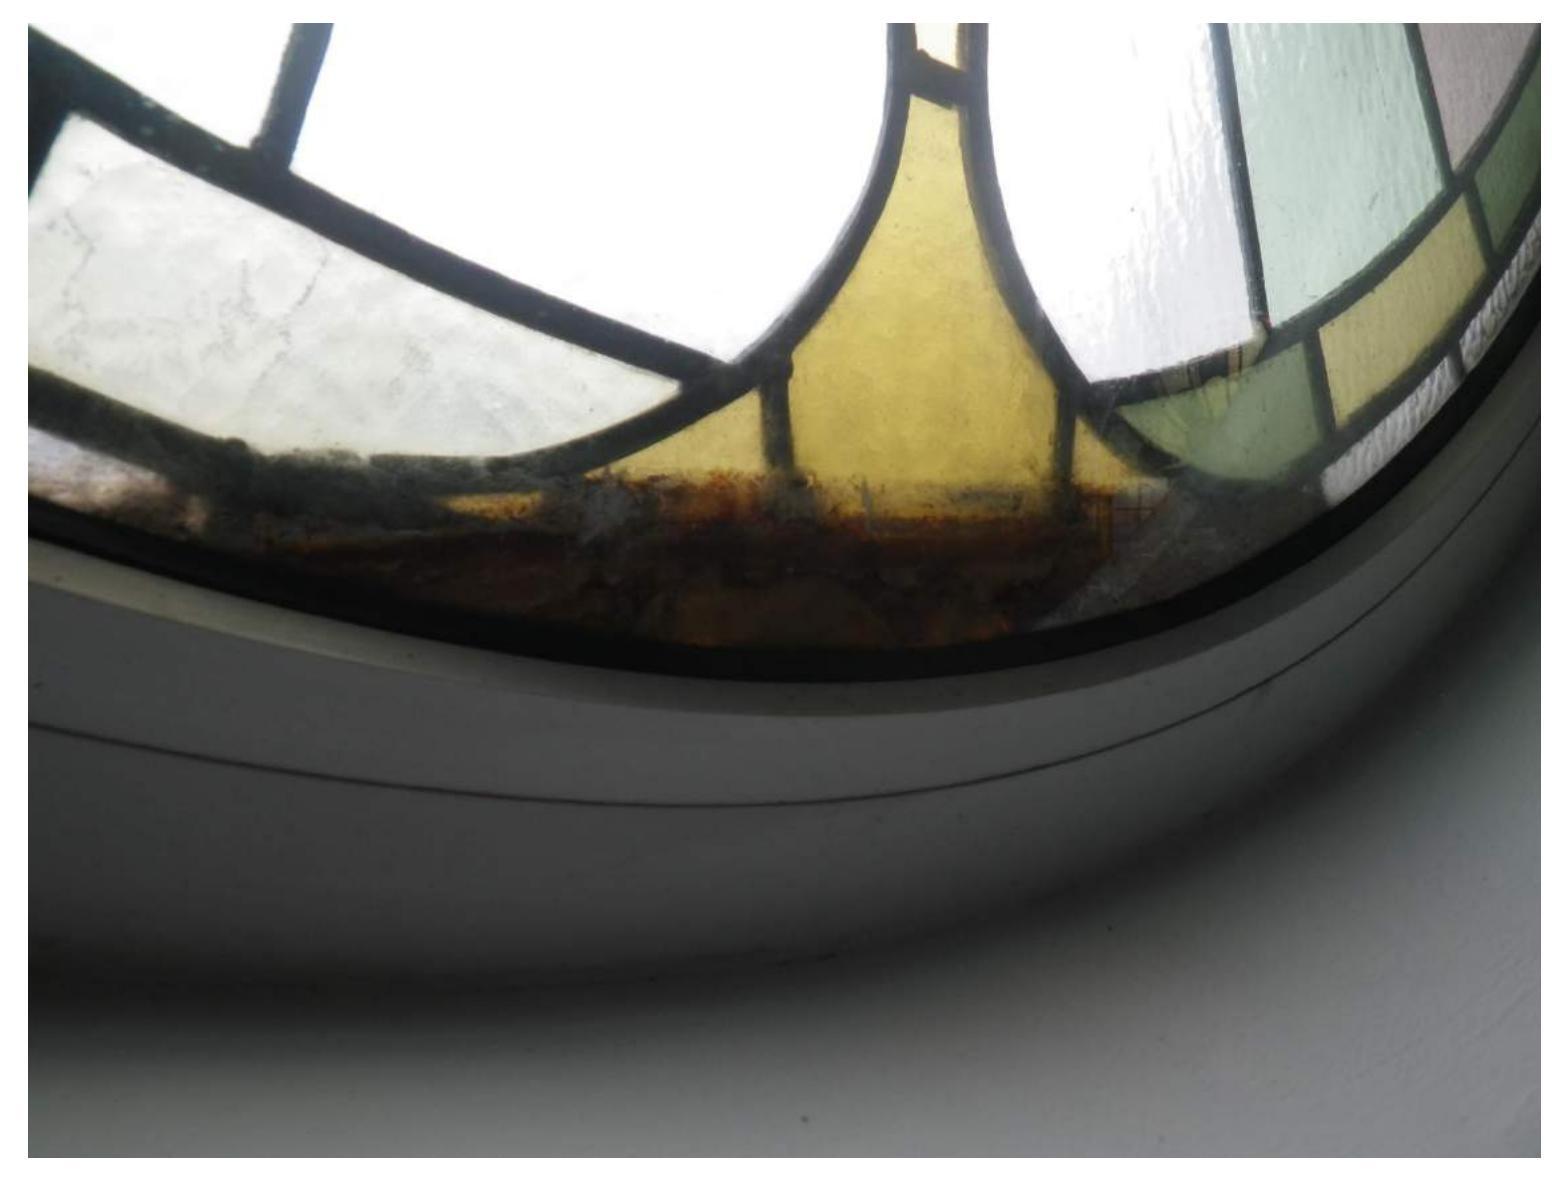
There is dampness accruing to the east wall of the Church and this takes the form internally of localised penetrating damp around the oculi windows to the Gallery and patchy dampness elsewhere. In addition, there is localised penetrating damp staining to both Transepts, some of which relates to older, now remedied, defects and a slight issue of rising and penetrating damp within both staircases behind the Chancel. This dampness is due to marine weather driving rain under pressure onto these walls where the render is beginning to fail. There is evidence of ongoing patching of wall render across the Church, but the time has come to initiate a programme of complete rerendering of the Church walls.

Water Penetration Oculi Windows Main Elevation of Church

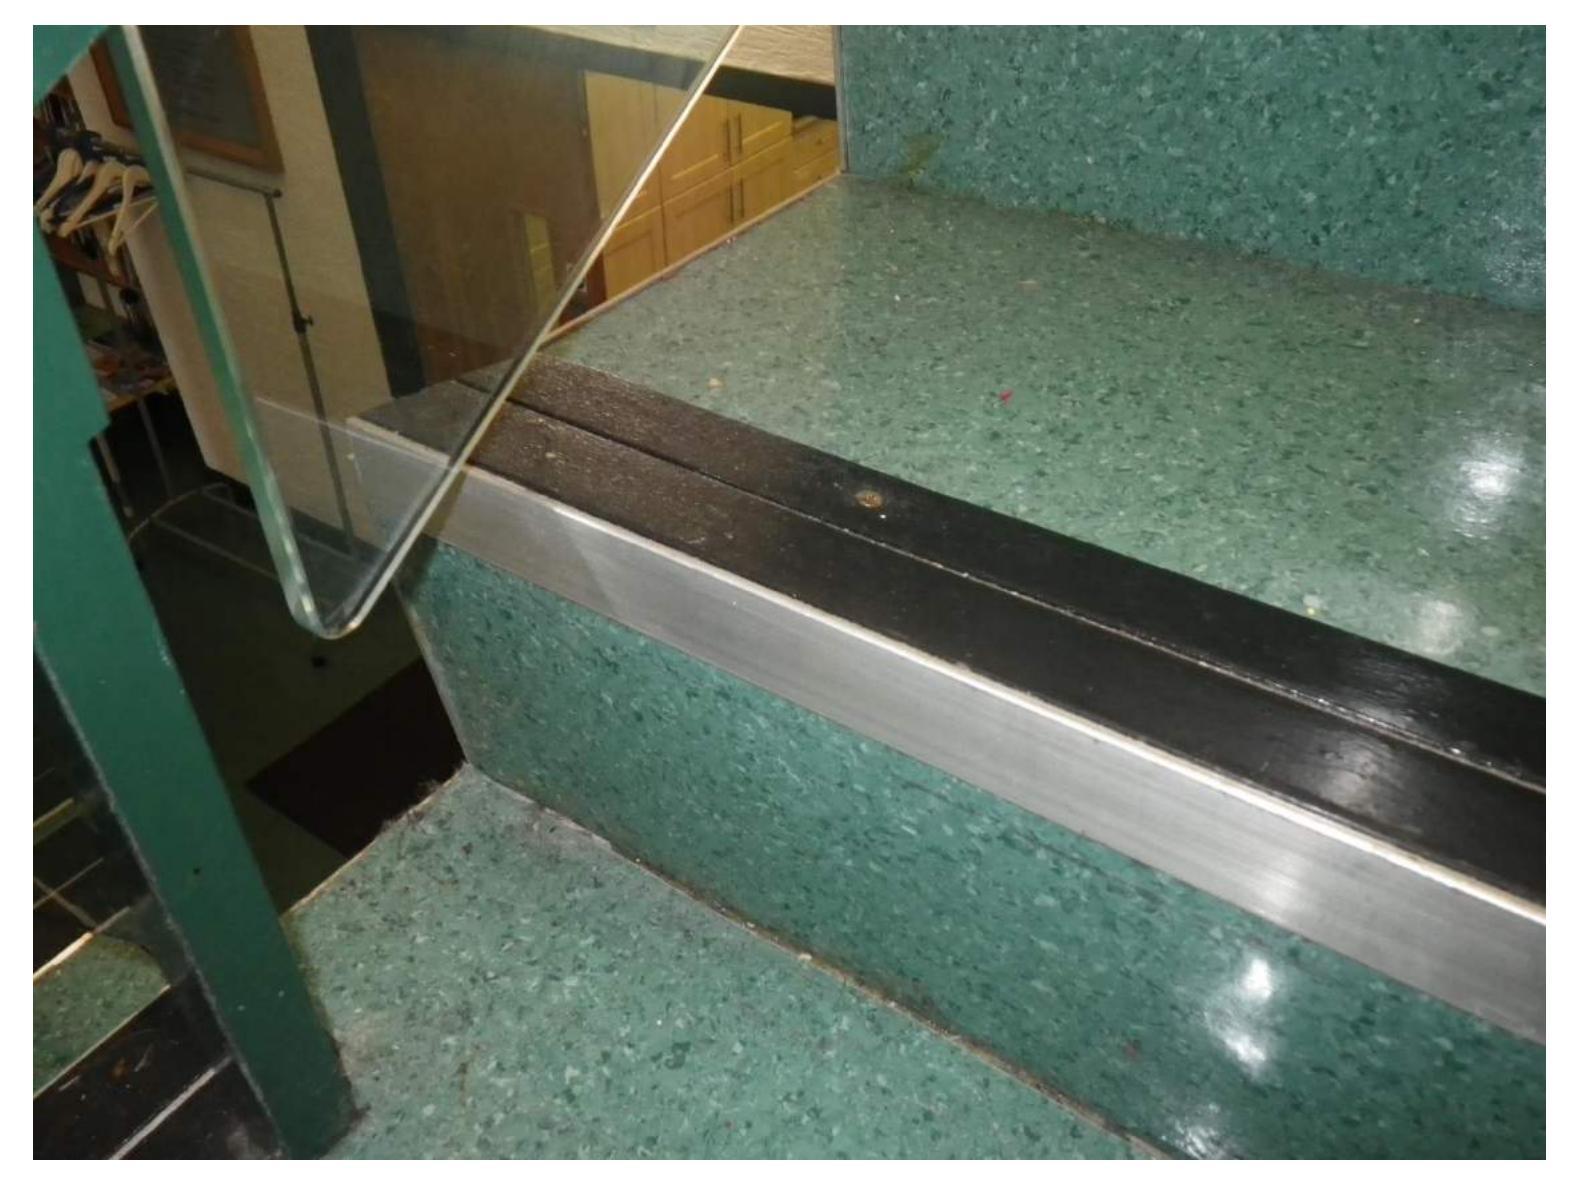
Loose Nosing to Principal Staircase

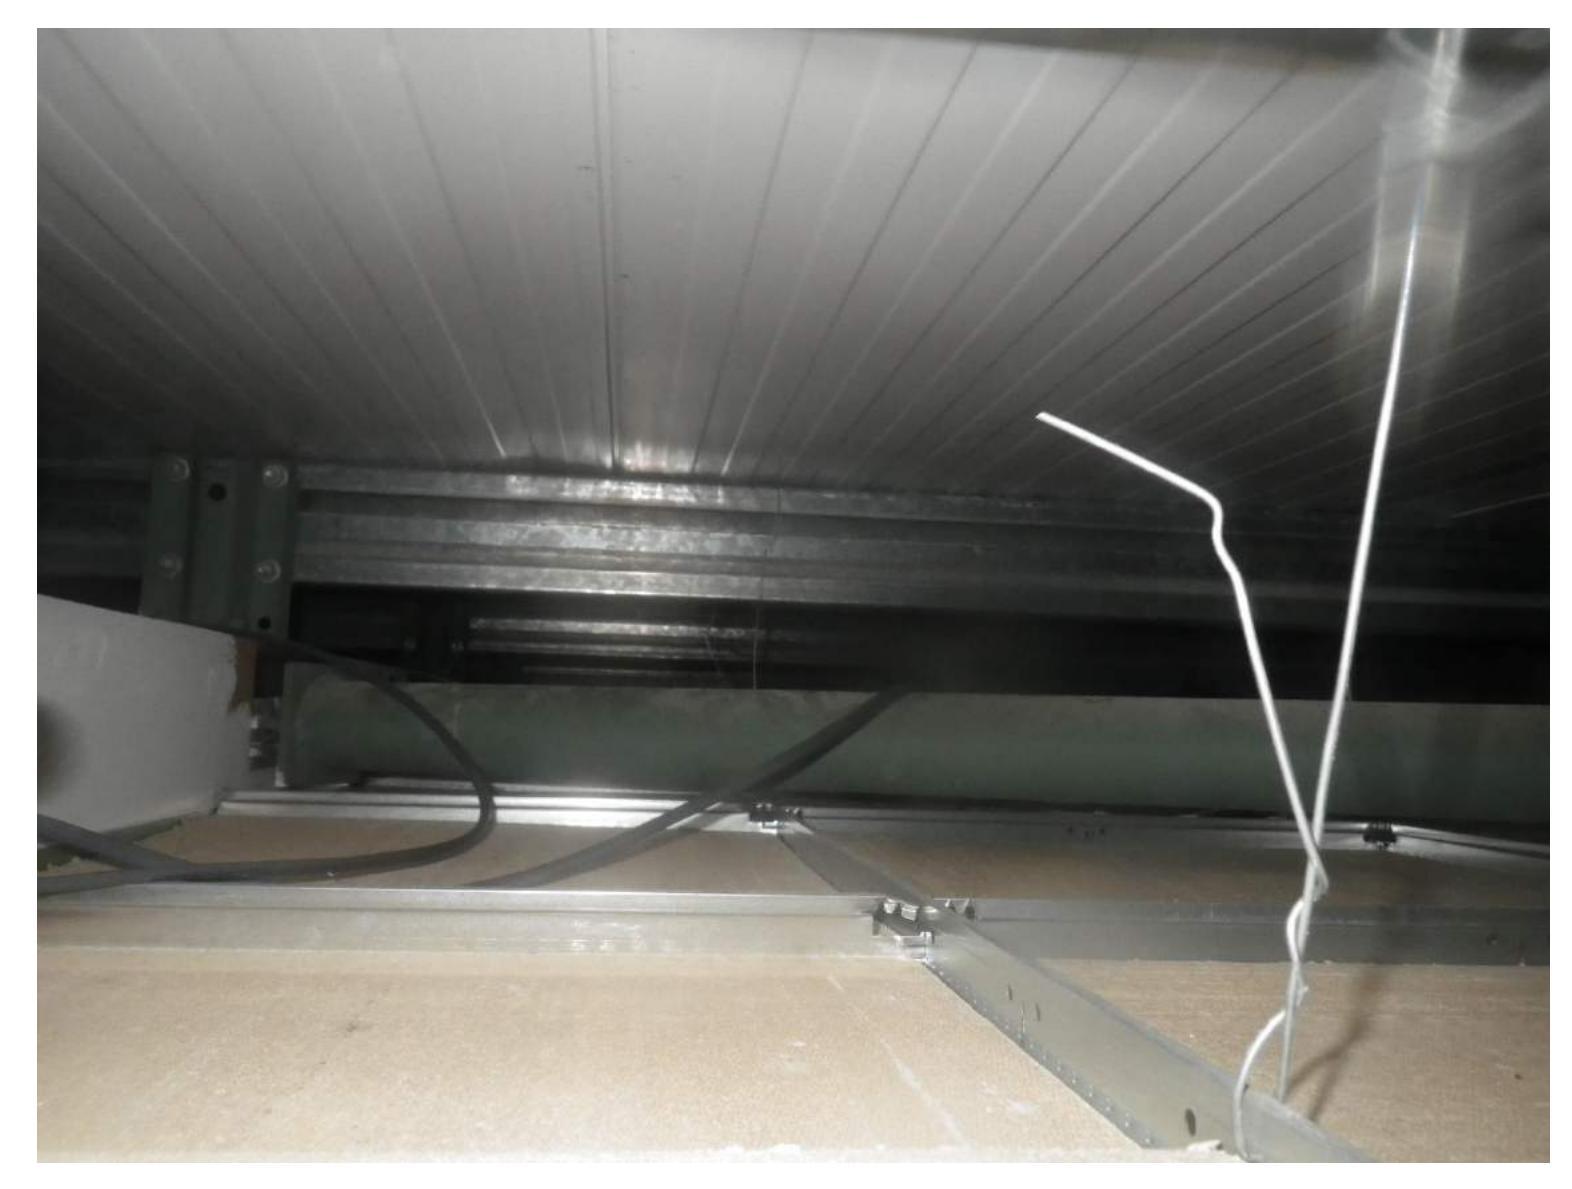
View of Roof Space to Hall
