Whiteabbey Presbyterian Church 602 Shore Road Newtownabbey

Detailed Condition Report (Church)

August 2022

McCOLLUM CONSERVATION

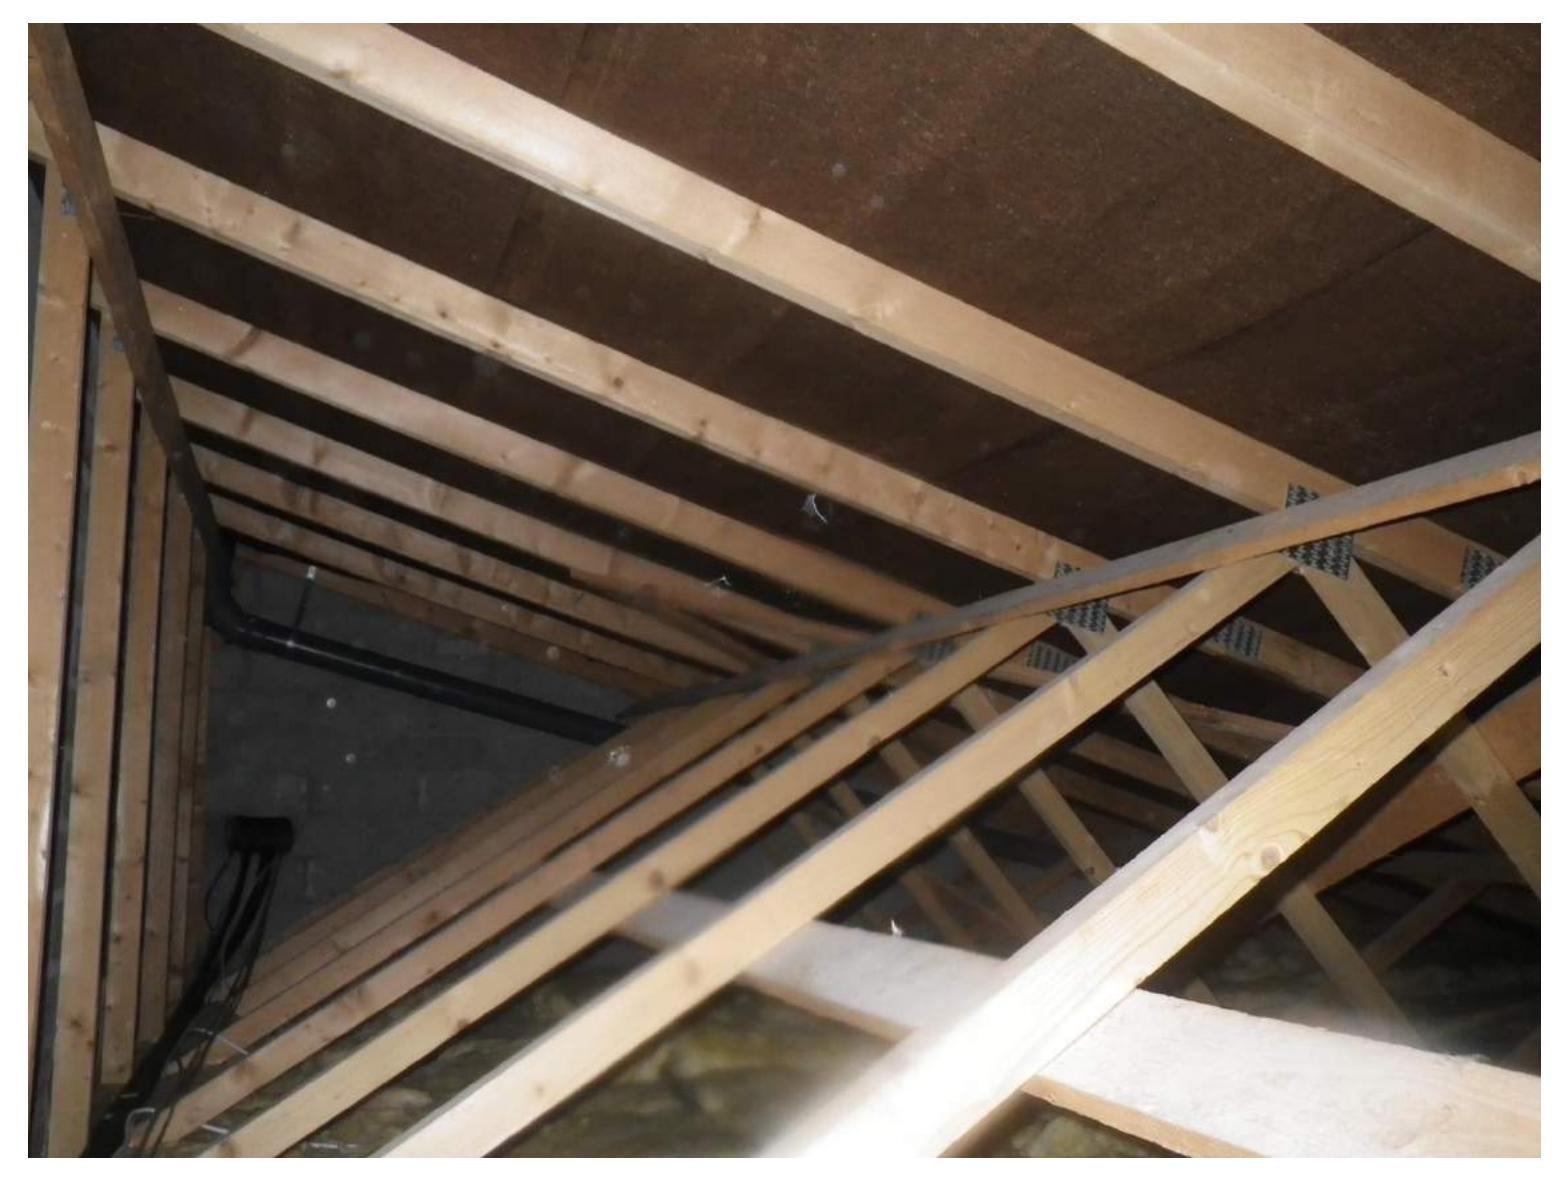
Trussed Roof to Hall Stores

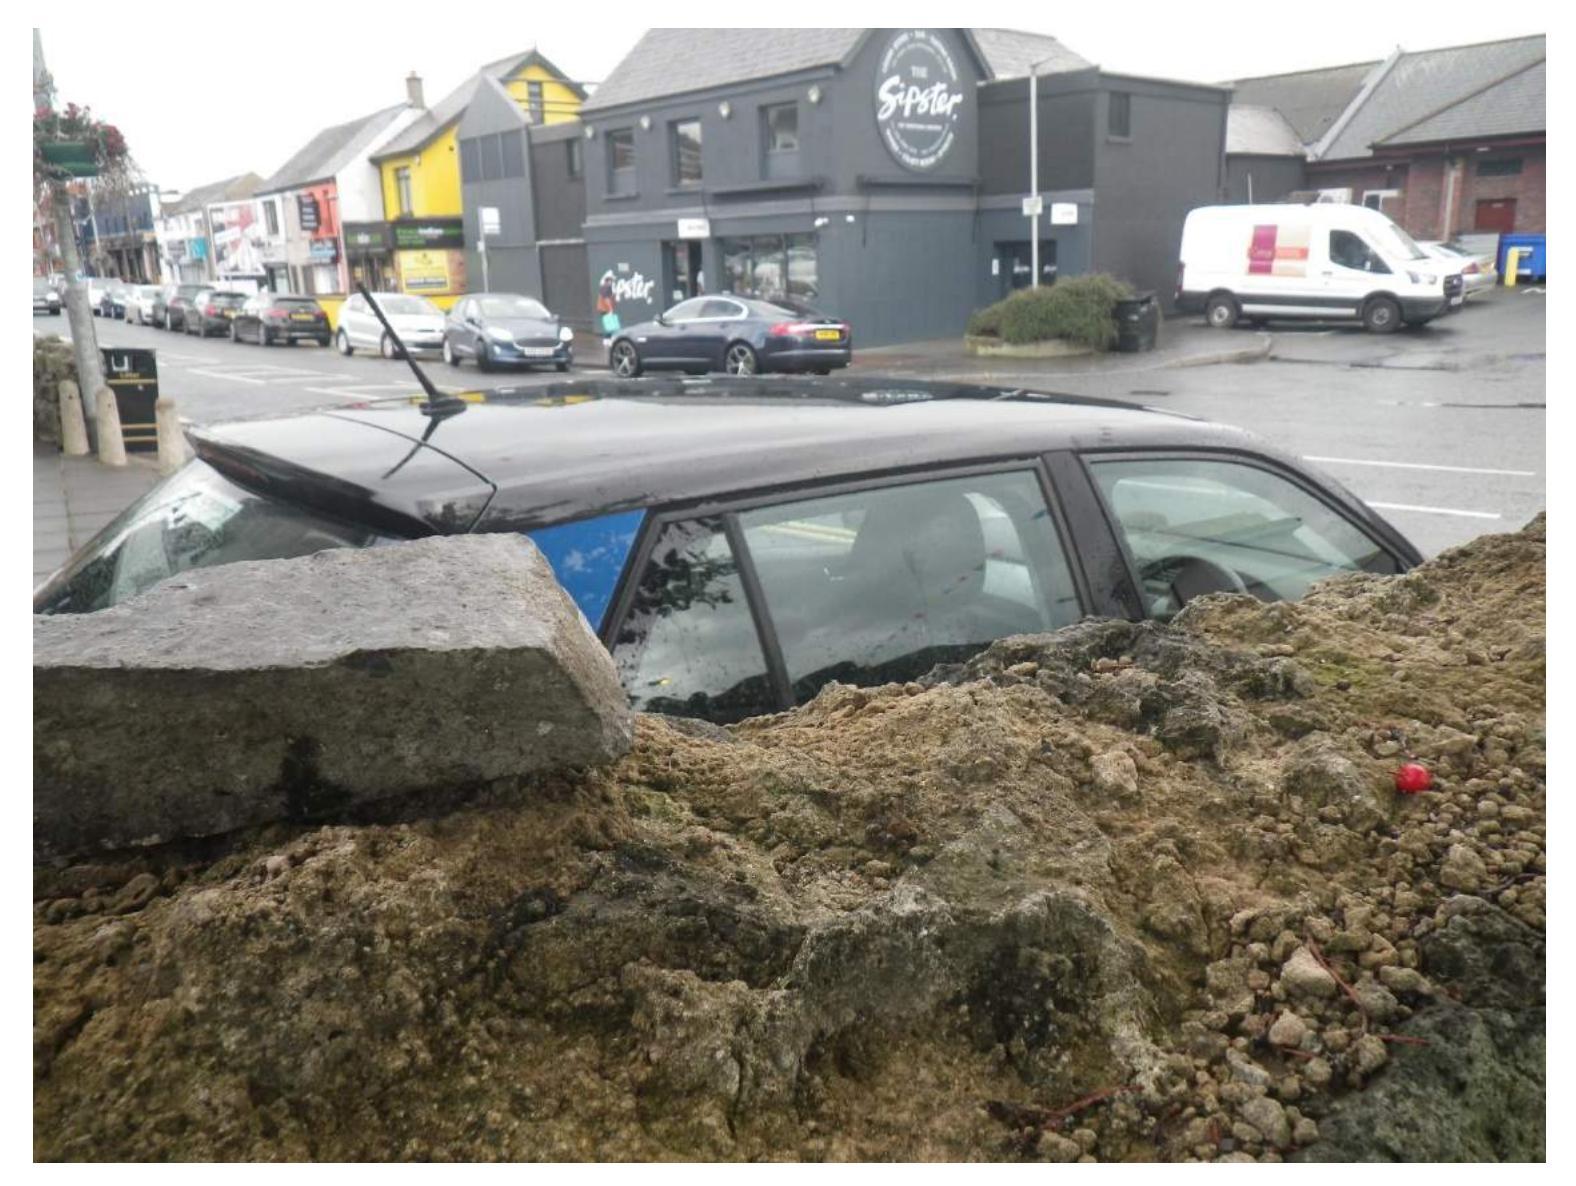
Missing Copings Boundary Wall

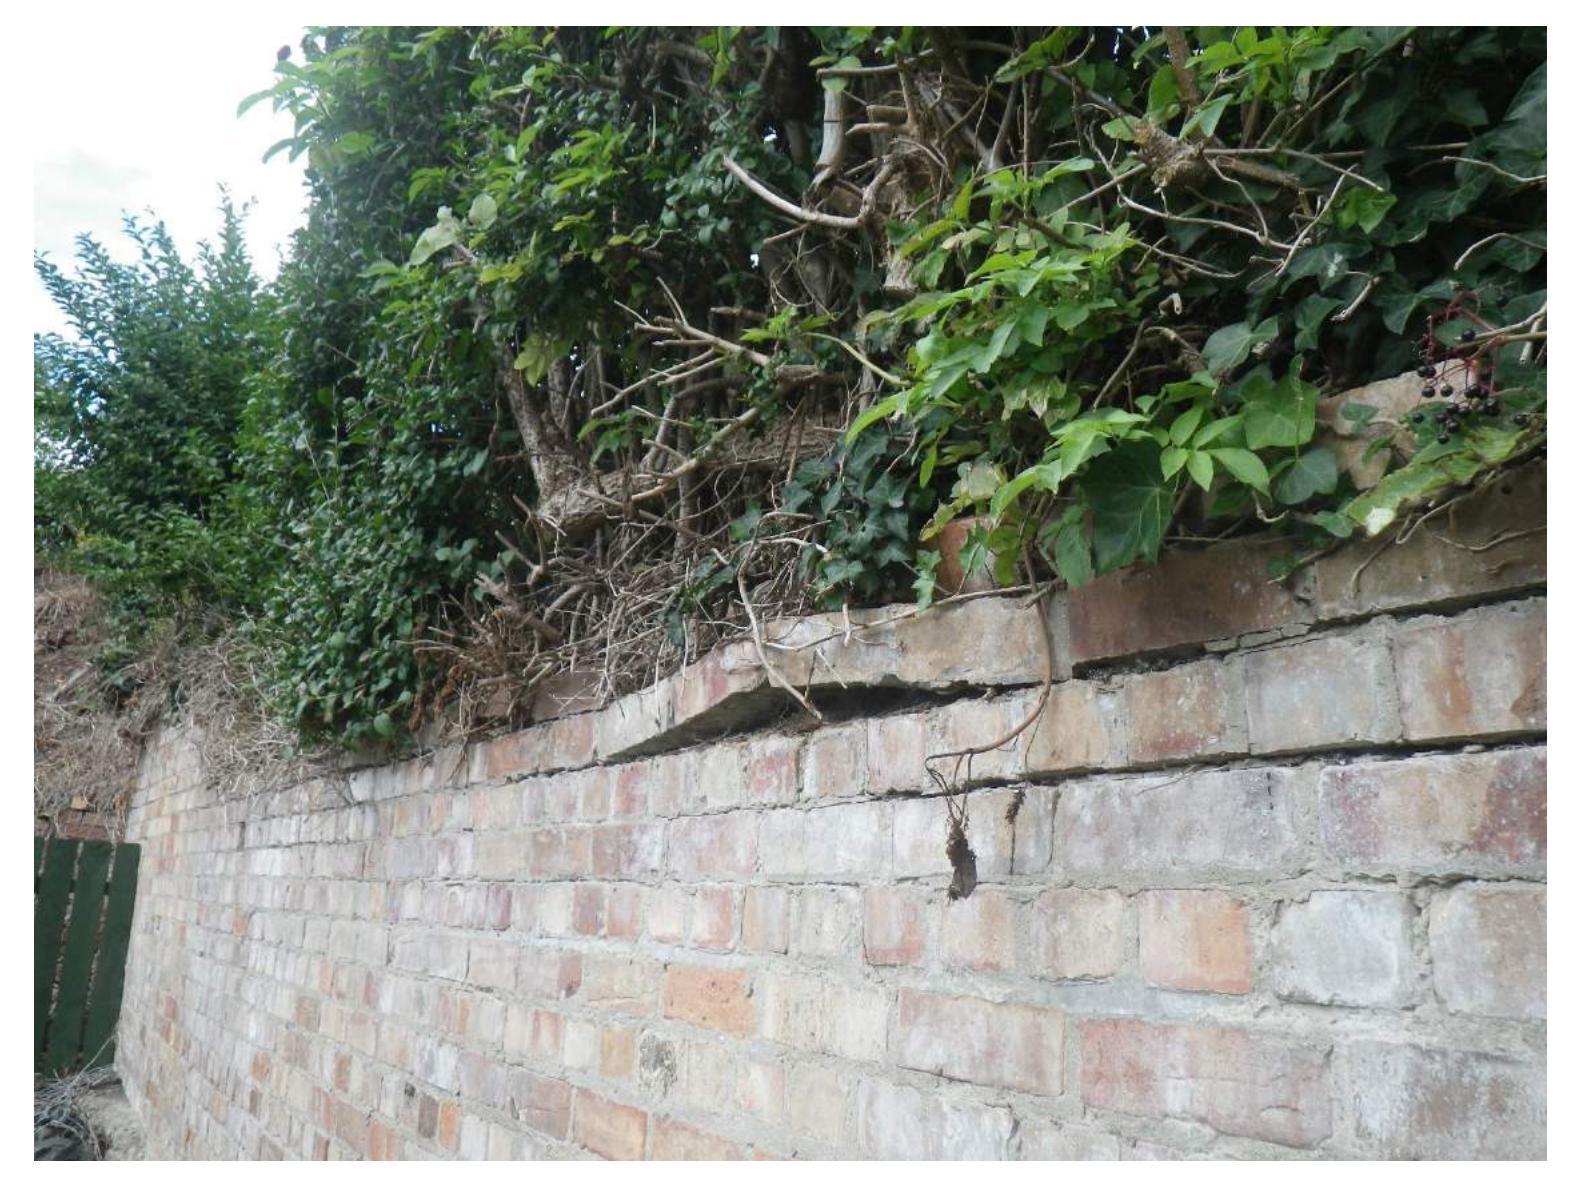
Dislodgement of Masonry due to roots North Boundary

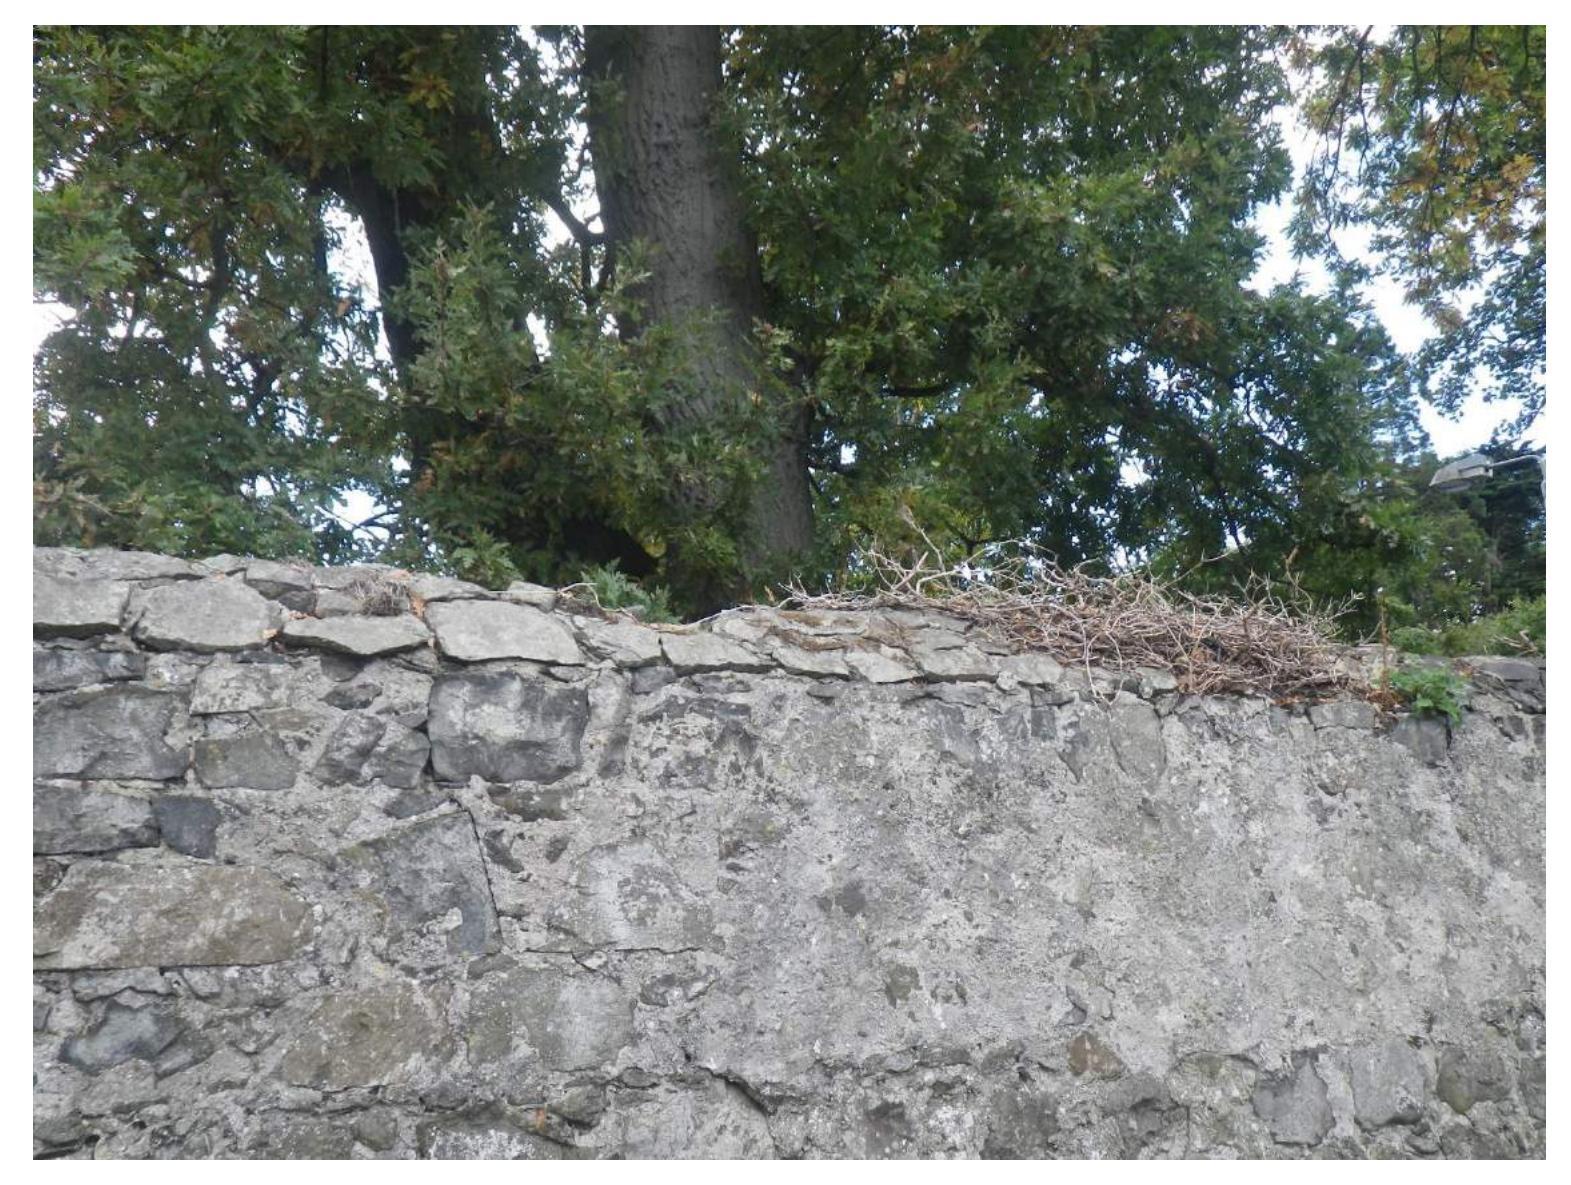
Loose Coping South Boundary

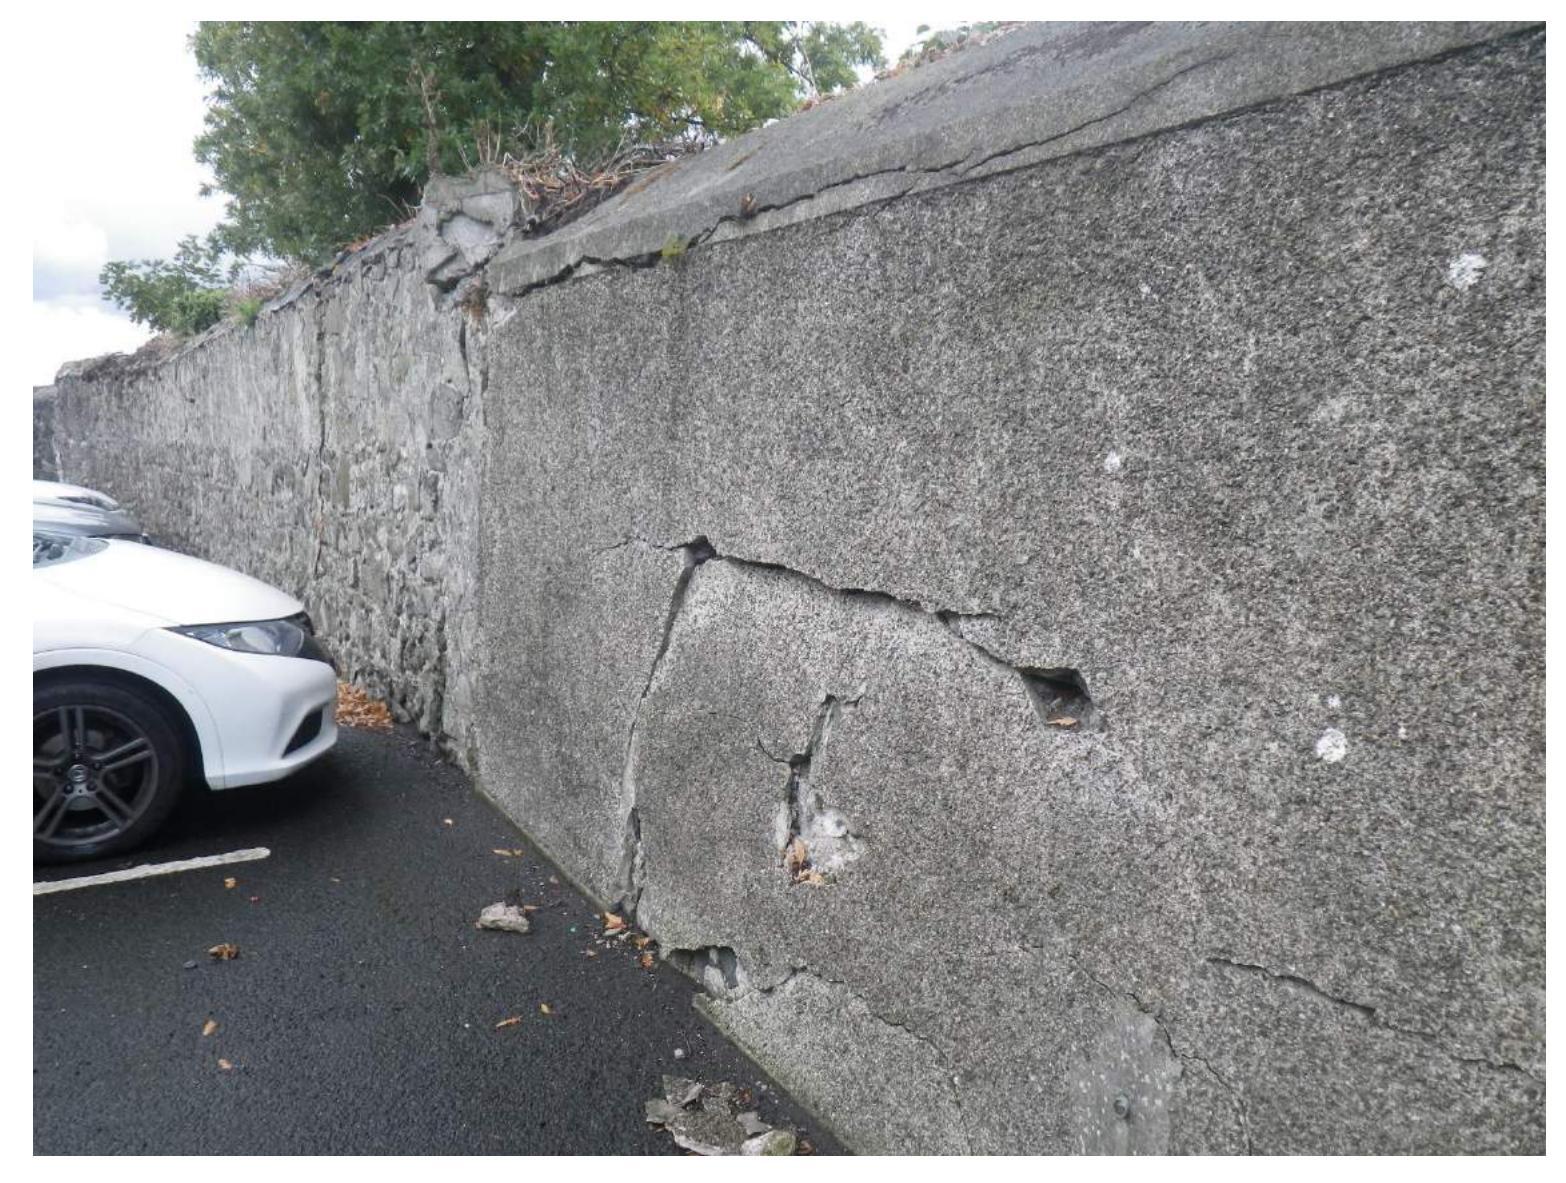
Failing Wall Render South Boundary

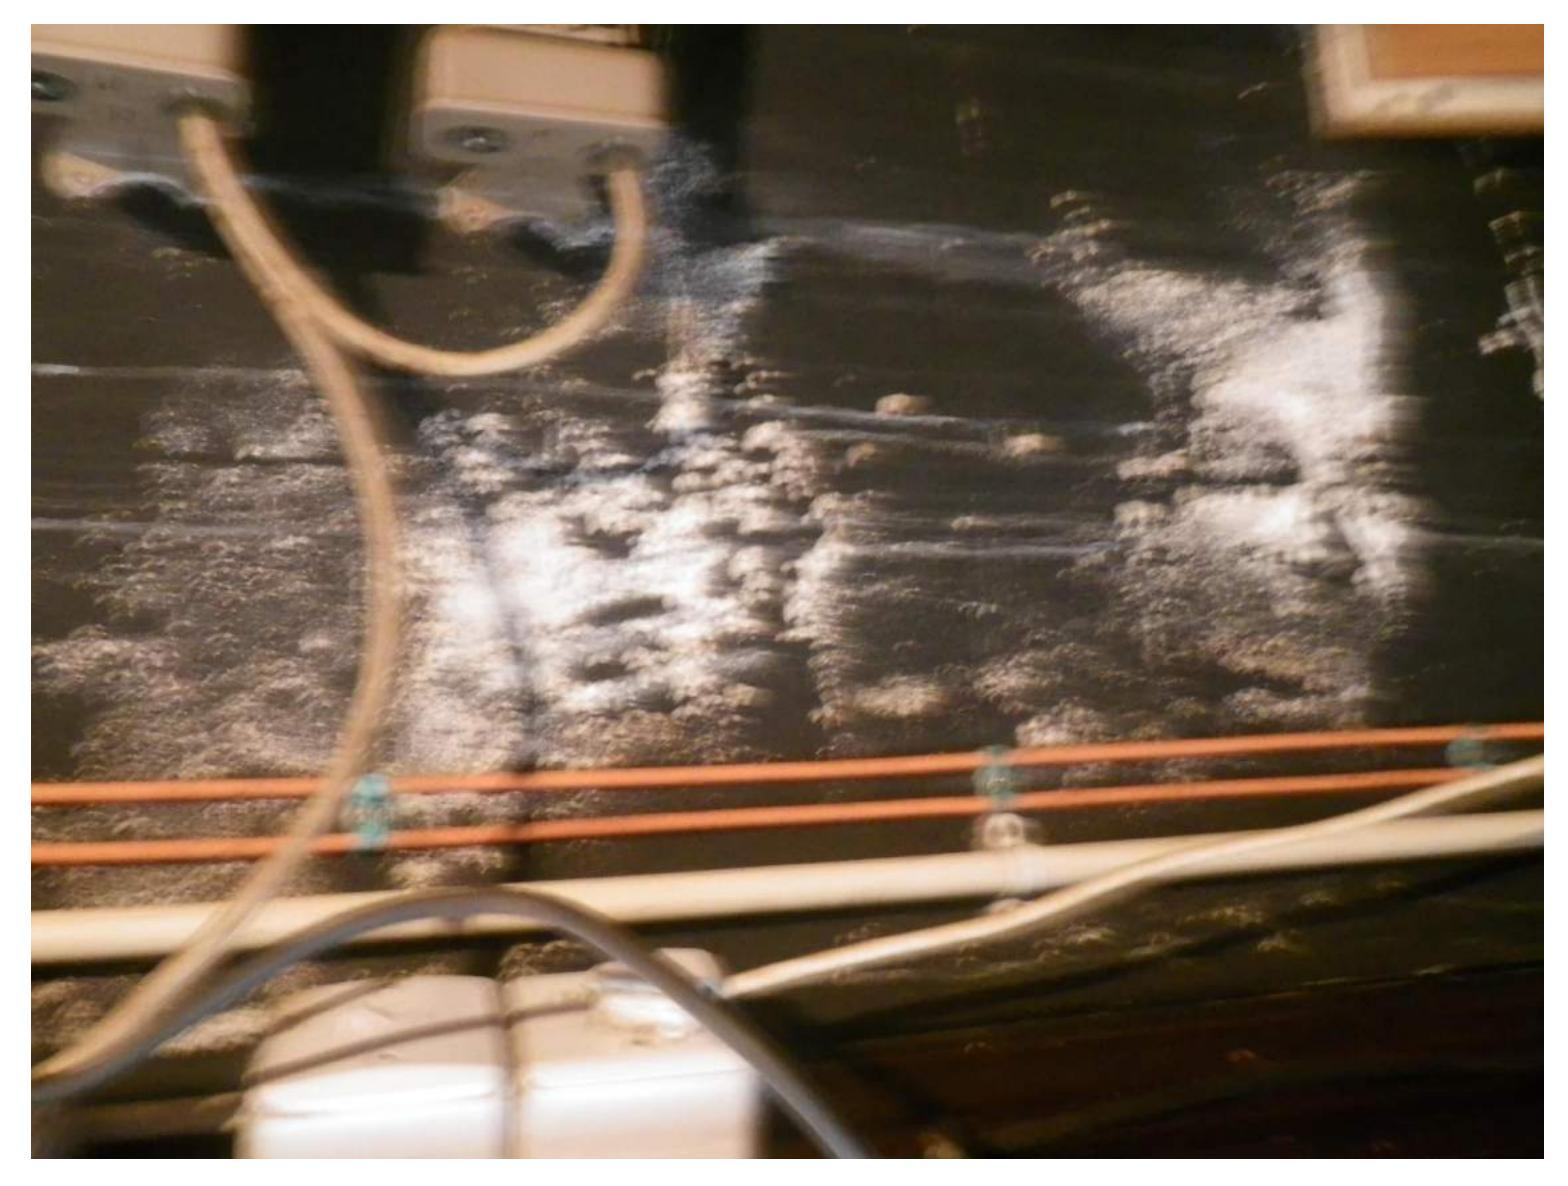
Salt Staining within Organ Loft
