Whiteabbey Presbyterian Church 602 Shore Road Newtownabbey

Detailed Condition Report (Church)

August 2022

McCOLLUM CONSERVATION

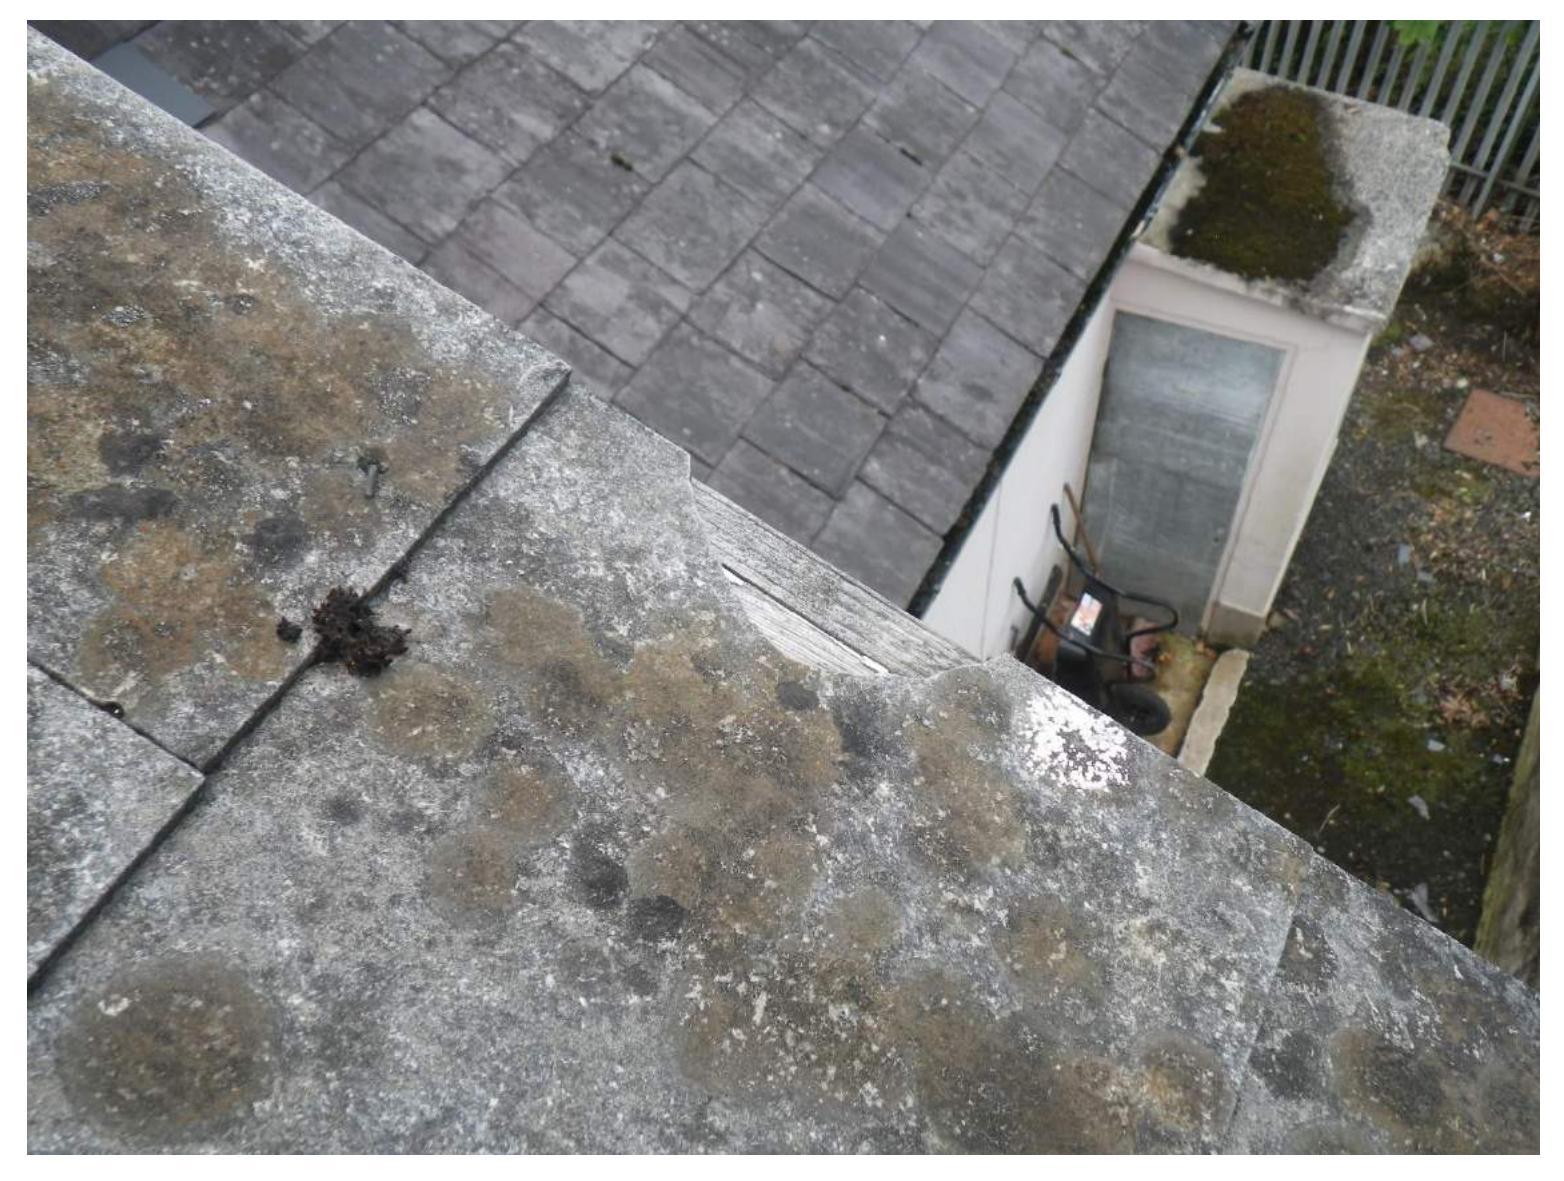
Roof RS15 – Poor Verge Detail

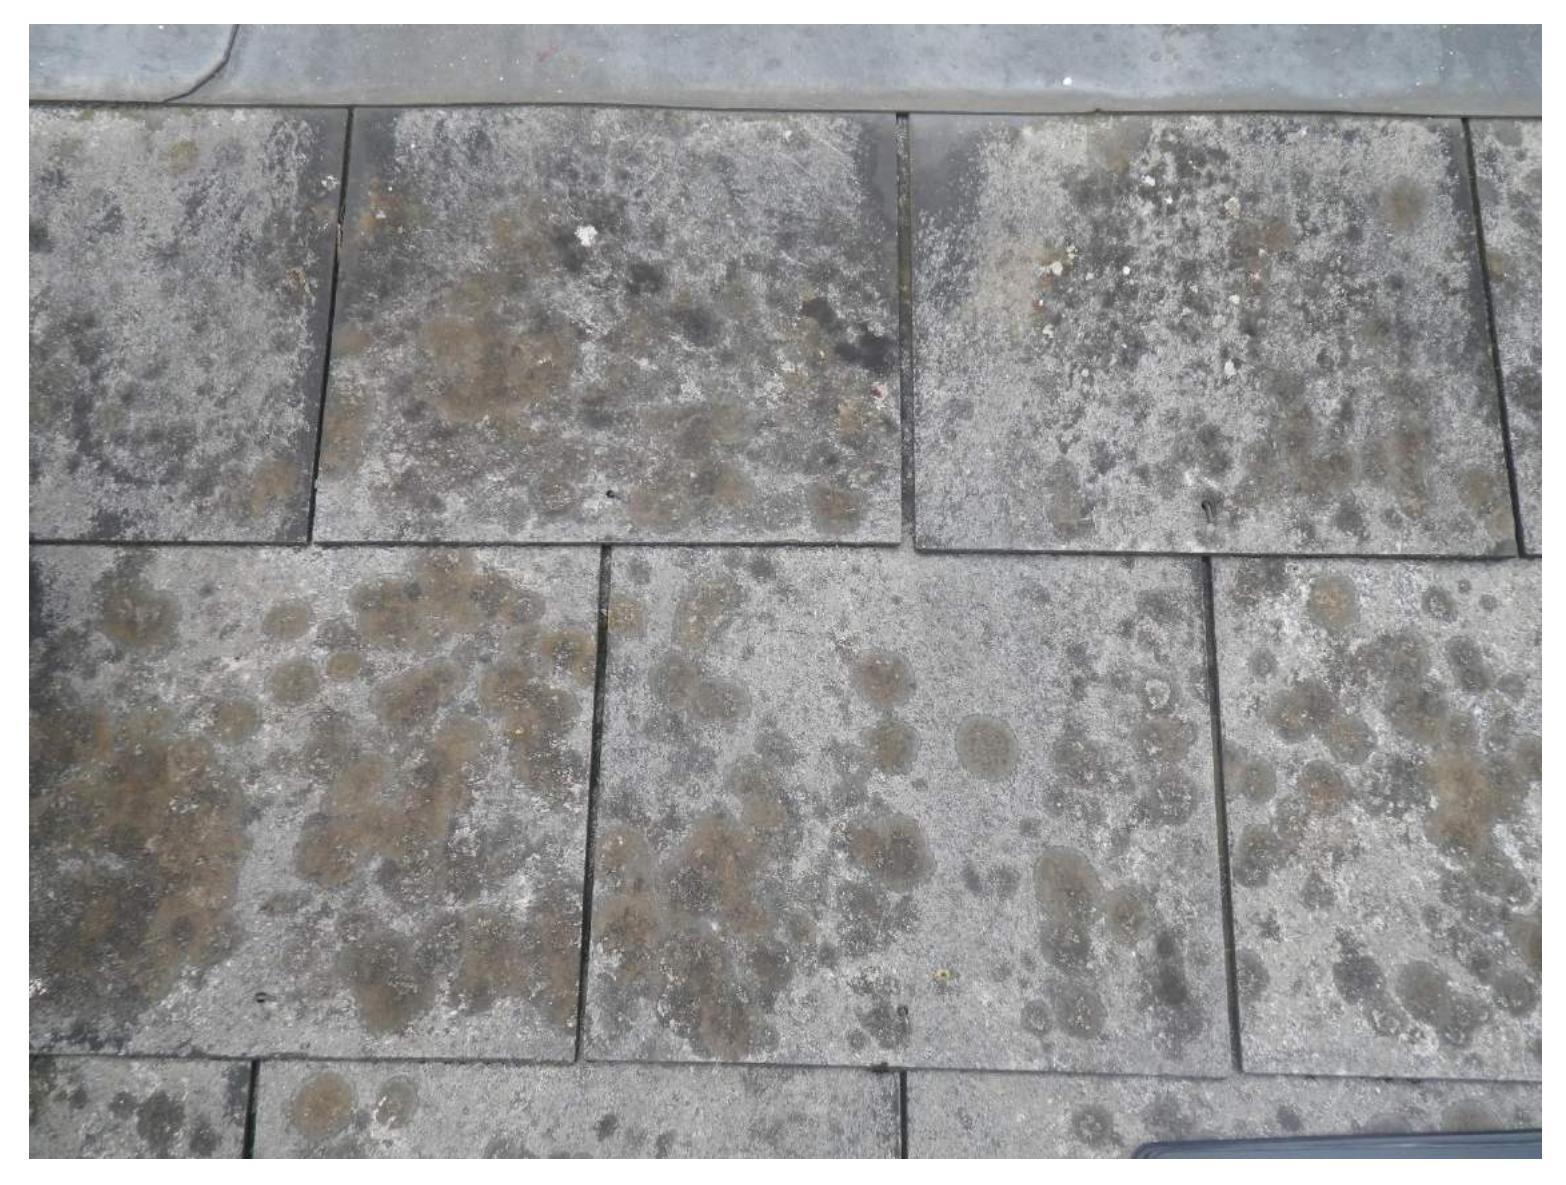
Roof RS15 – Weathered Artificial Slate

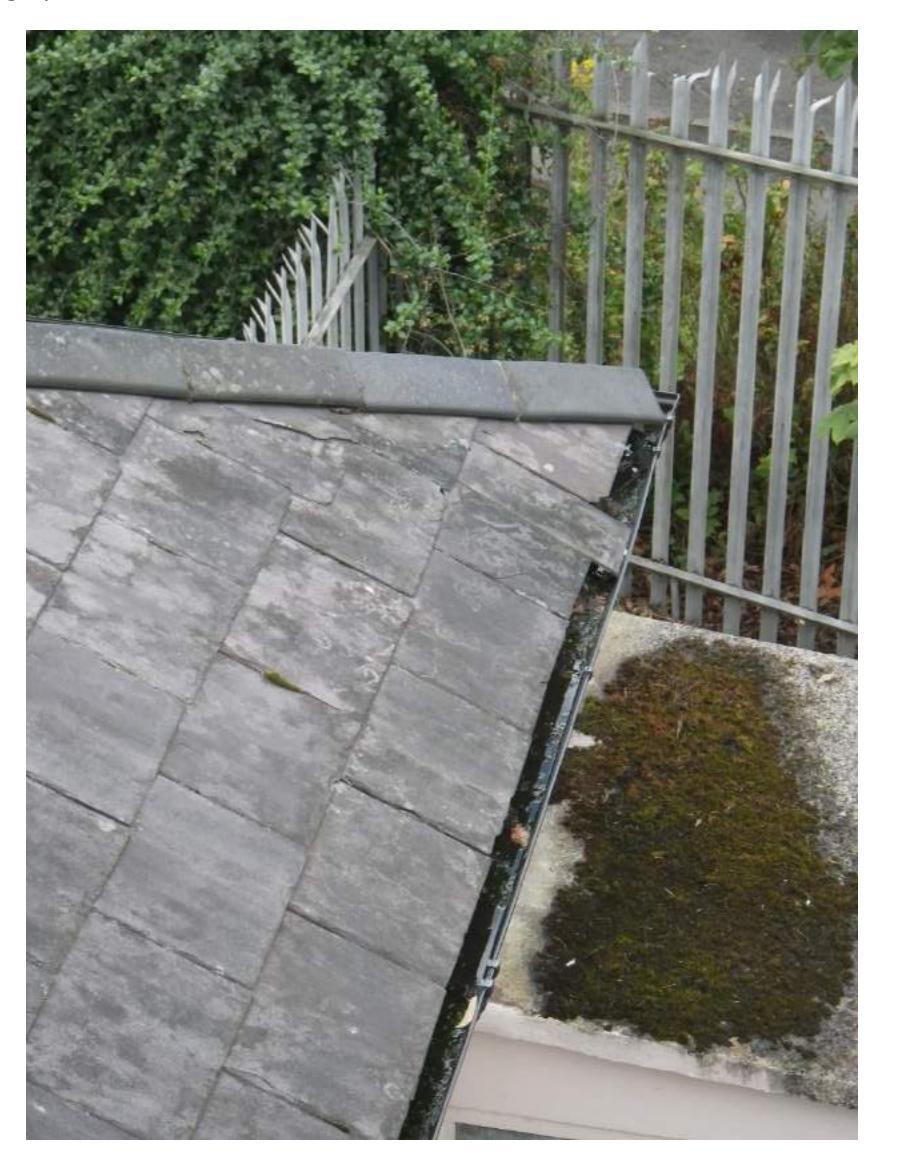
Roof RS16 – Slipped Slates

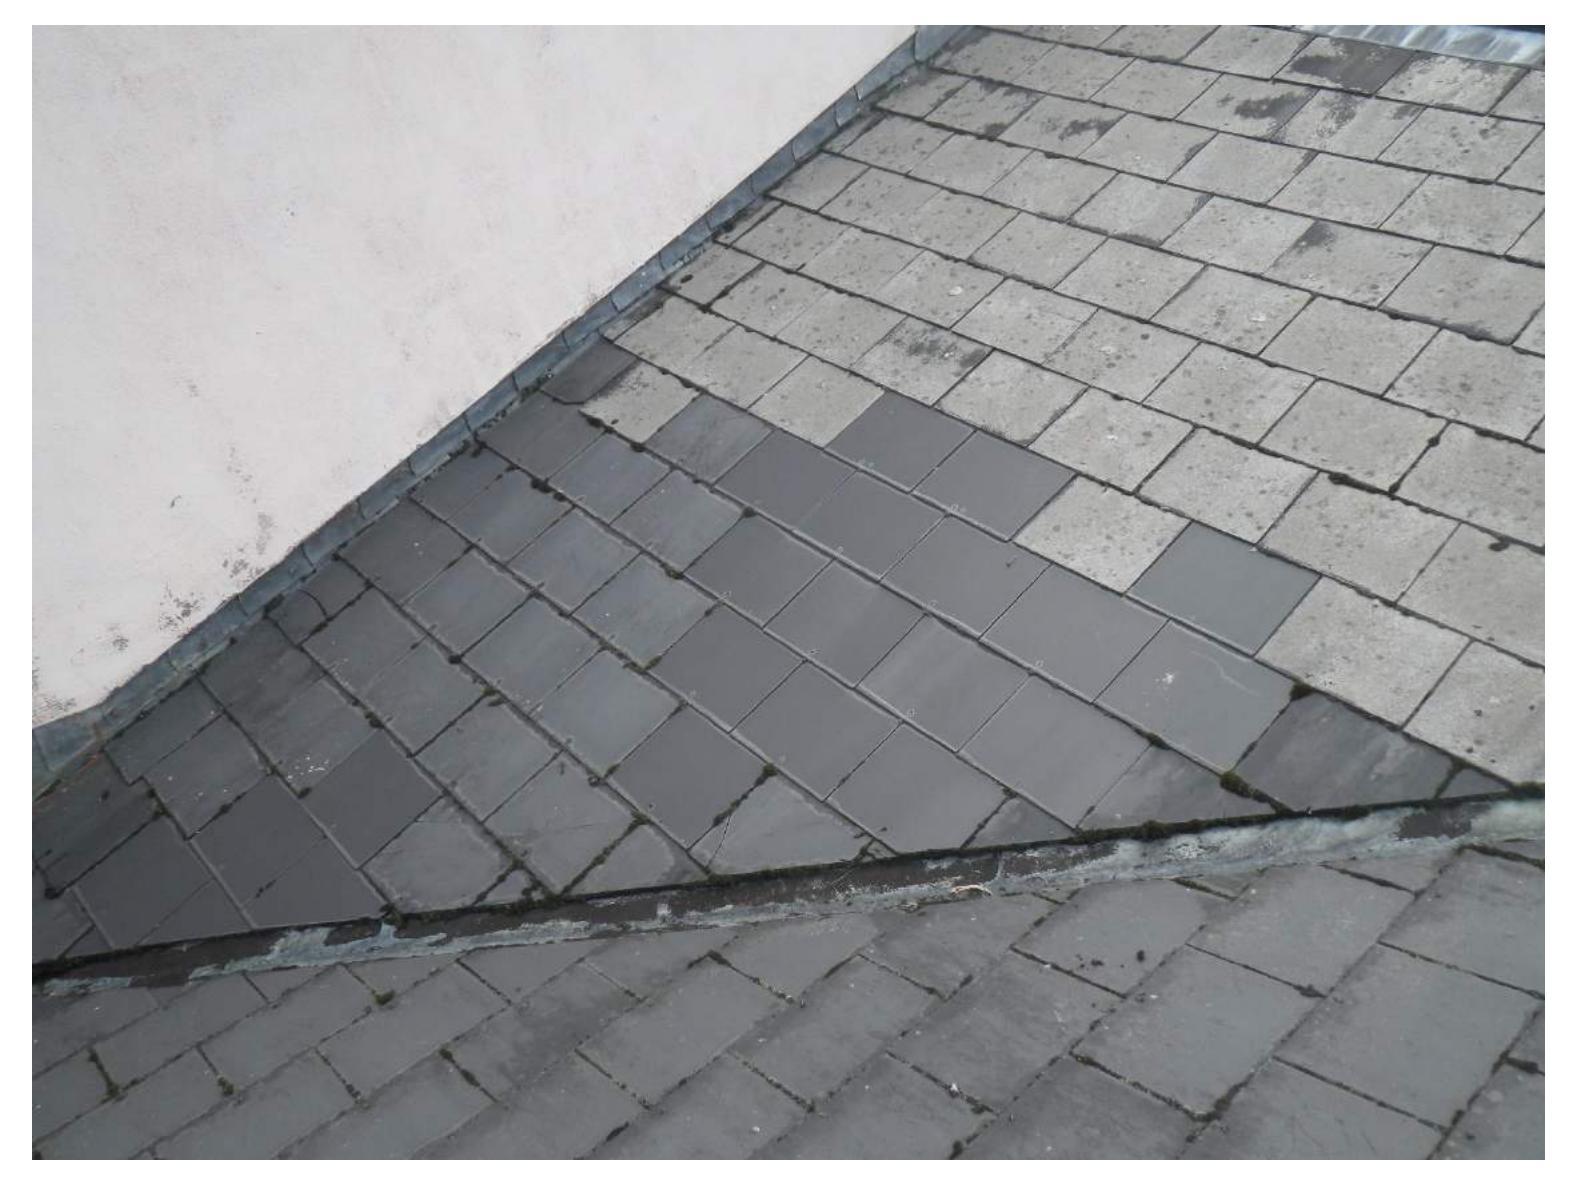
Roof RS18/RS15 – Extensive Roof Slate Patching

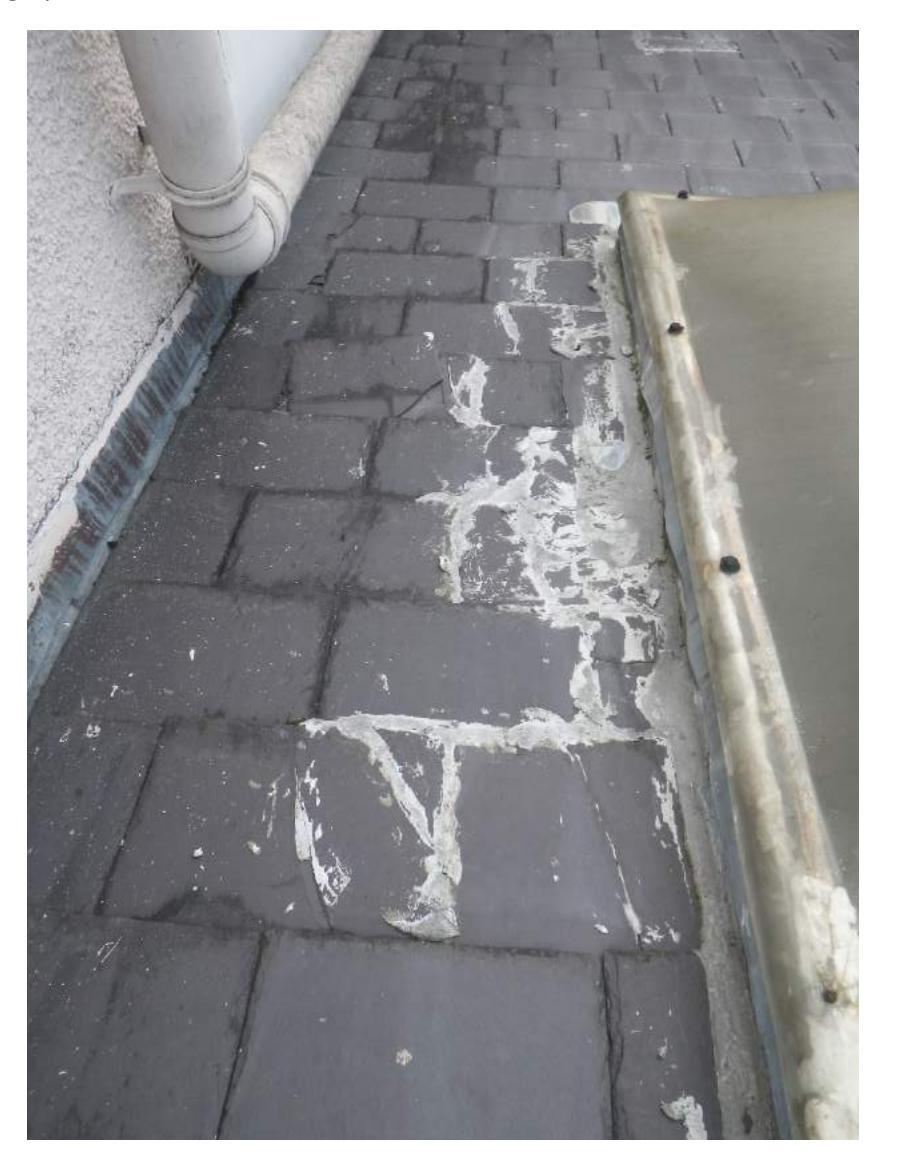
Roof RS14 – Heavy Patching Around Skylight

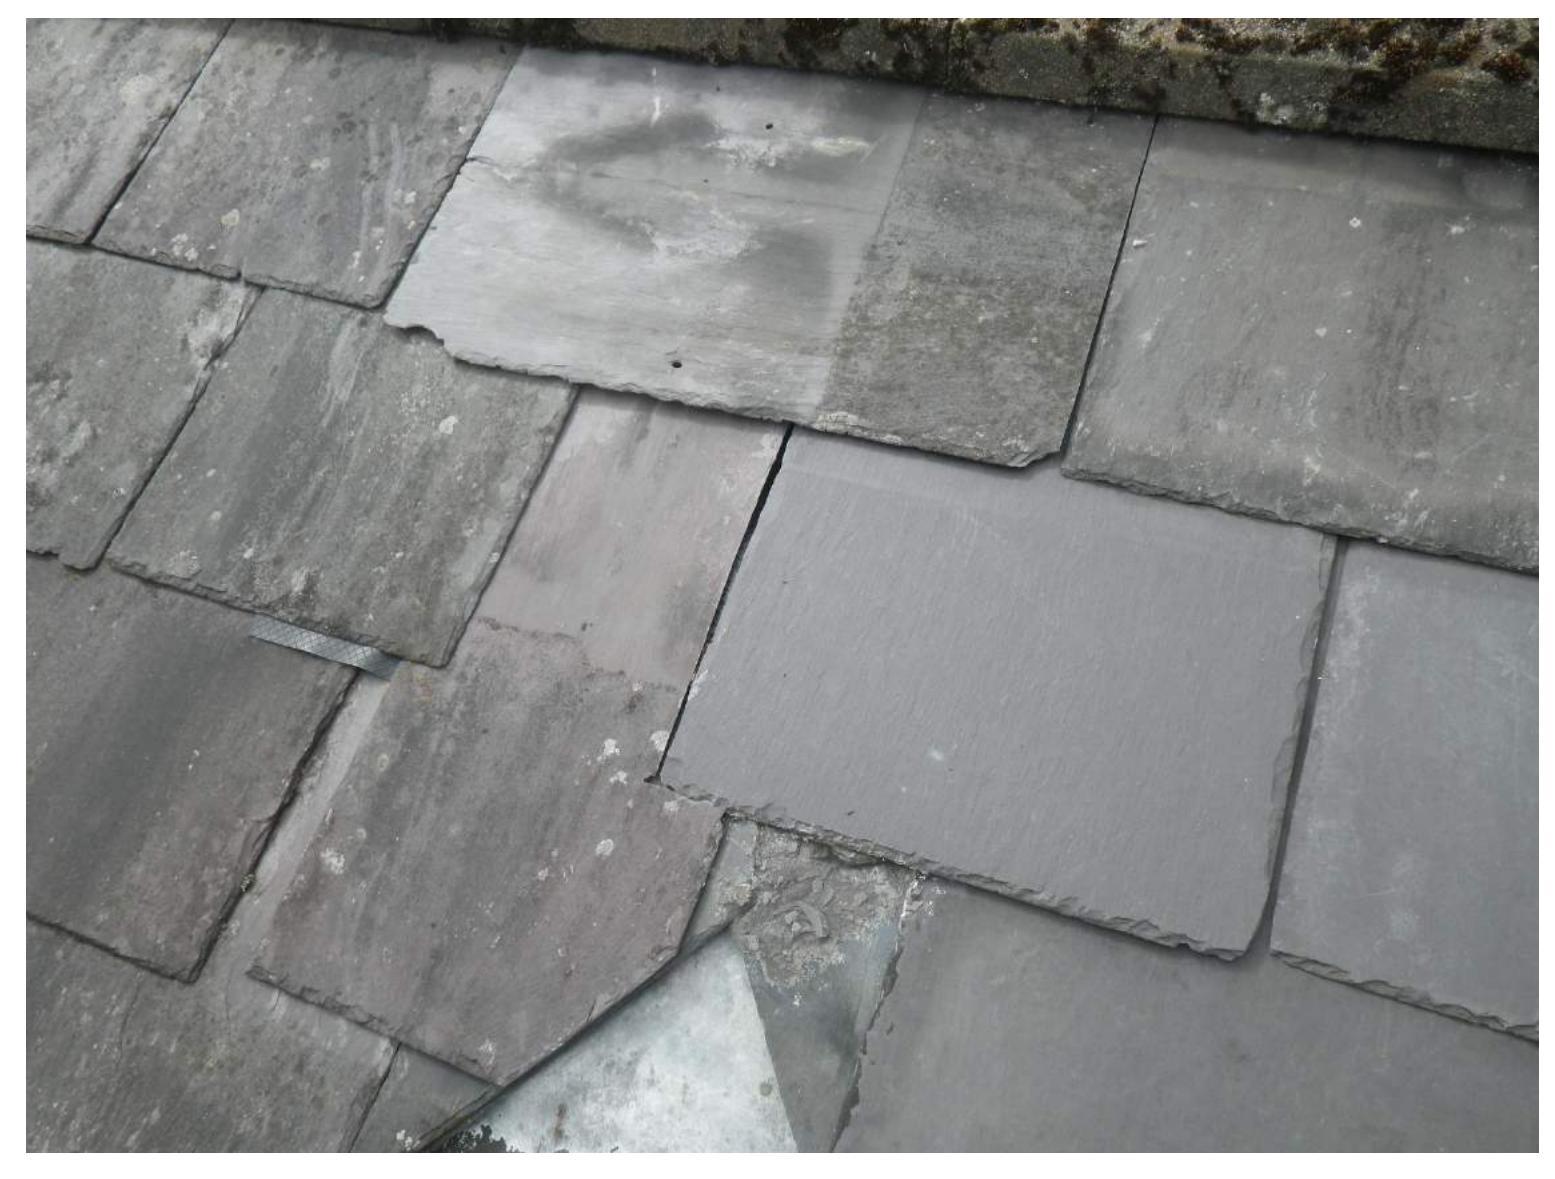
Roof RS08/RS09 – Poor Slating Practice and Patching with a dpc

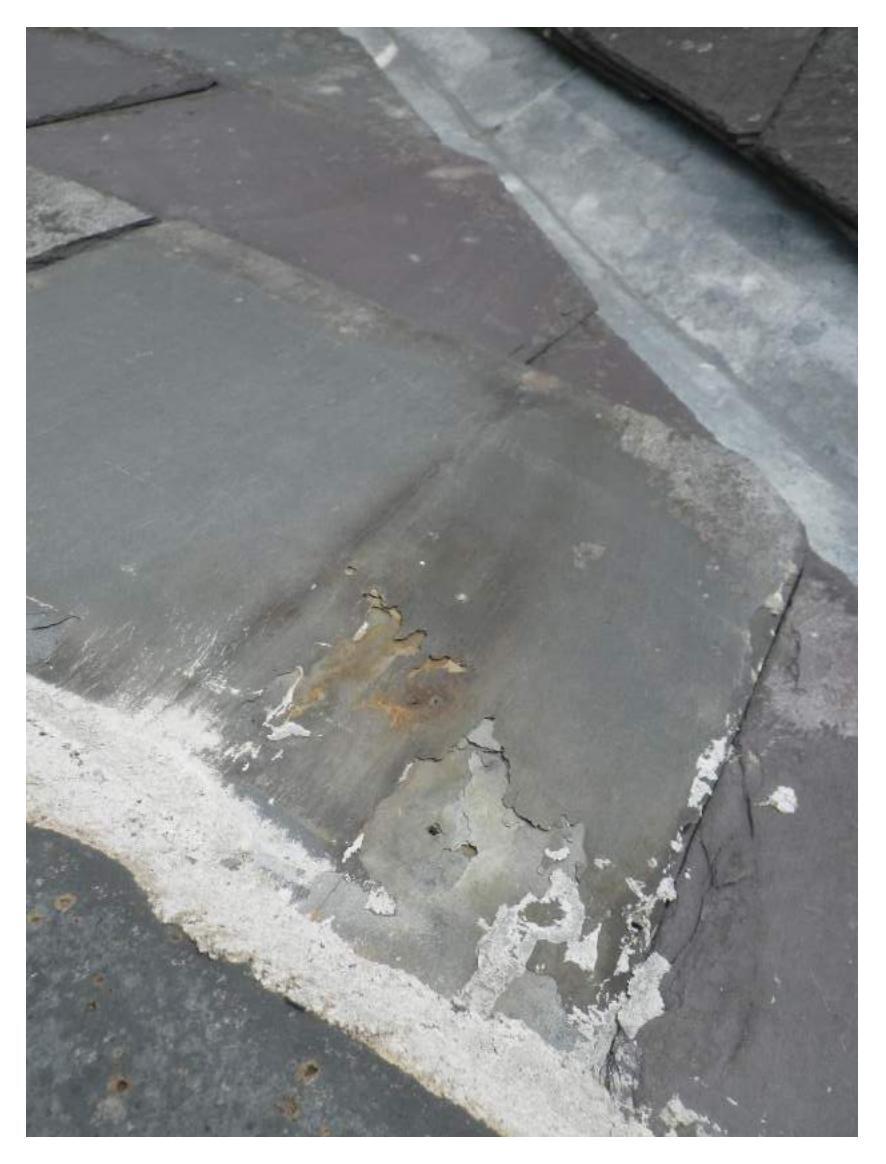
Roof RS07 – Failing Slate

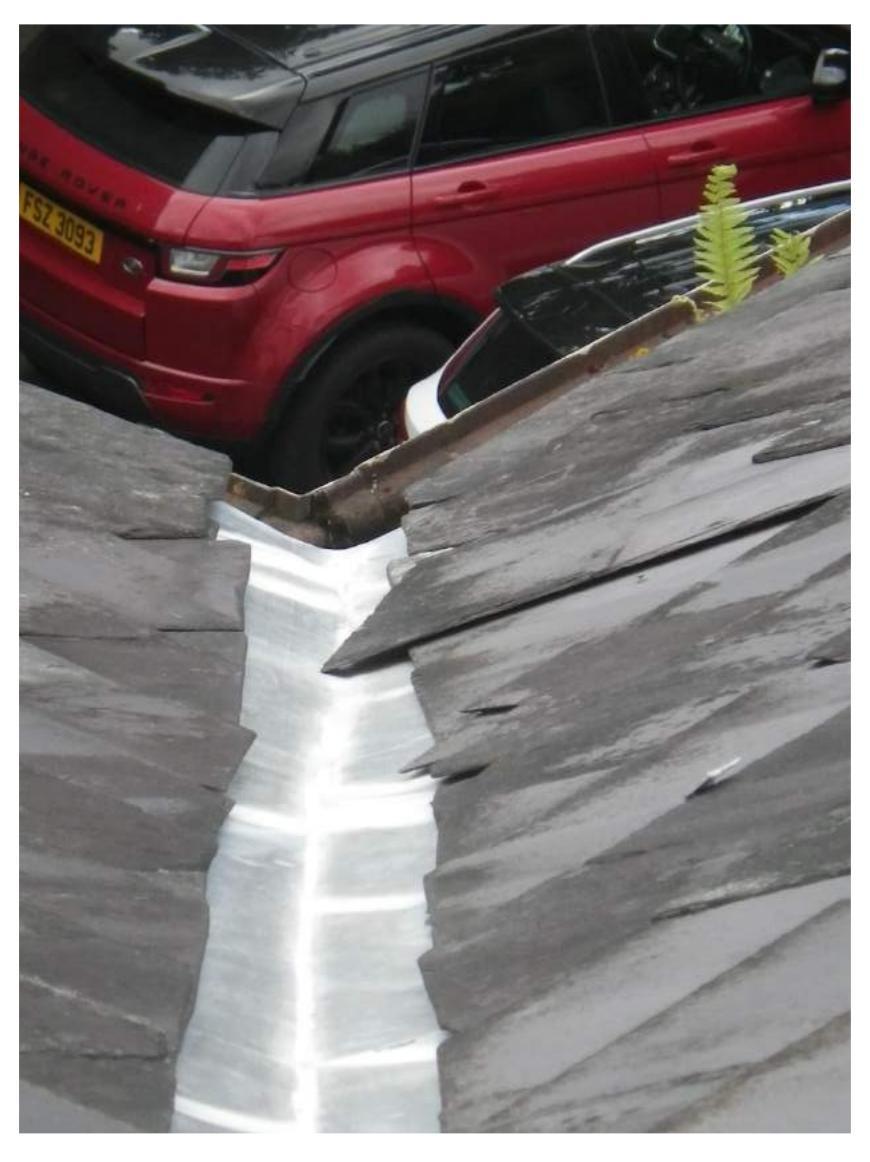
Roof RS01/RS03 – Loose Slates into Valley

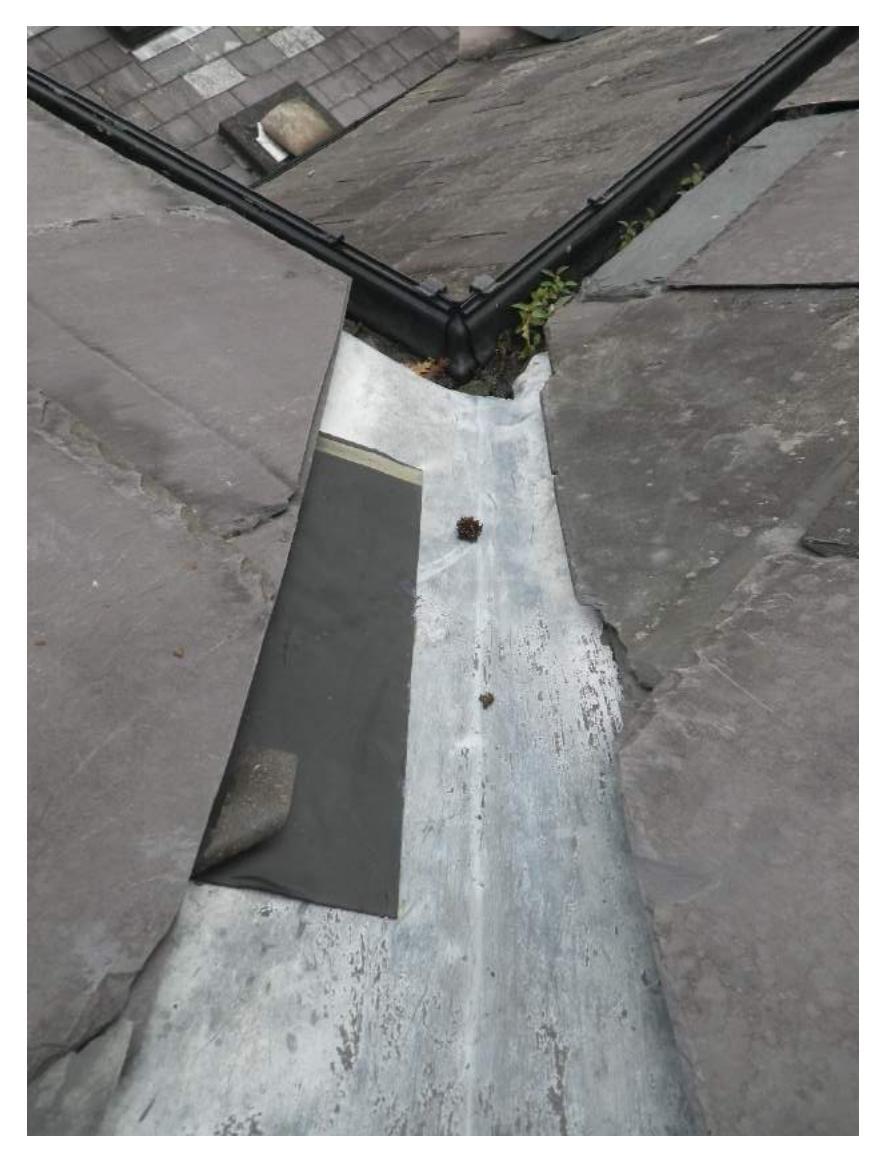
Roof RS07 – Temporary Patch to Valley

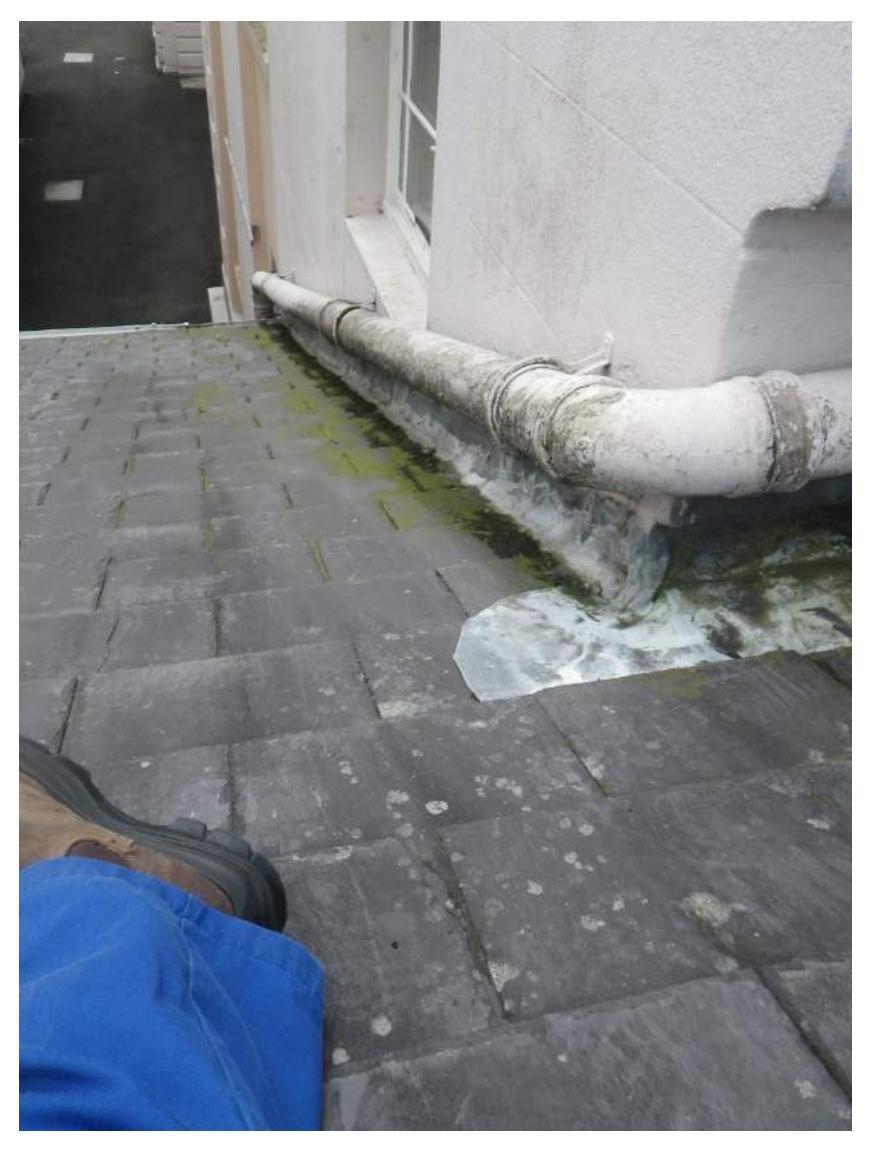
Roof RS13 – Cracking to Render above Apron

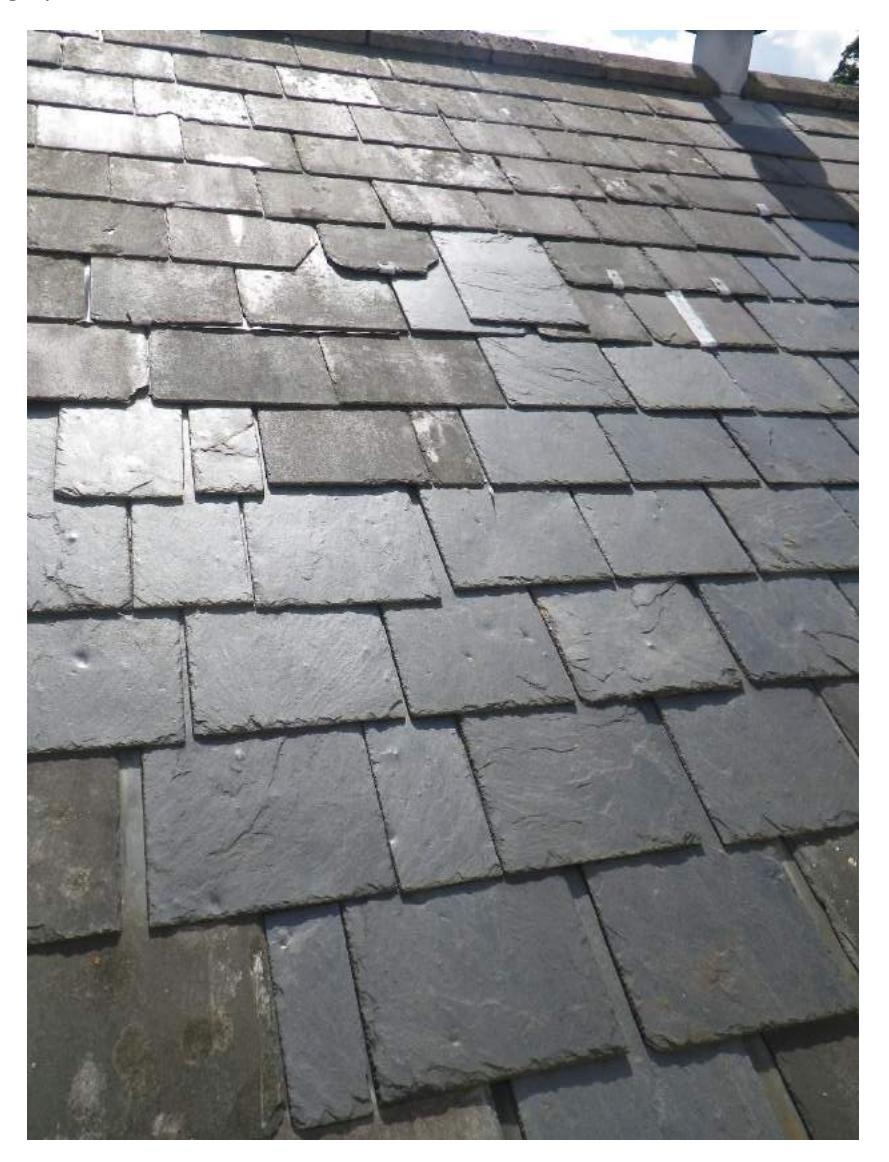
Roof RS08 – Heavy Patching of Roof with Incorrect Size and Type of Slate

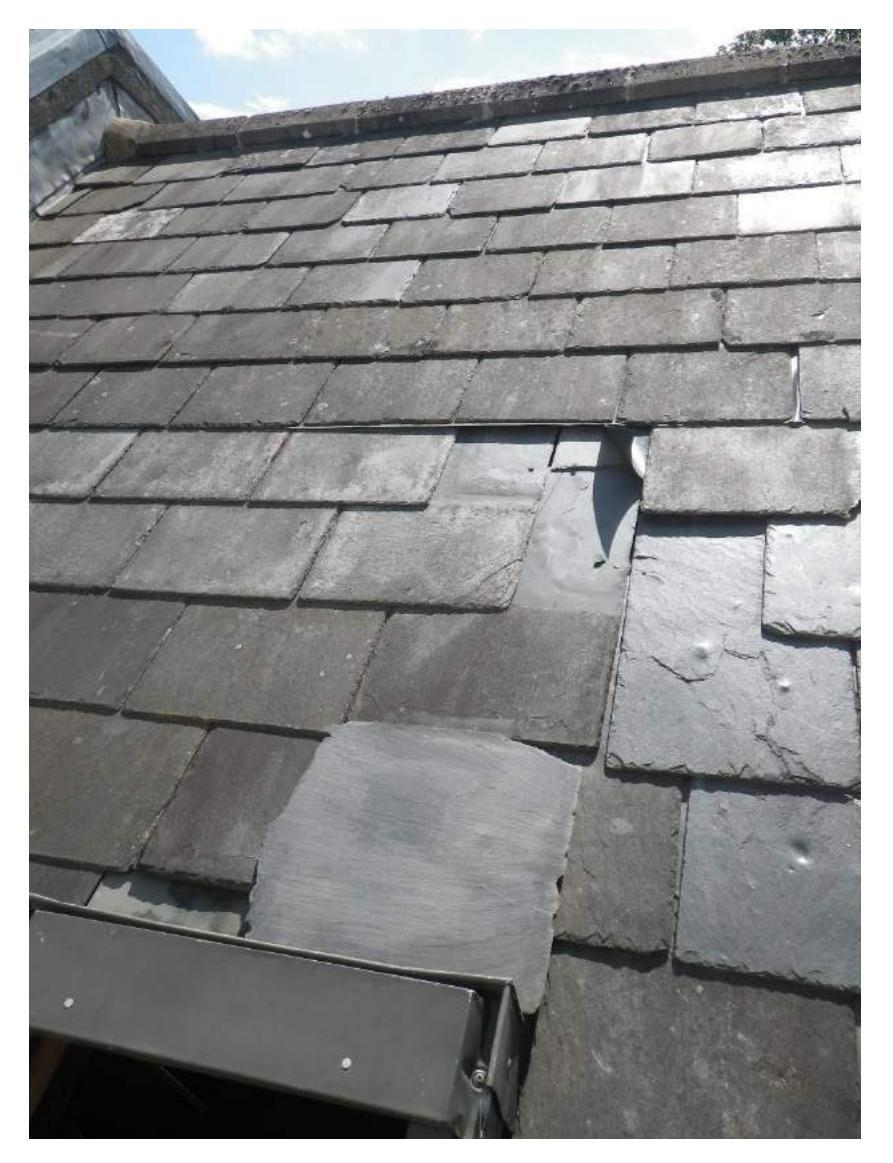
Slipped Slates and Slates Patched with Different Type of Slate RS02

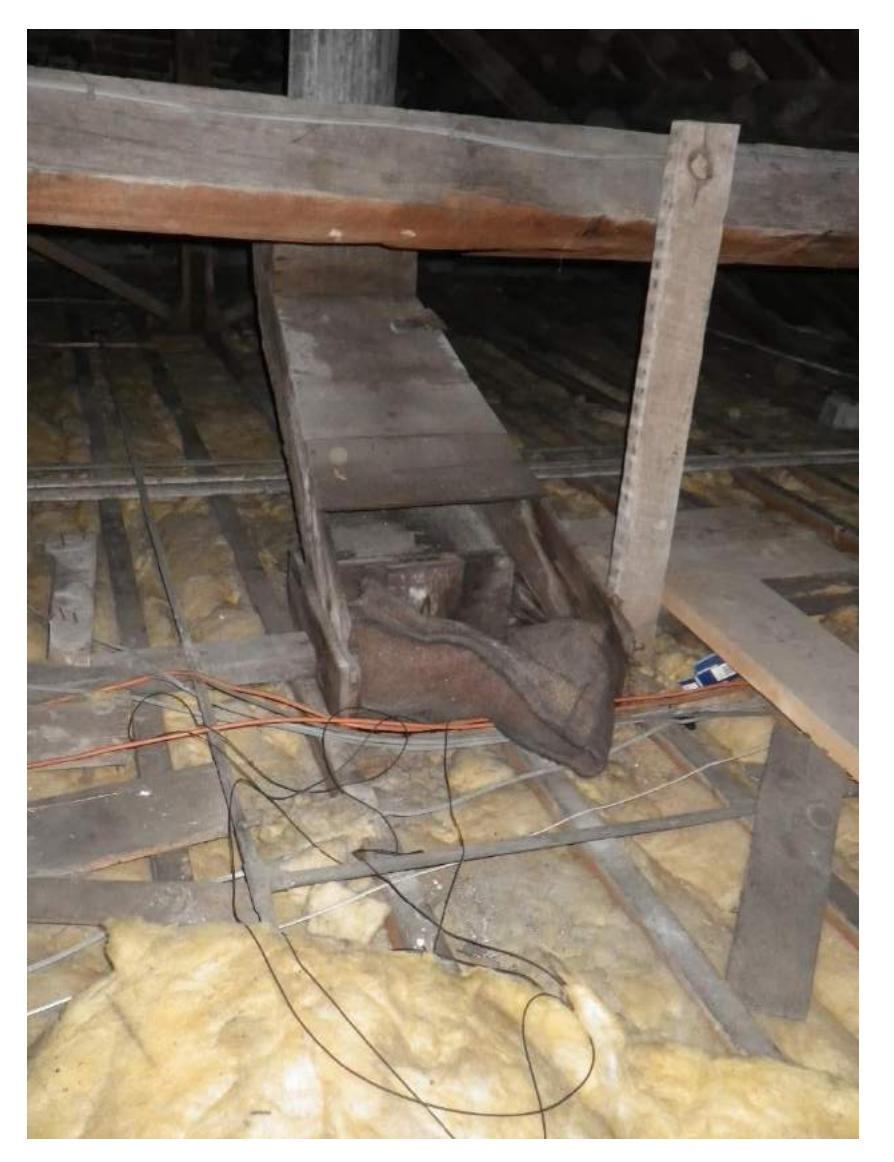
Top of Ventilation Cowl in Main Roof Space

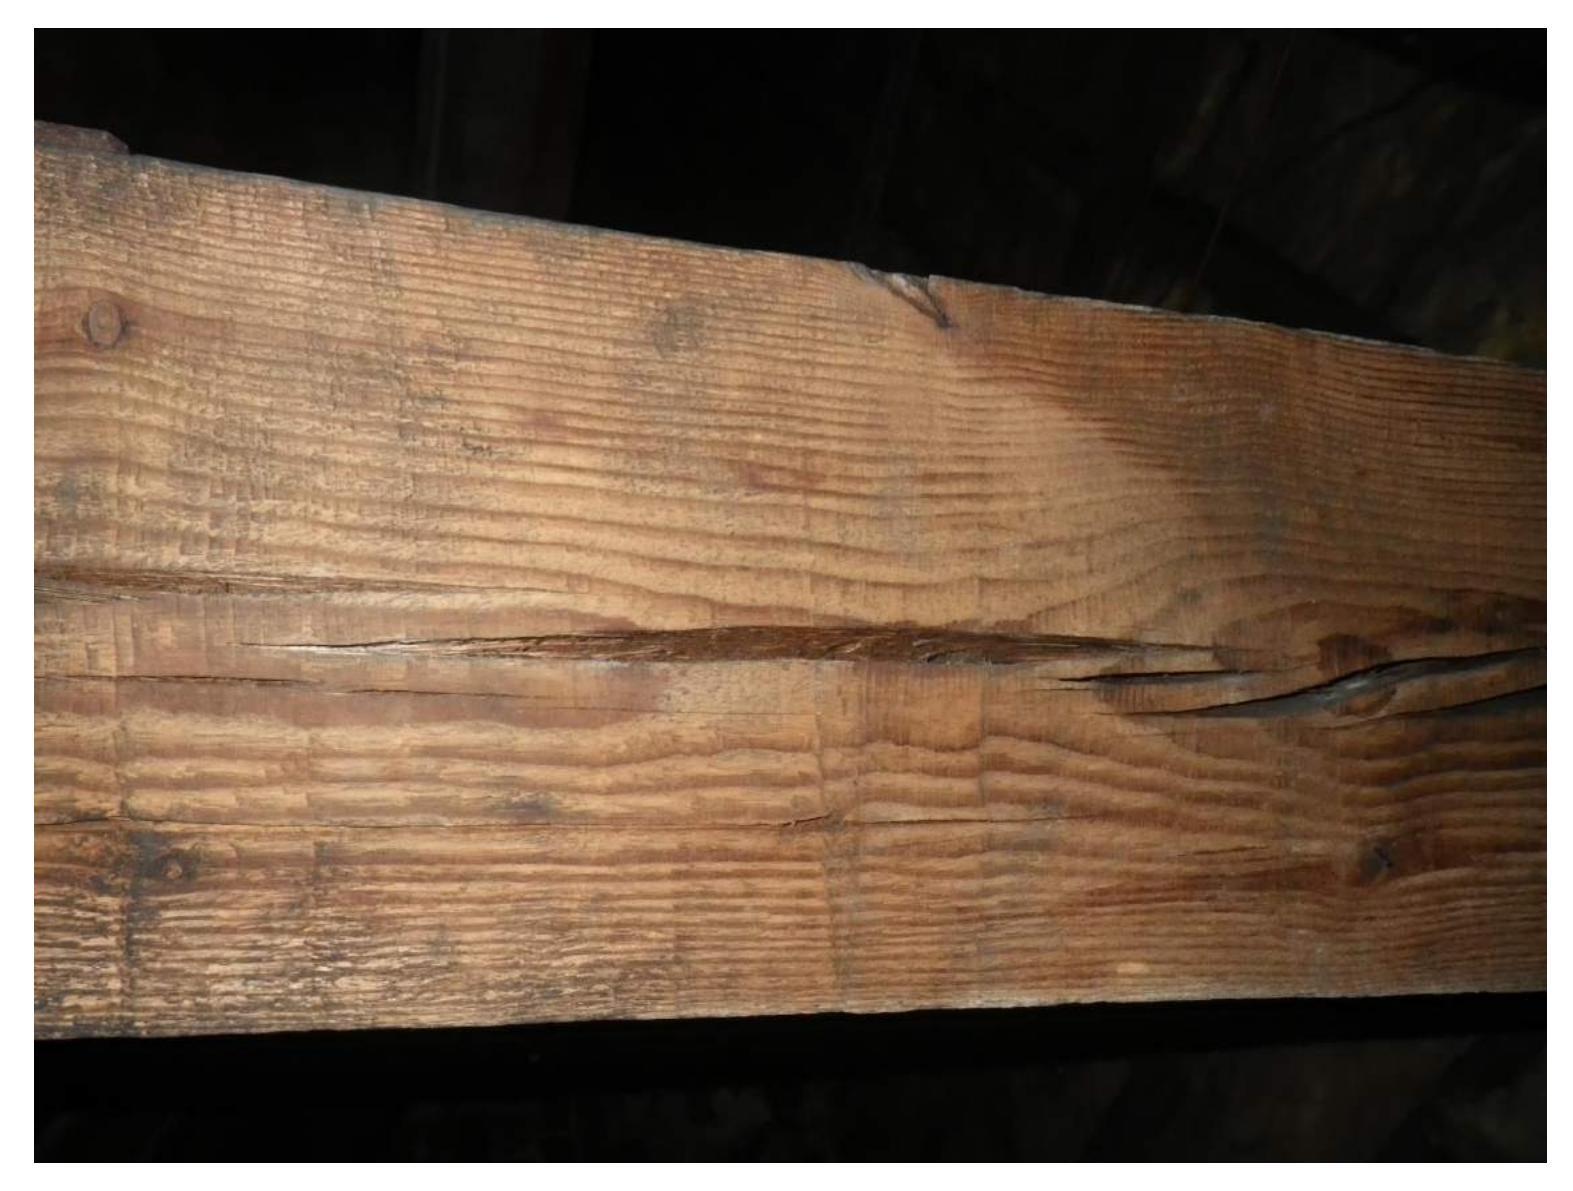
Typical Shake to Timbers within Main Roof Space

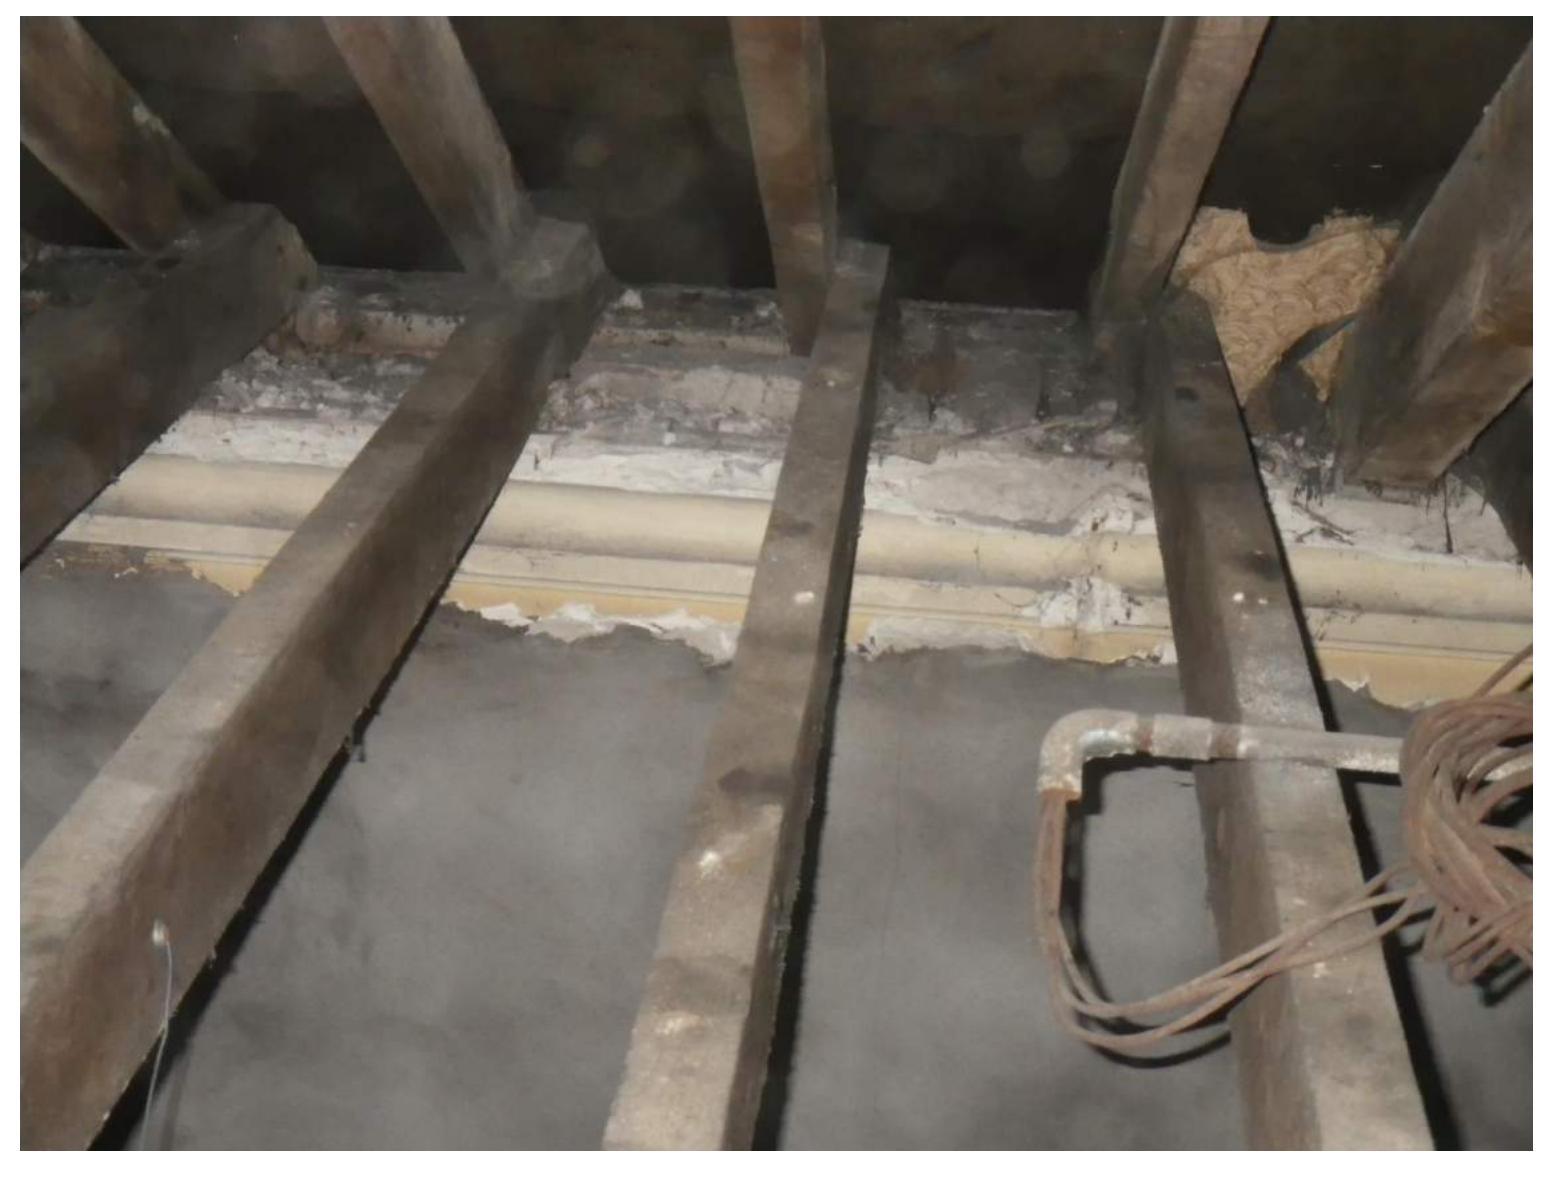
Timbers Below Roof RS05, RS06, RS07 with Remains of Wasp's Nest

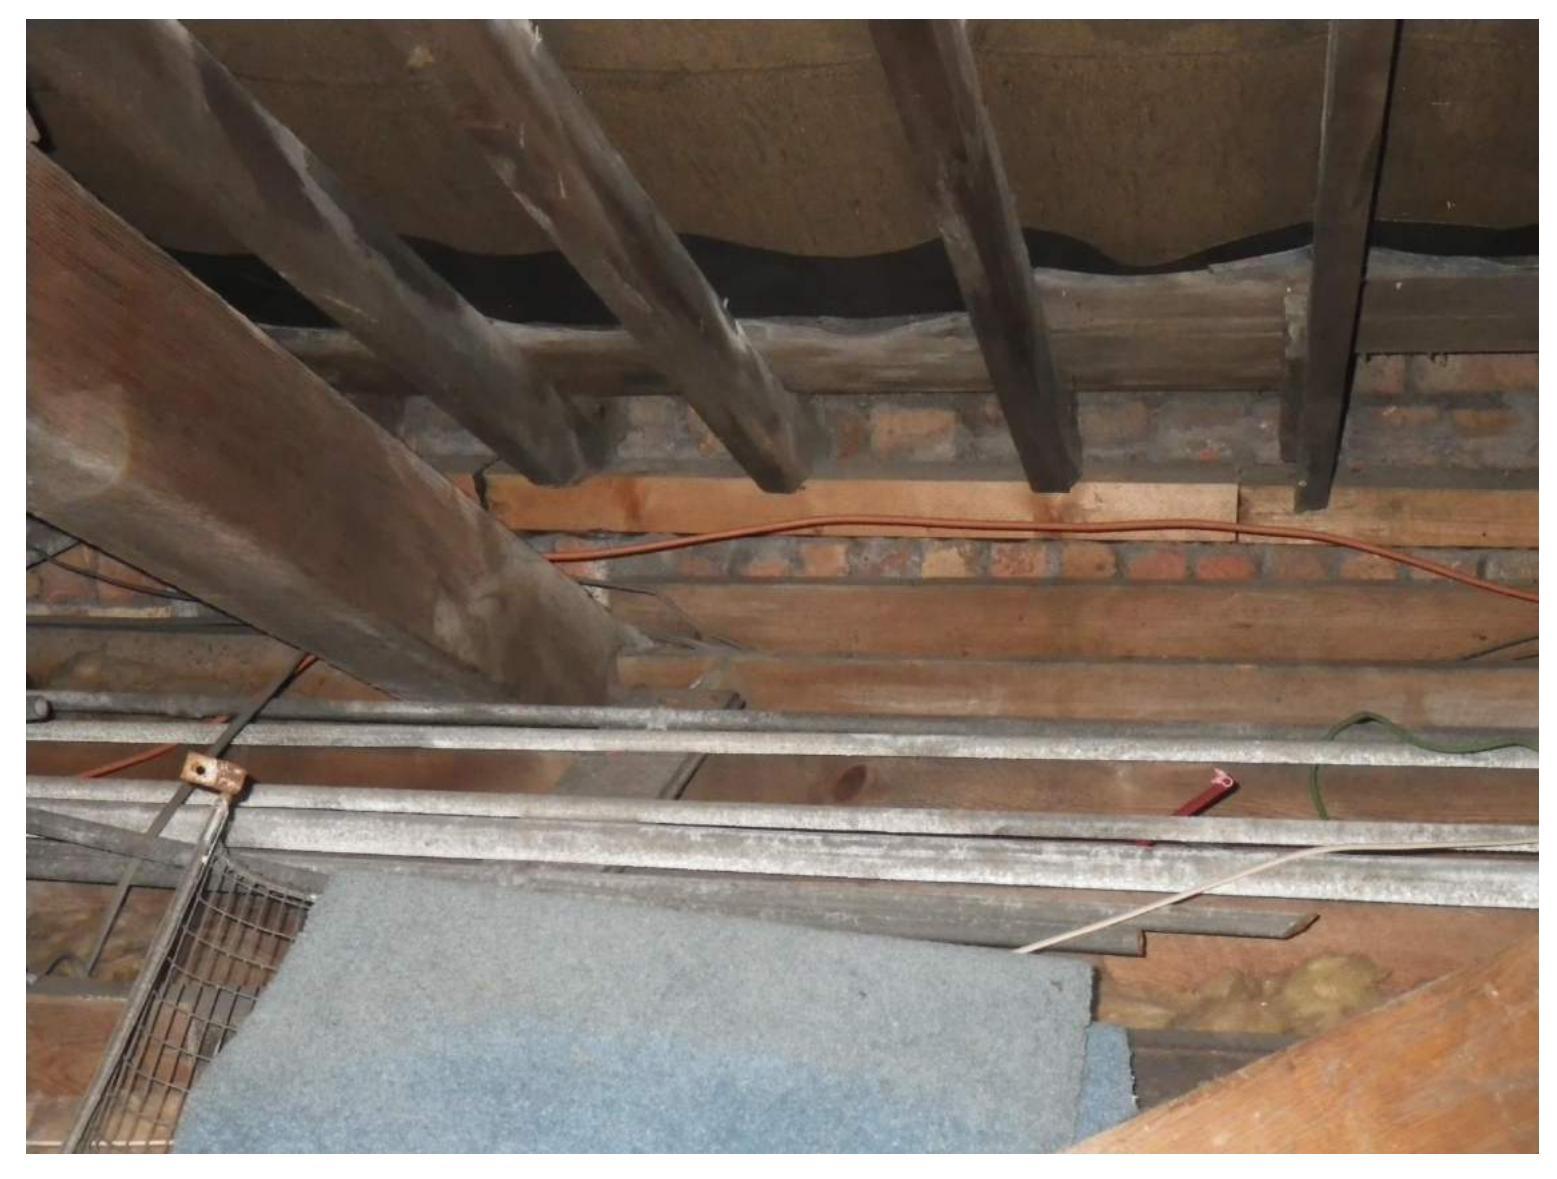
Past Wall Plate Renewal Main Roof
