Whiteabbey Presbyterian Church 602 Shore Road Newtownabbey

Detailed Condition Report (Church)

August 2022

McCOLLUM CONSERVATION

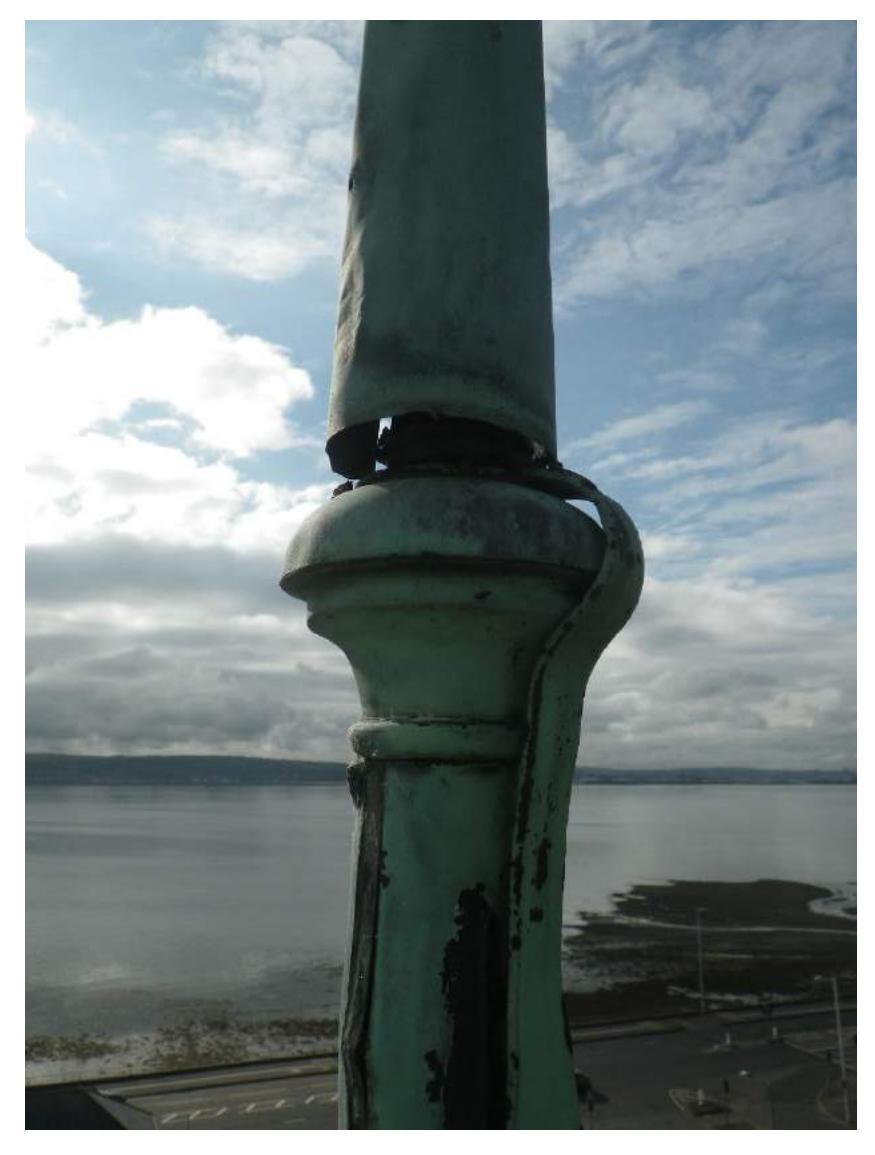
Sections of Copper Loose to Upper Reaches of Spike

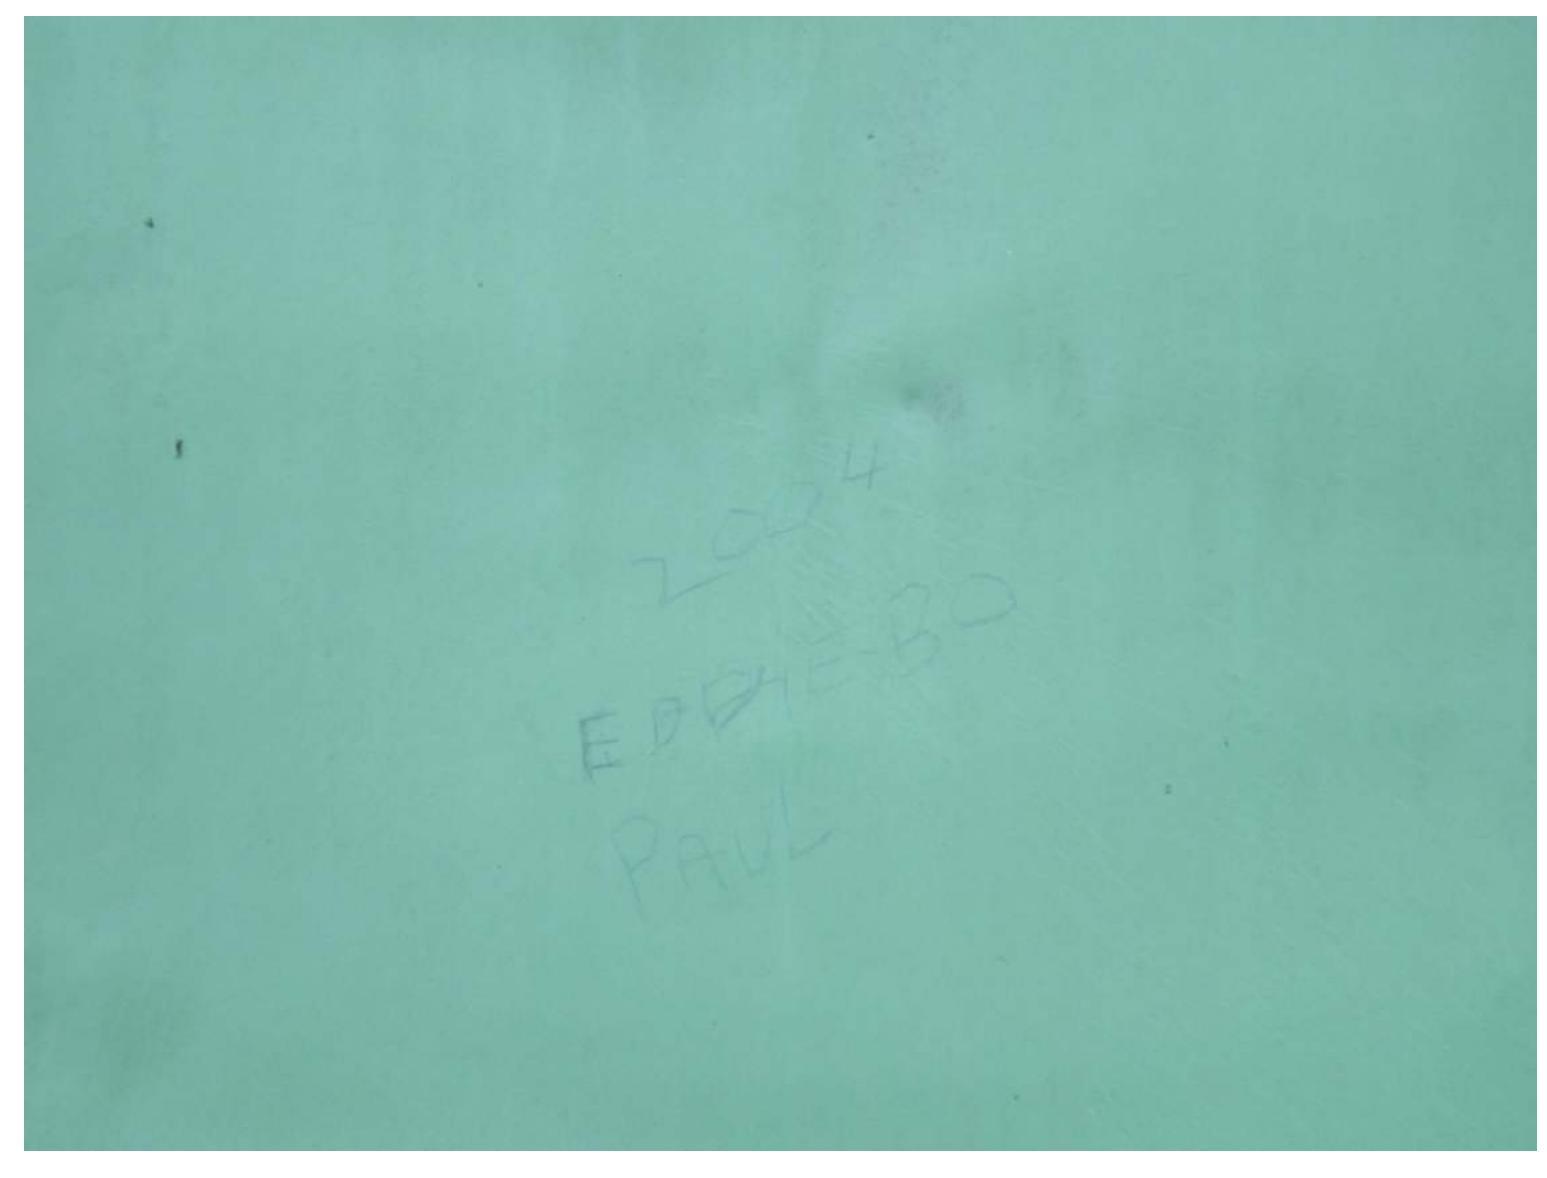
Copper Detailing Working Loose

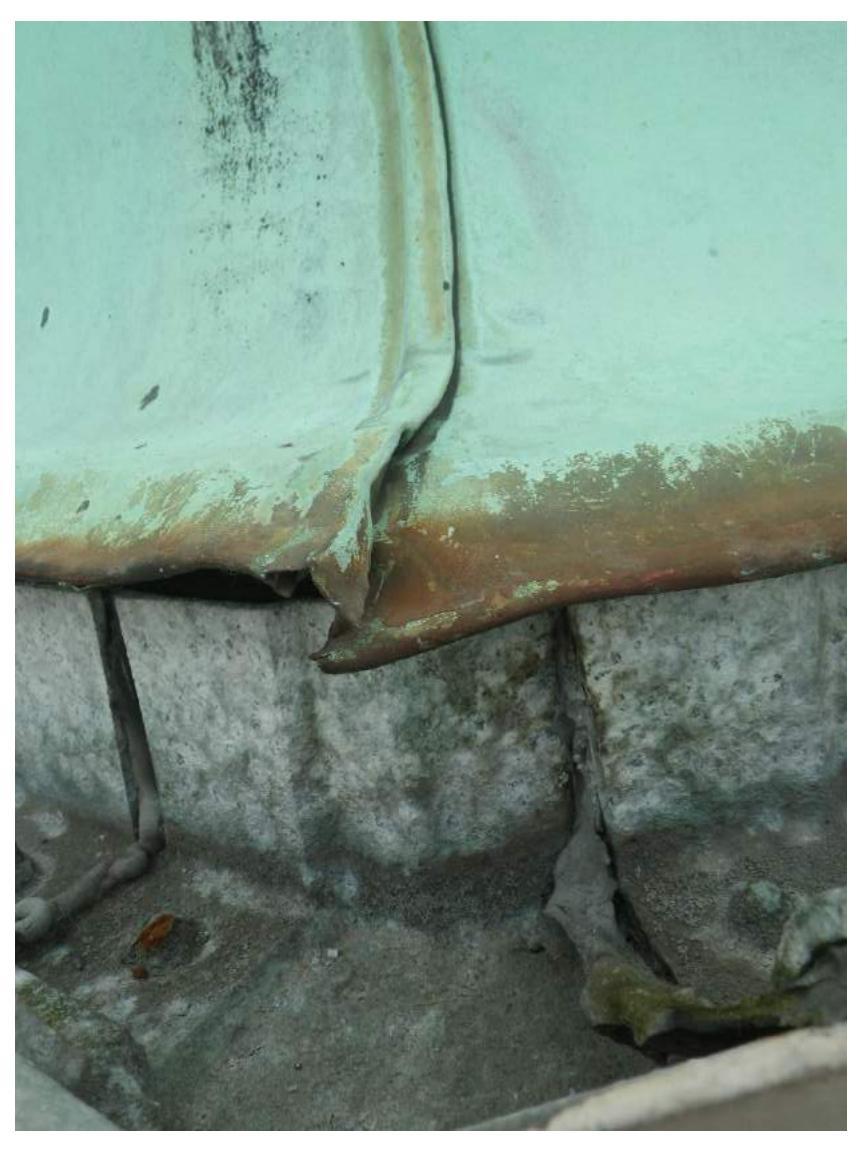
Past Repairs and Some Corrosion to the Base of the Copper Roof

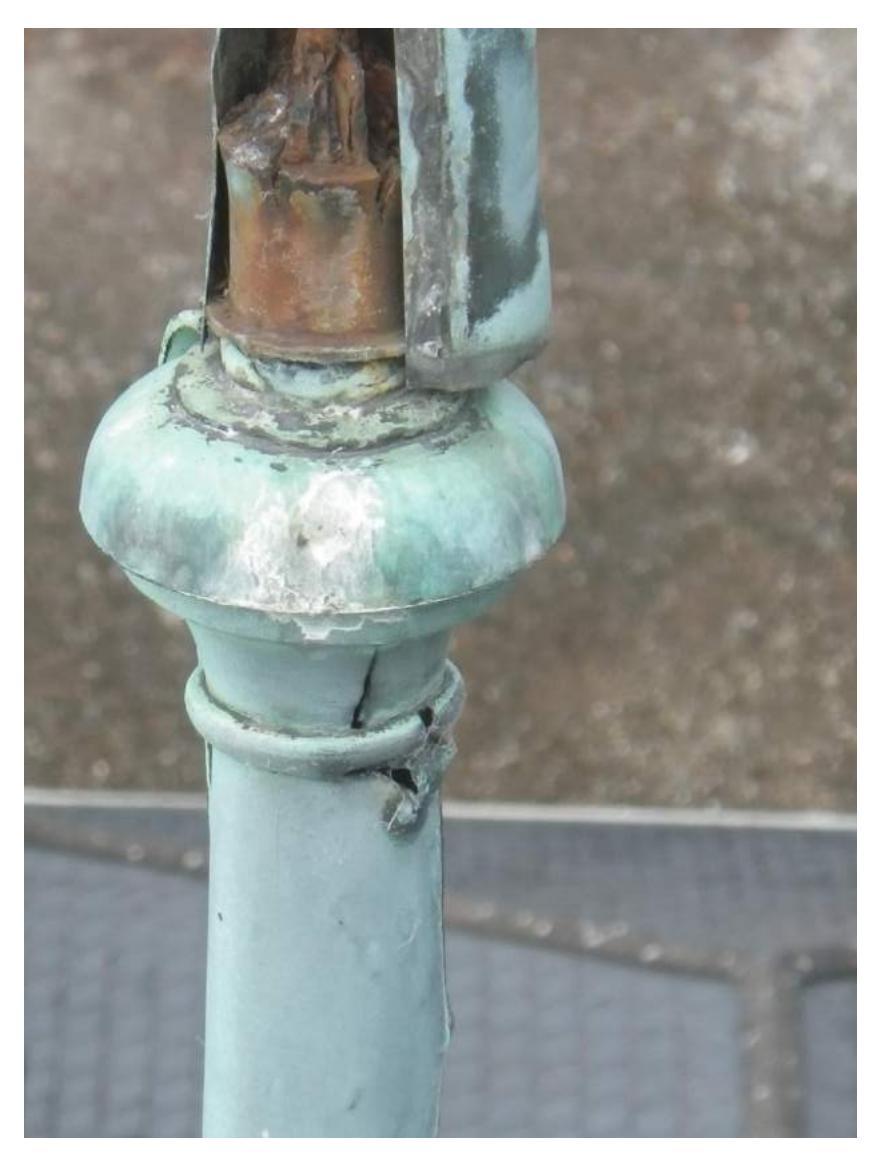
Failing Welted Detail to Base of Copper Roof

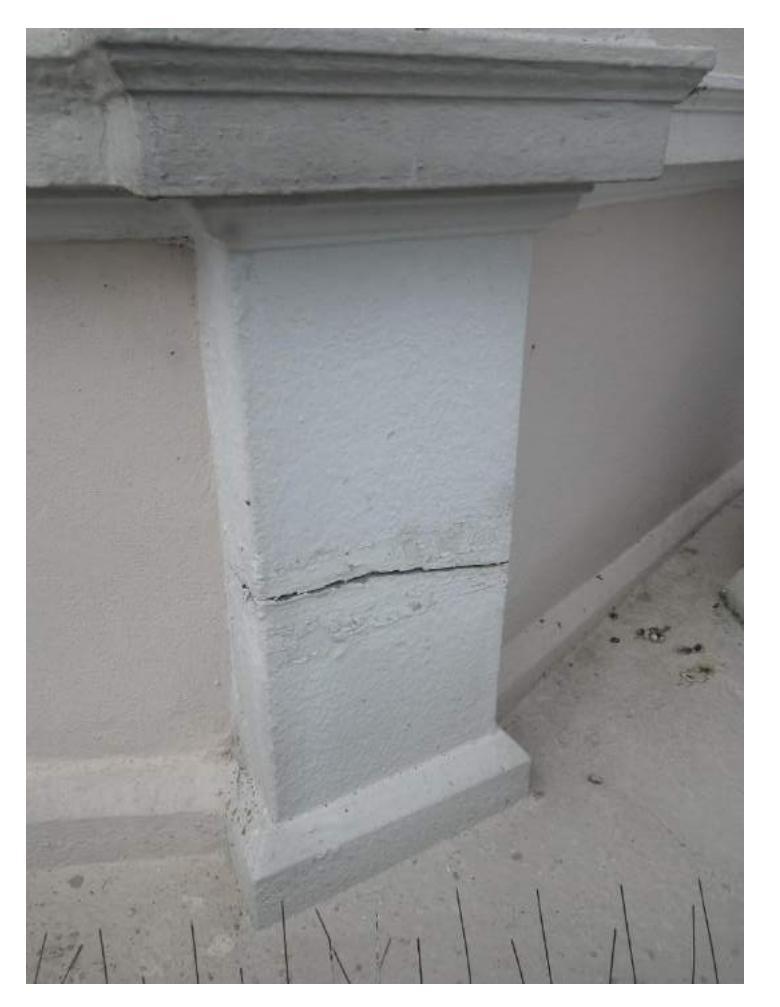
Horizontal Cracking to Bell Louvre Section of Tower

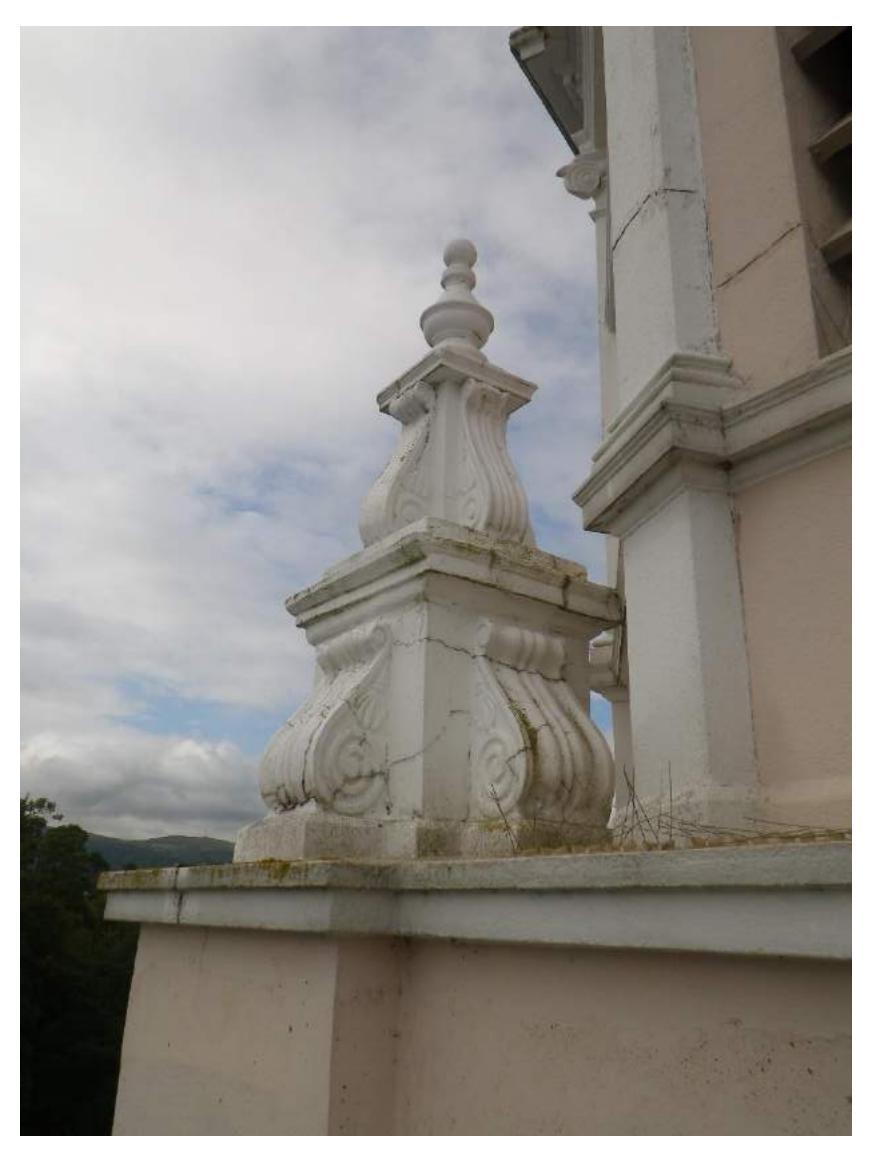
Further Cracking to Upper Reaches of Tower

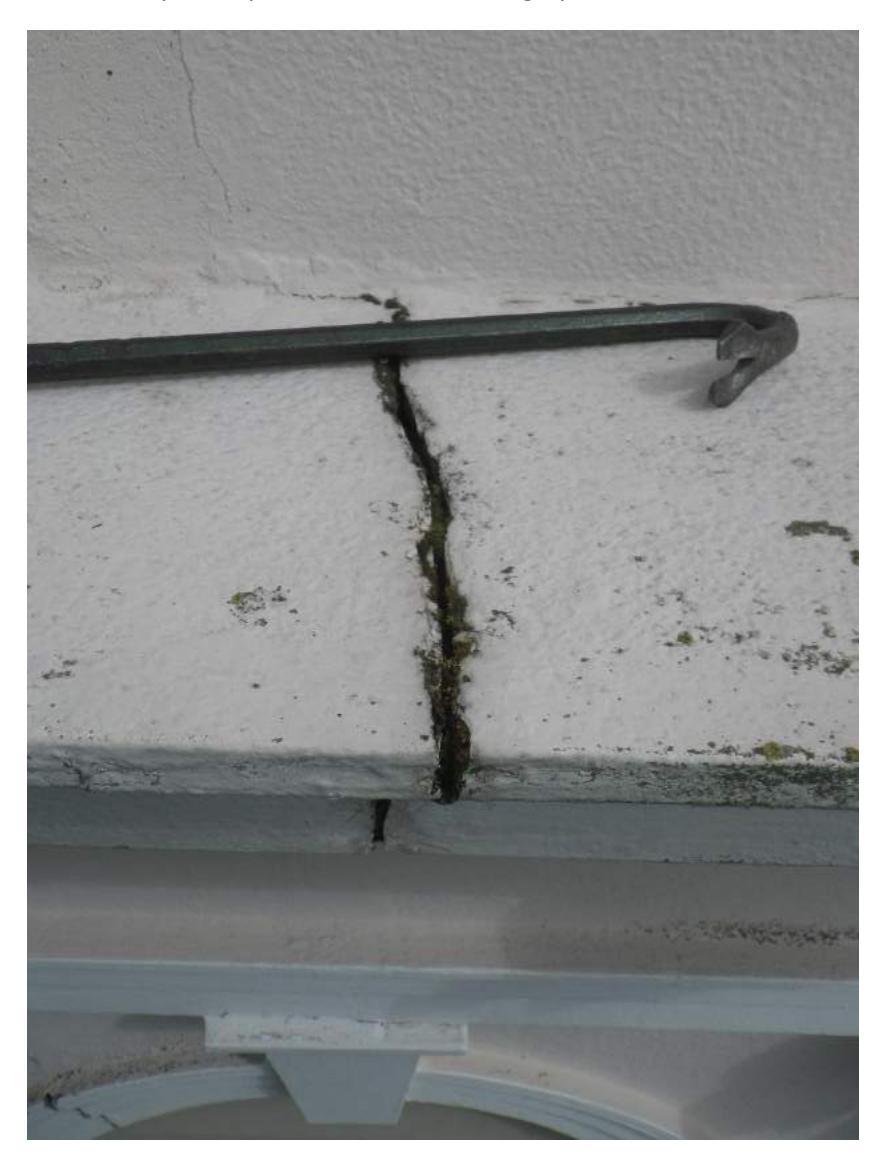
Prolonged Water Spilling Over Projections to Tower

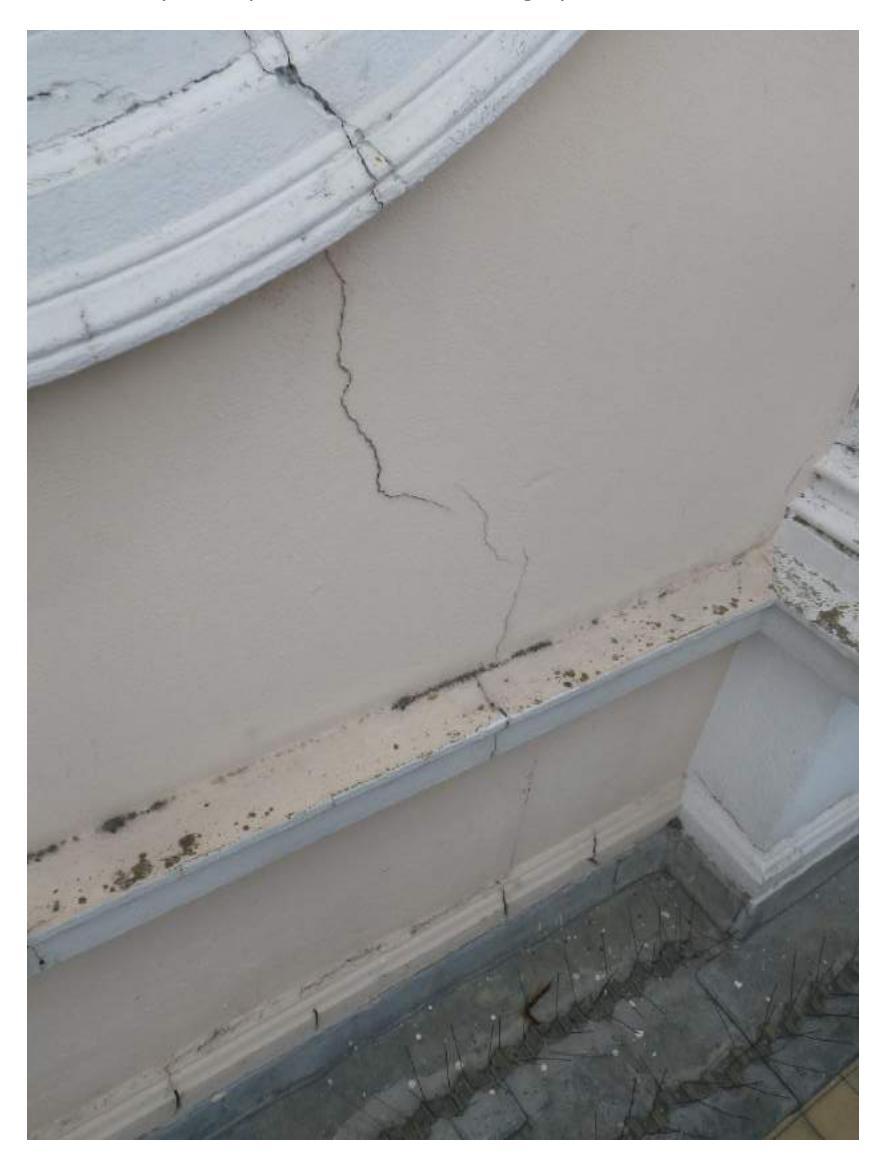
Cracking to Oculi Window Liners Front Elevation of Church

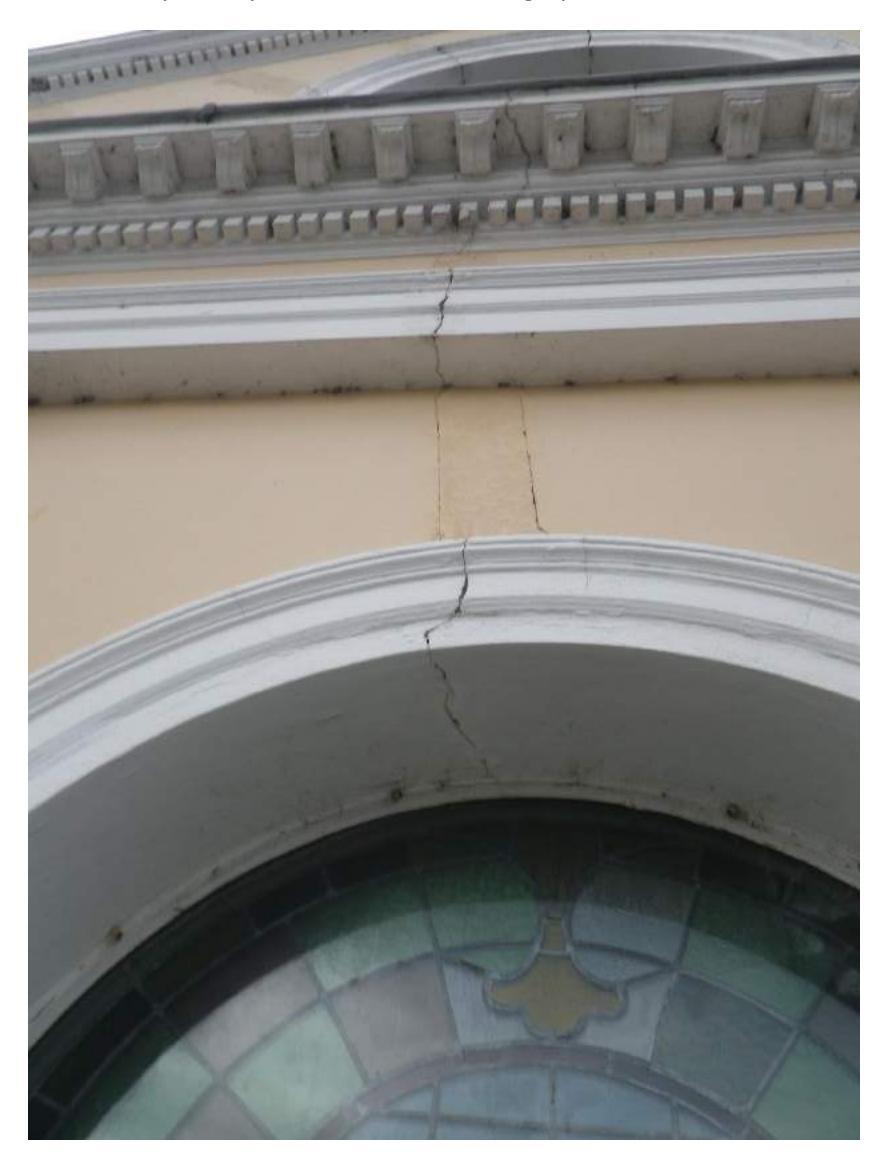
Cracking to Pilasters at Front Elevation of Church

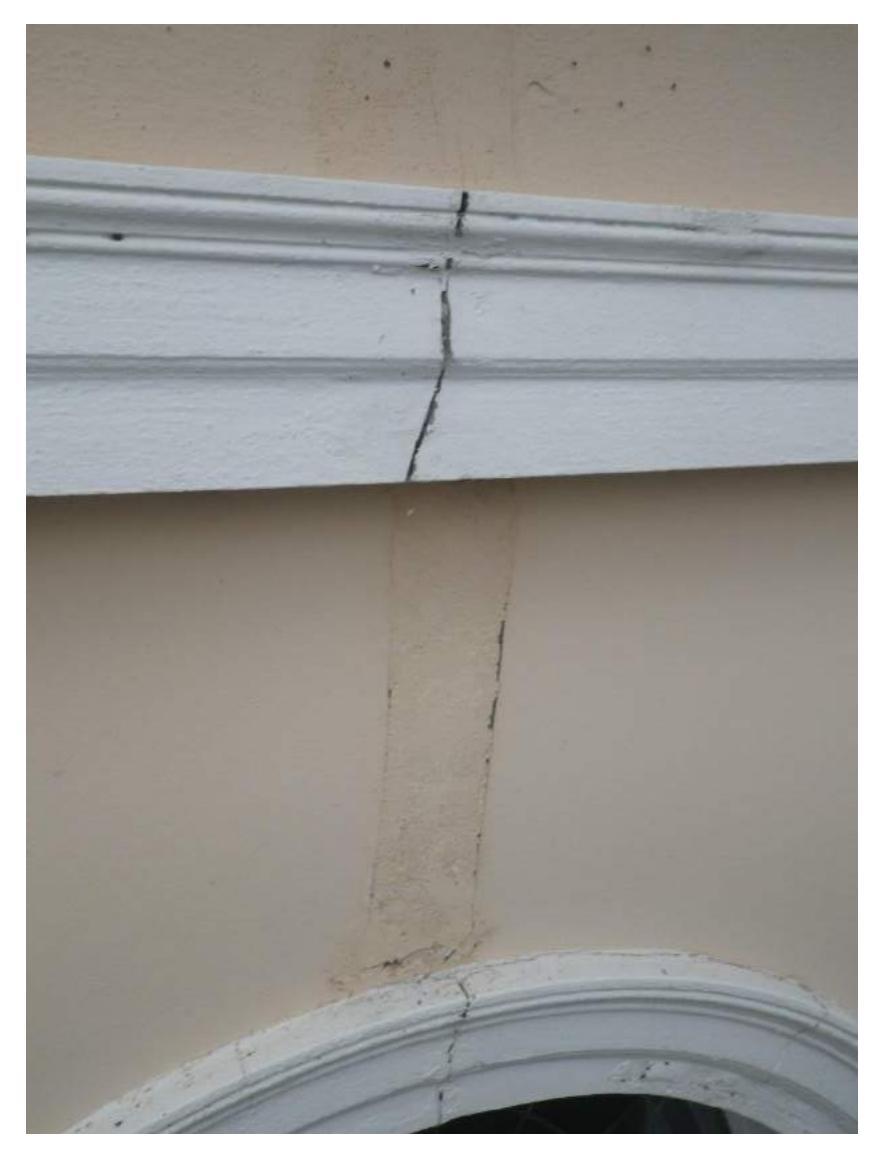
Typical Cracking to Front Elevation of Church

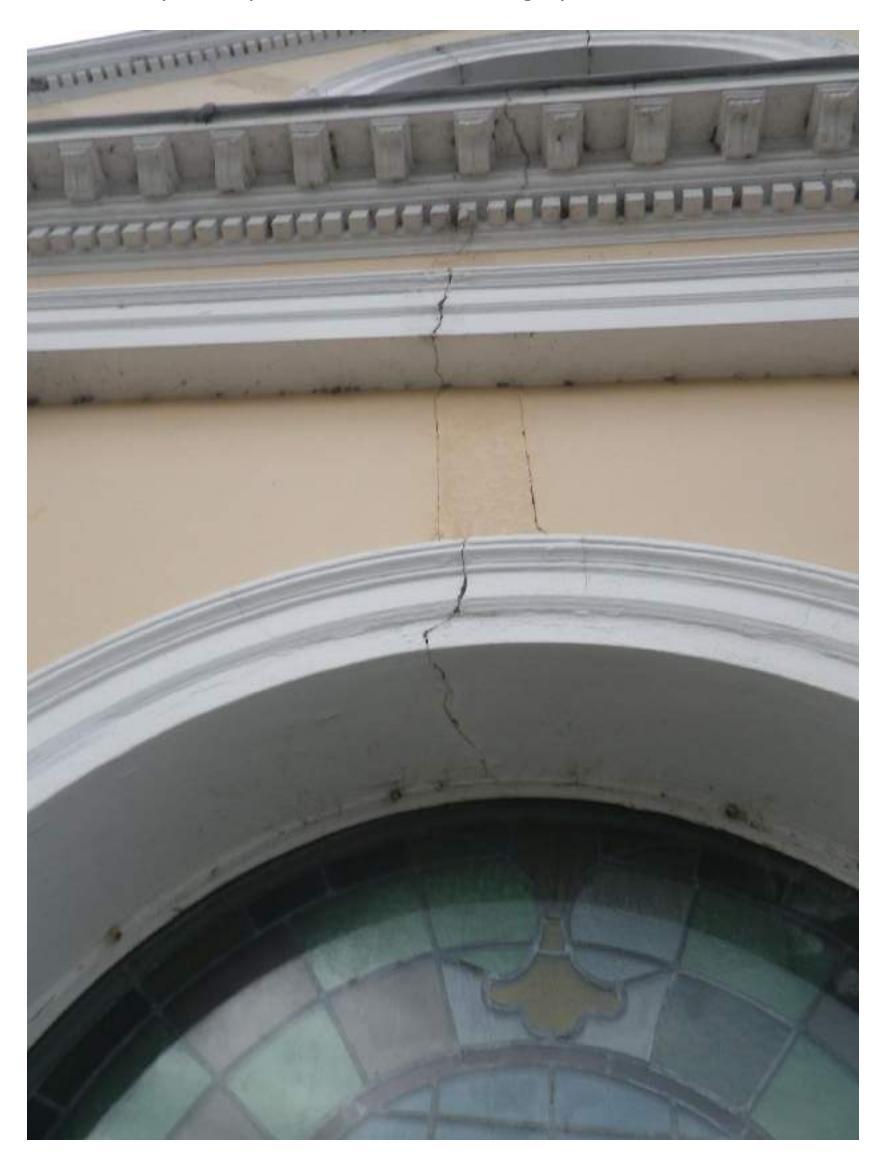
Cracking to Pilasters at Front Elevation of Church

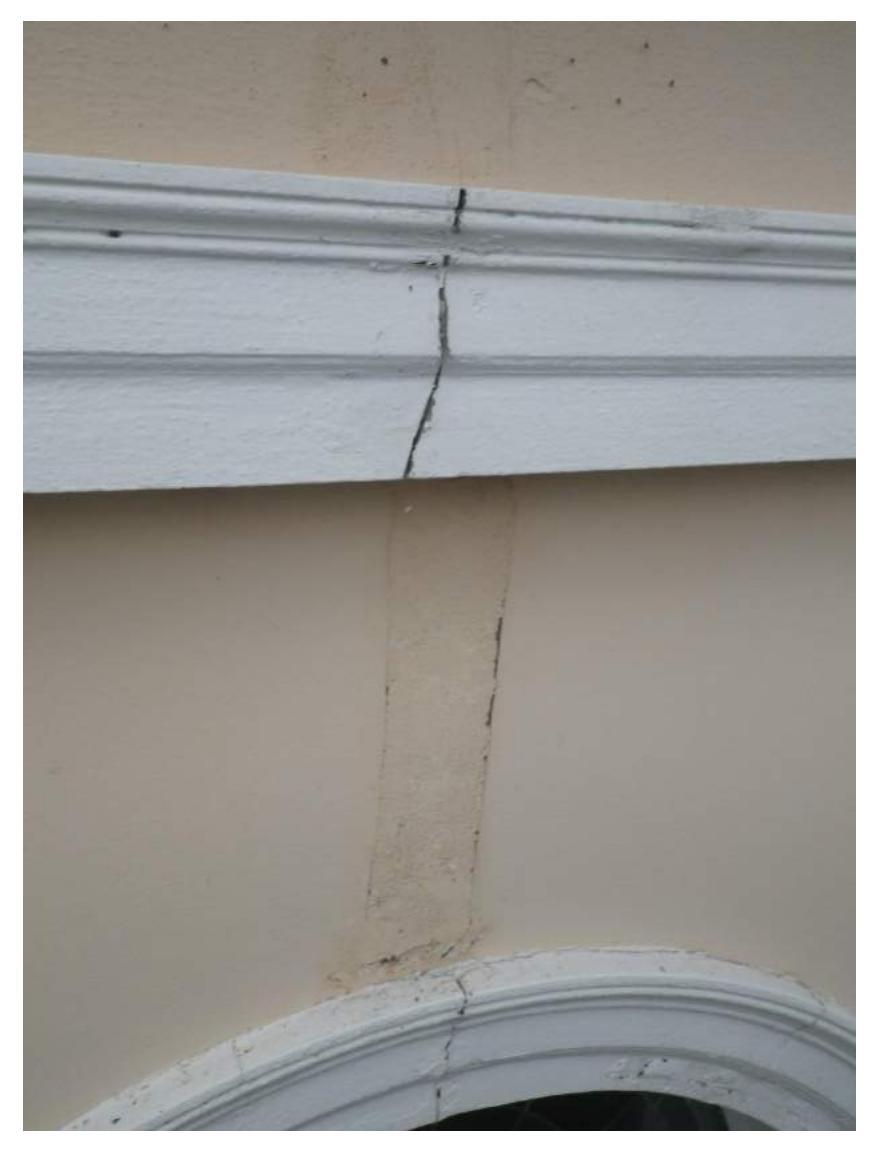
Typical Cracking to Front Elevation of Church

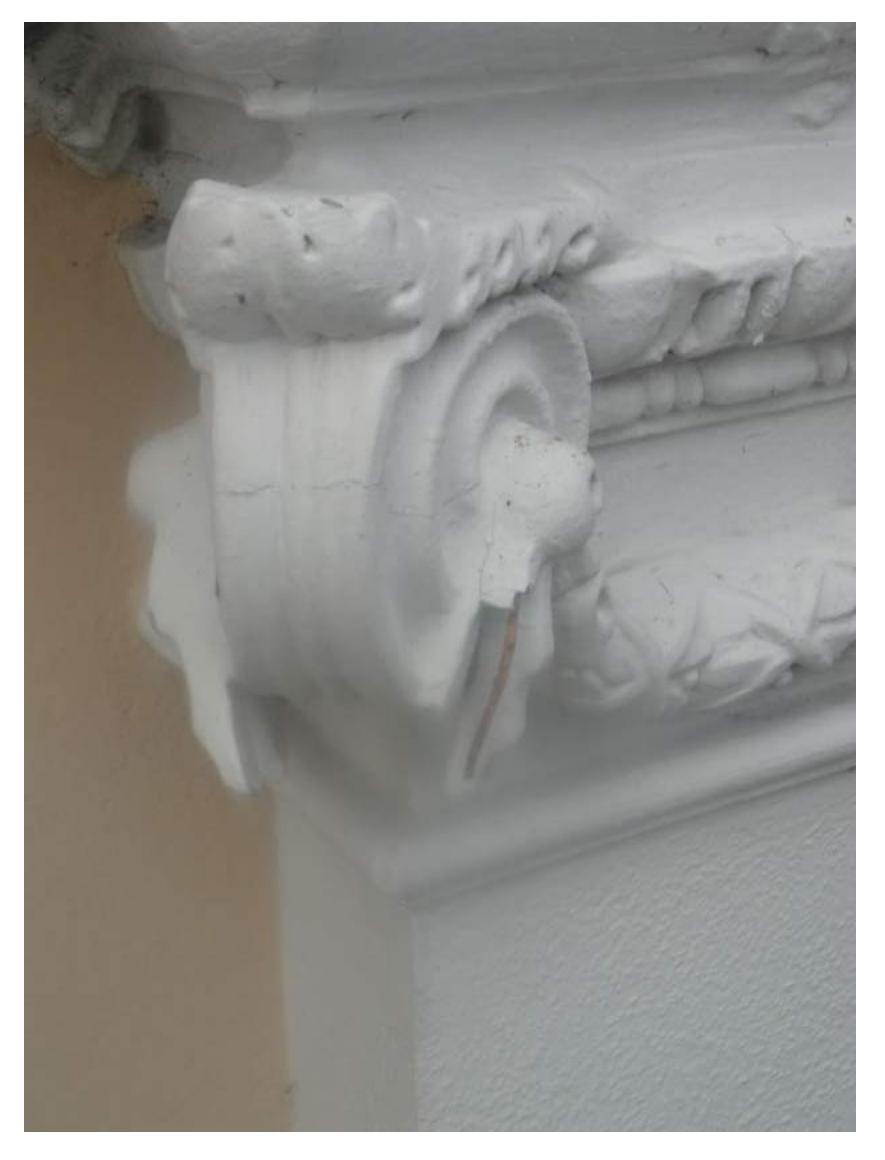
Previous Cracking Now Patched to Front Elevation of Church

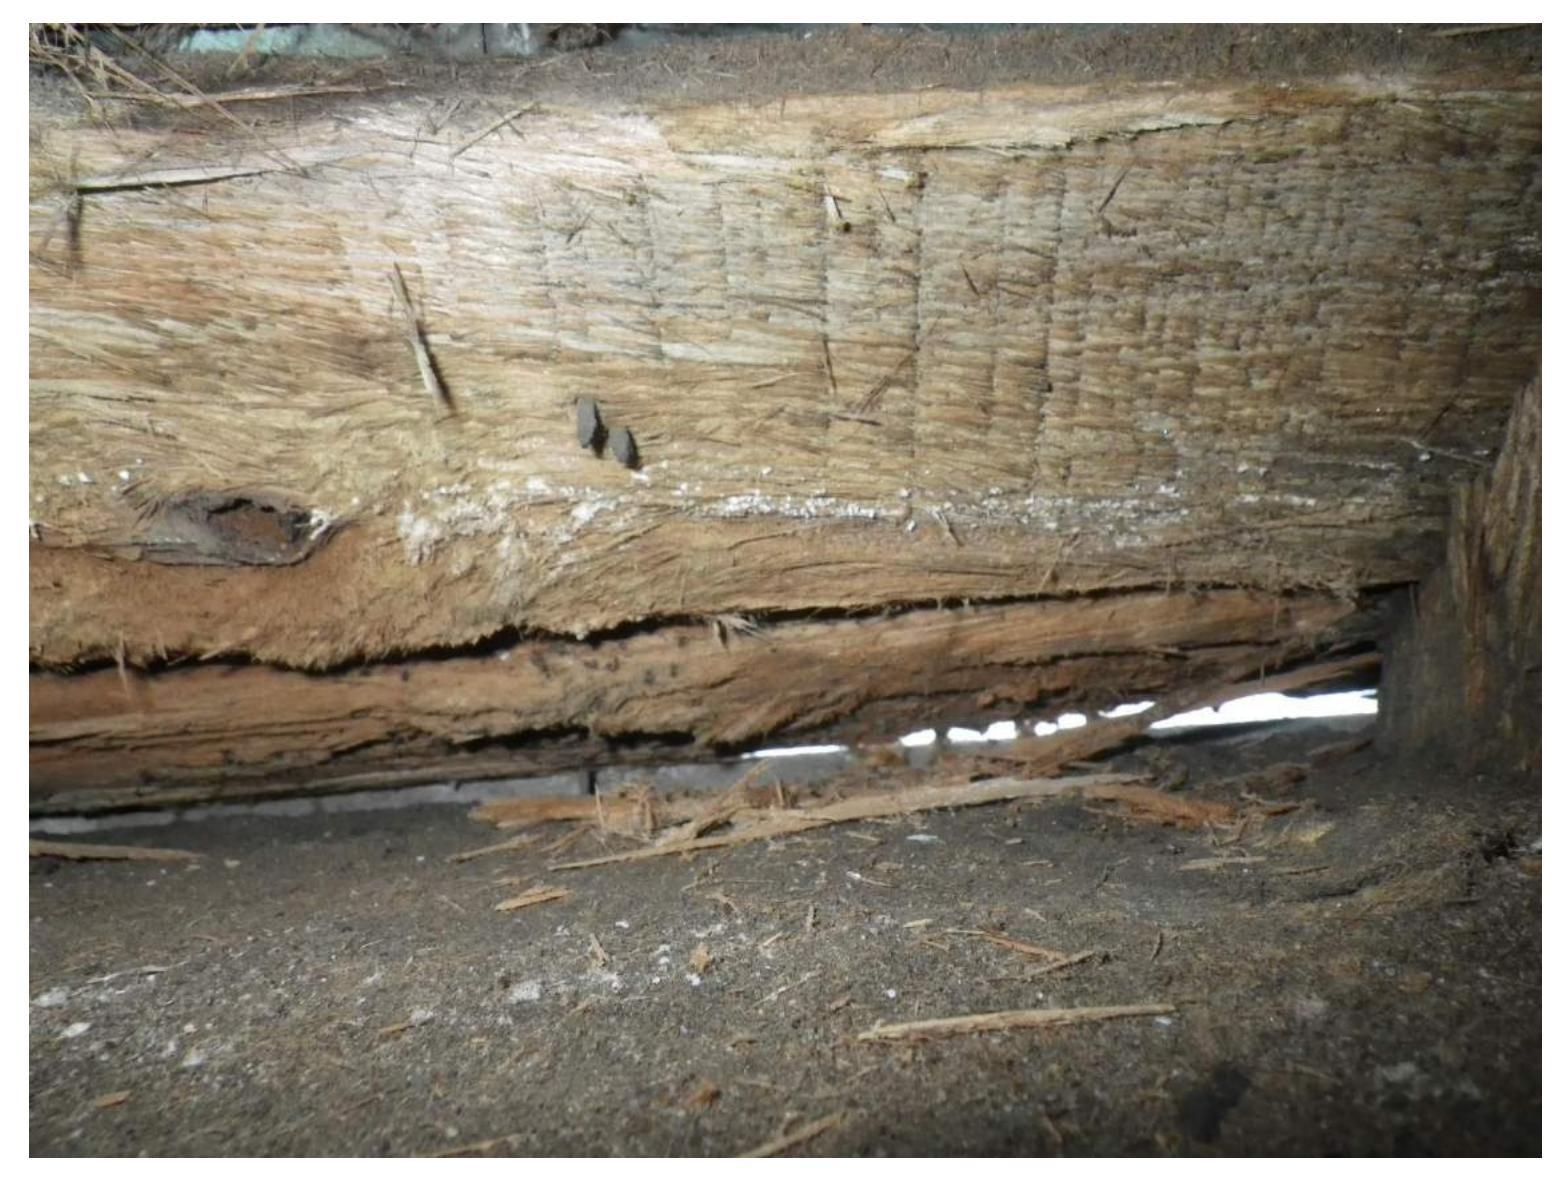
Softening Timbers at Base of Copper Roof Internally

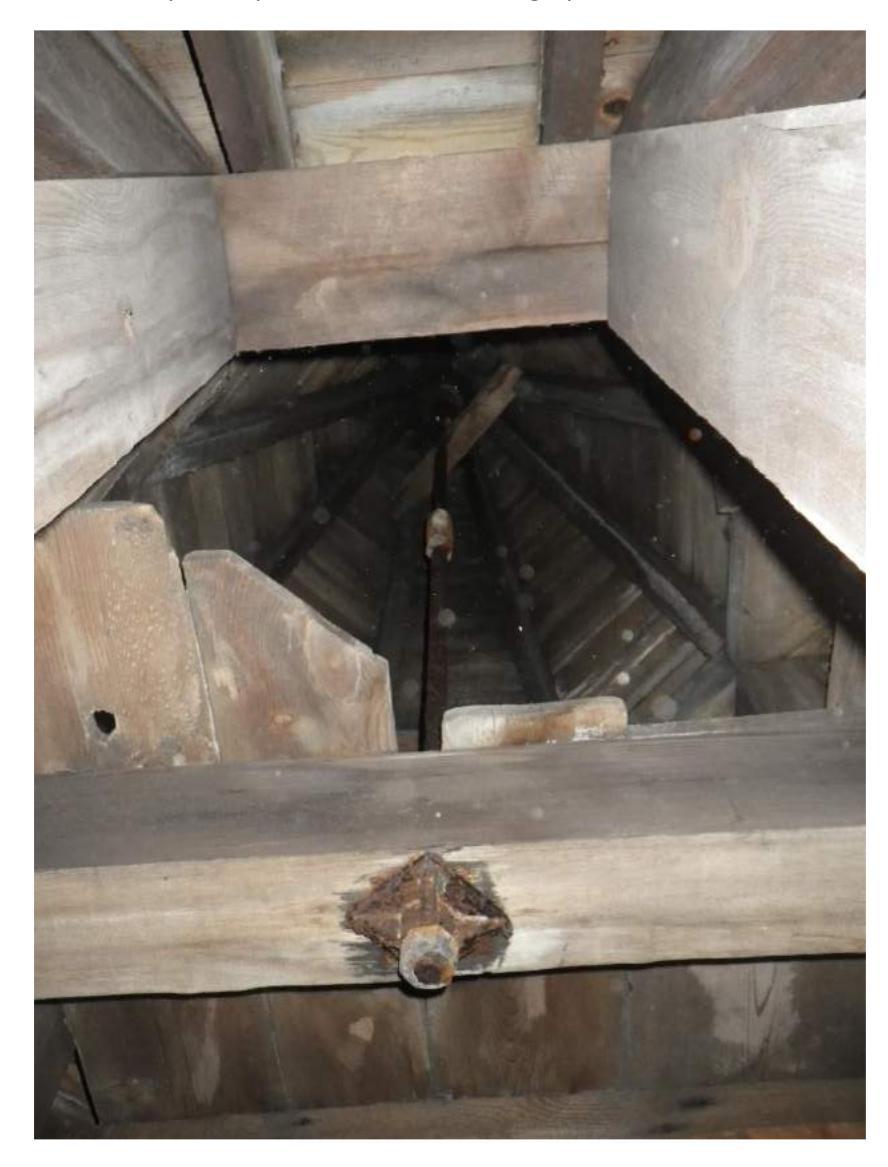
Softening Timbers at Base of Copper Roof with Driving Rain Penetrating

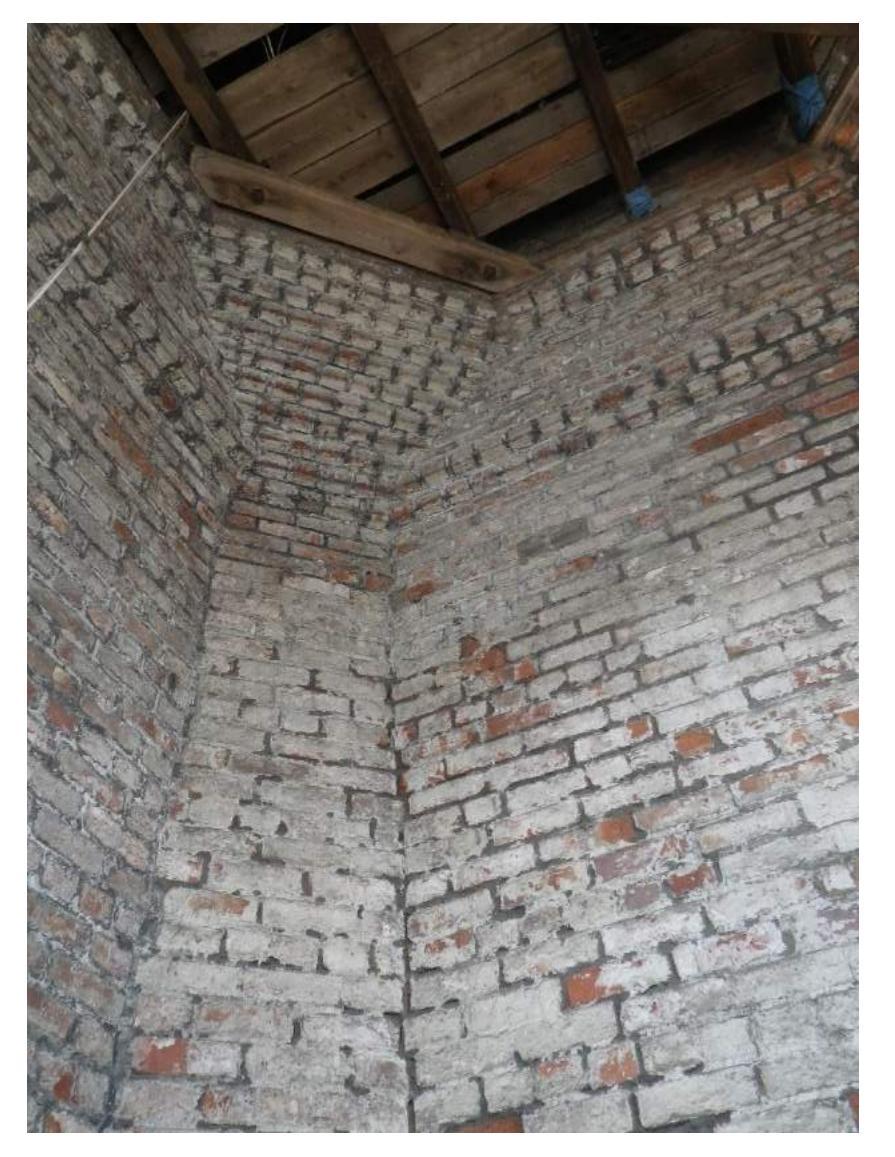
Penetrating Damp around Windows to Tower

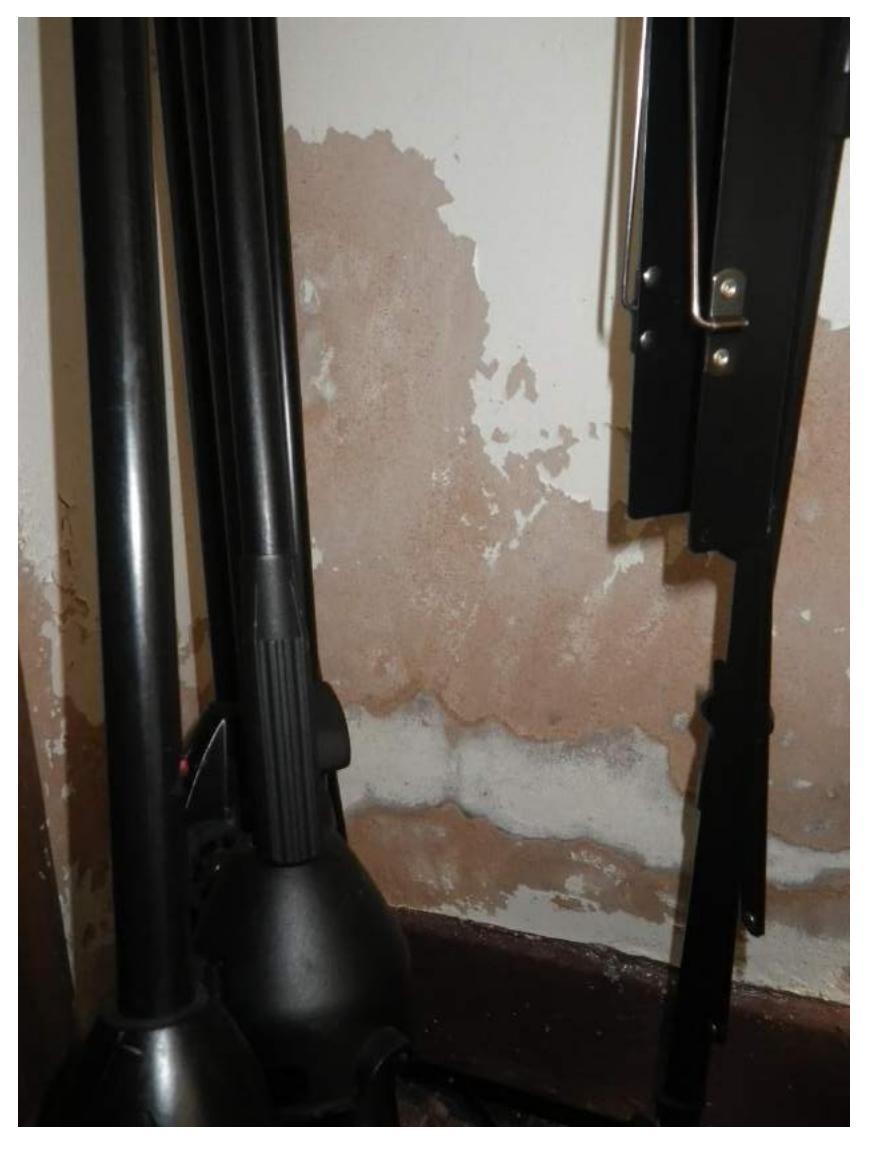
Dampness into South Transept

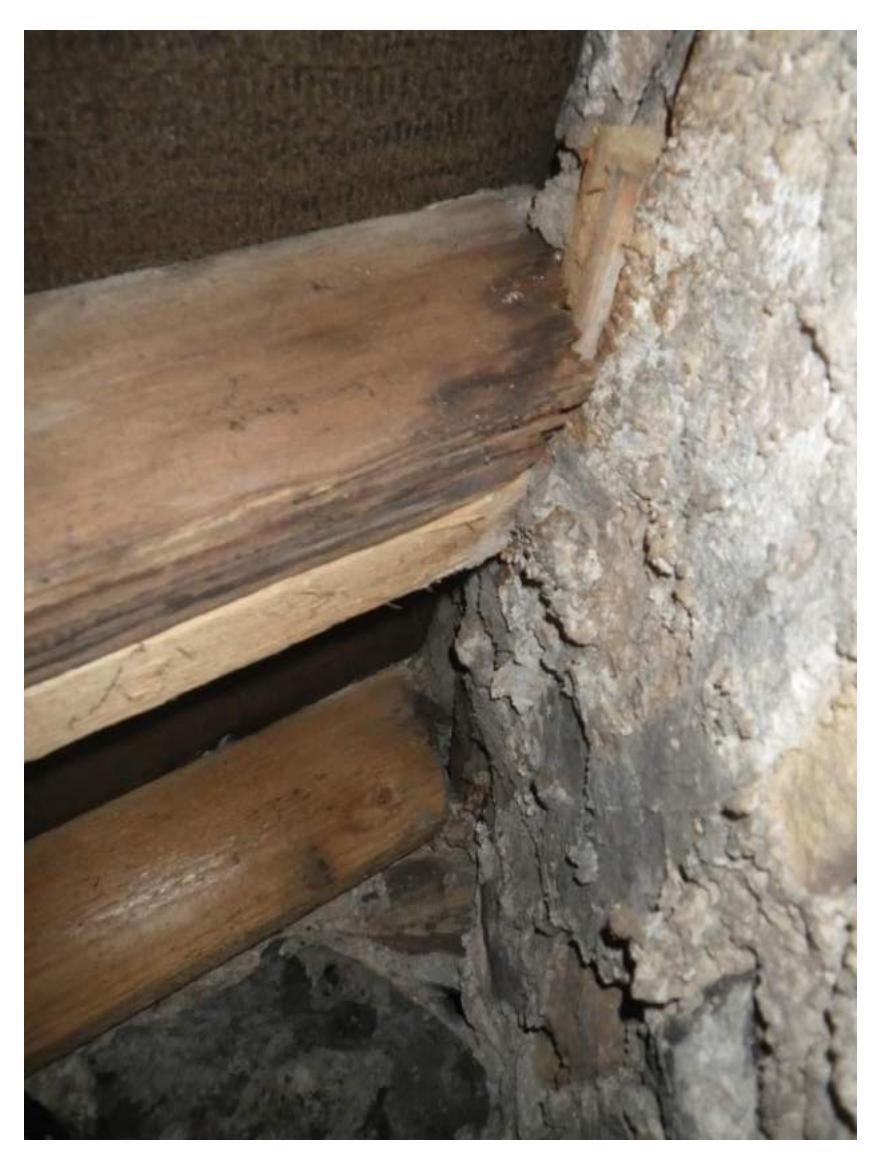
Dampness within Stores into South-west Corner

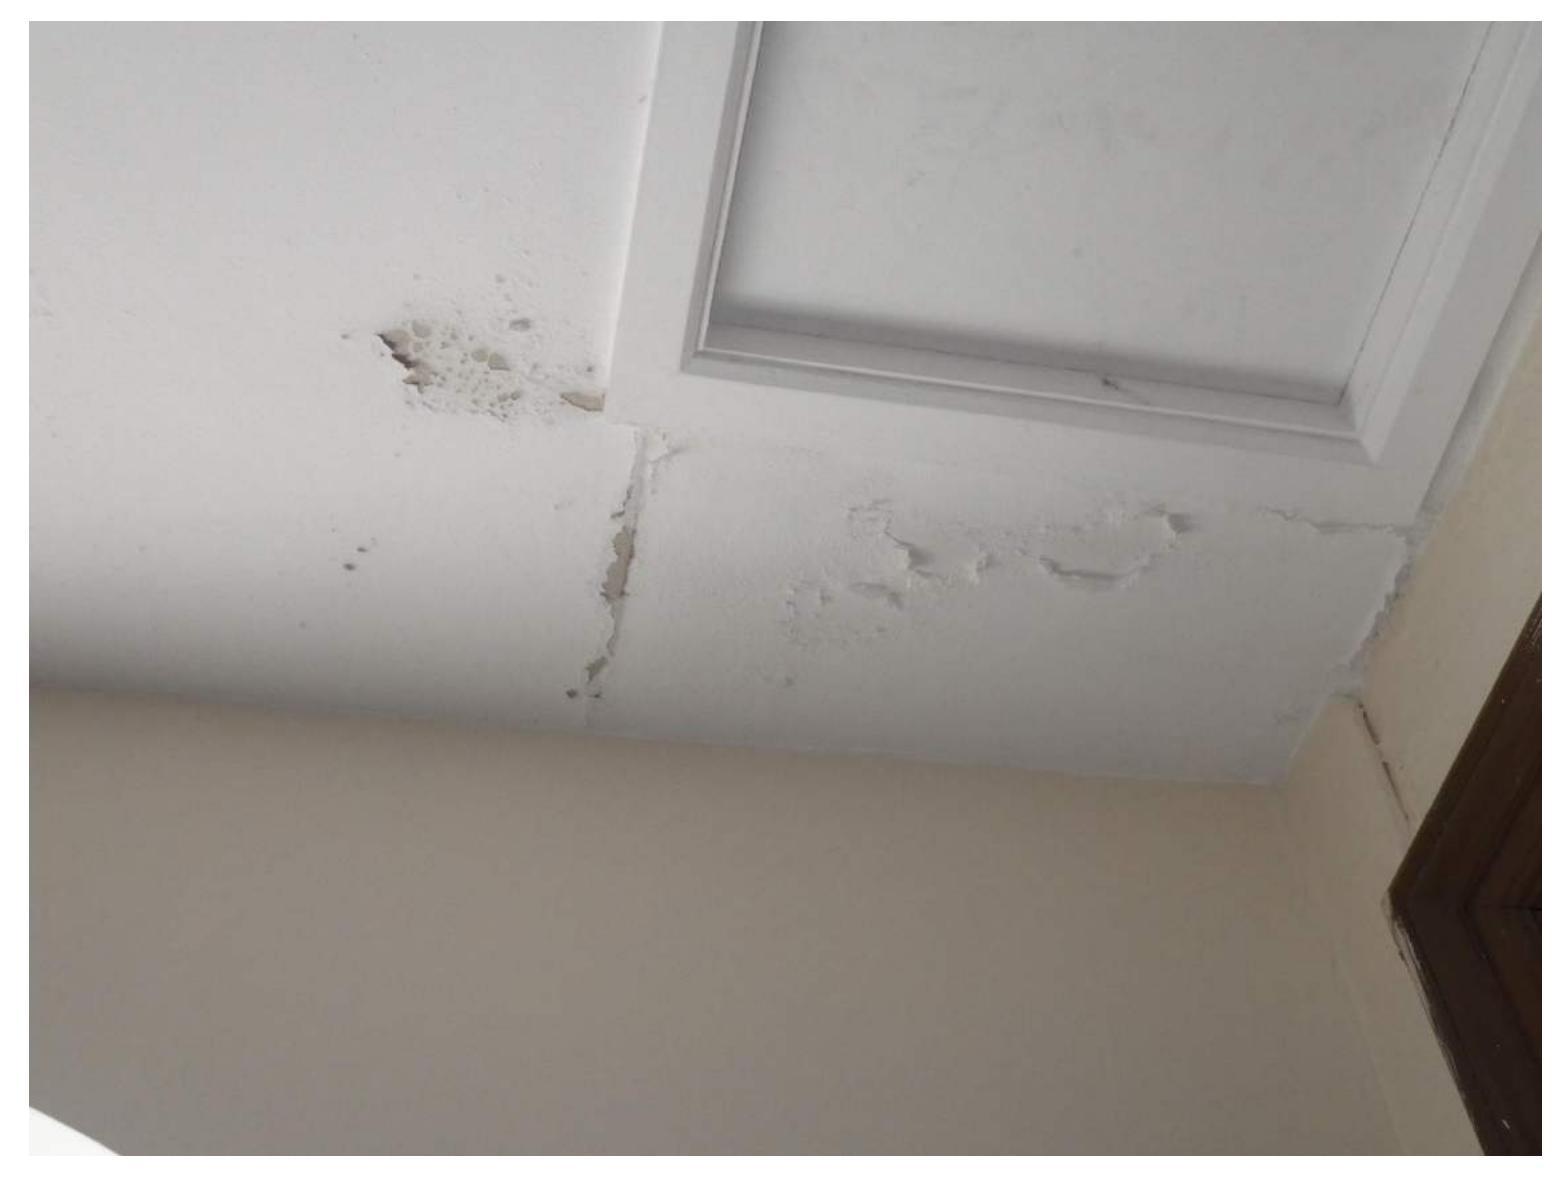
Penetrating Damp to Walls below Roof RS13
