Whiteabbey Presbyterian Church 602 Shore Road Newtownabbey

Detailed Condition Report (Church)

August 2022

McCOLLUM CONSERVATION

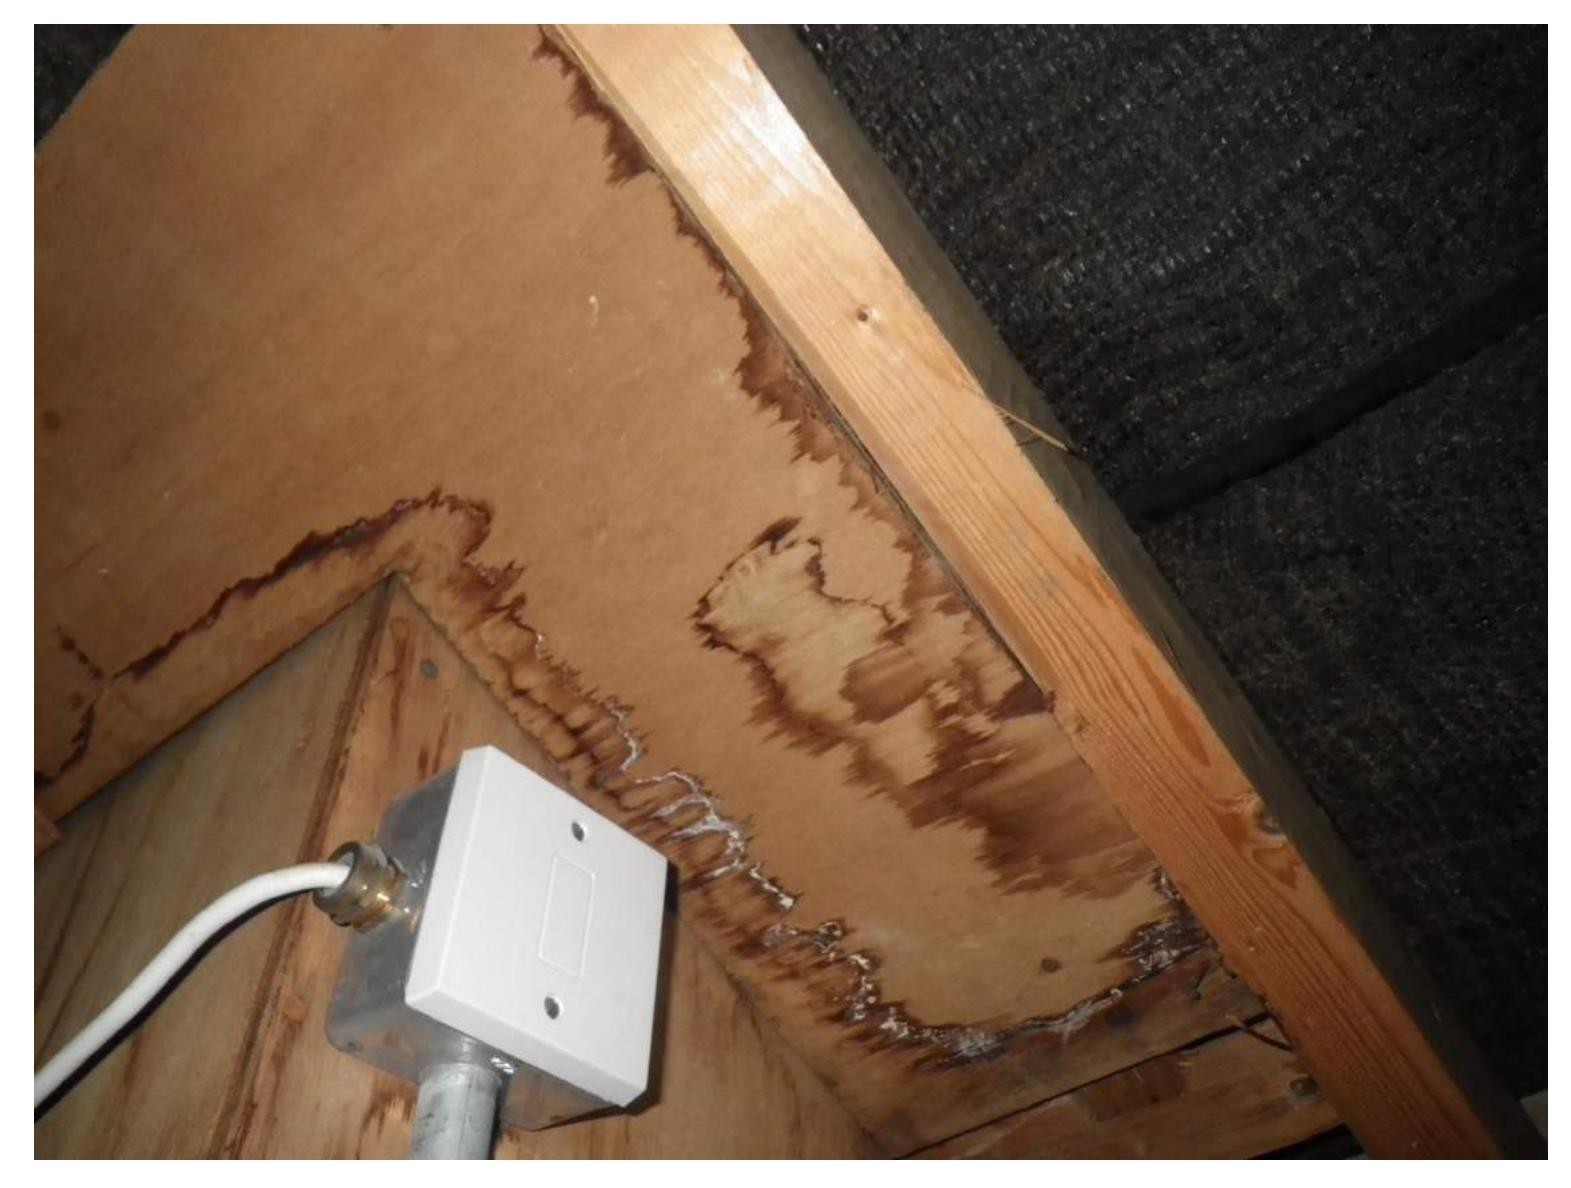
Dampness to Ceiling below Roof RS15

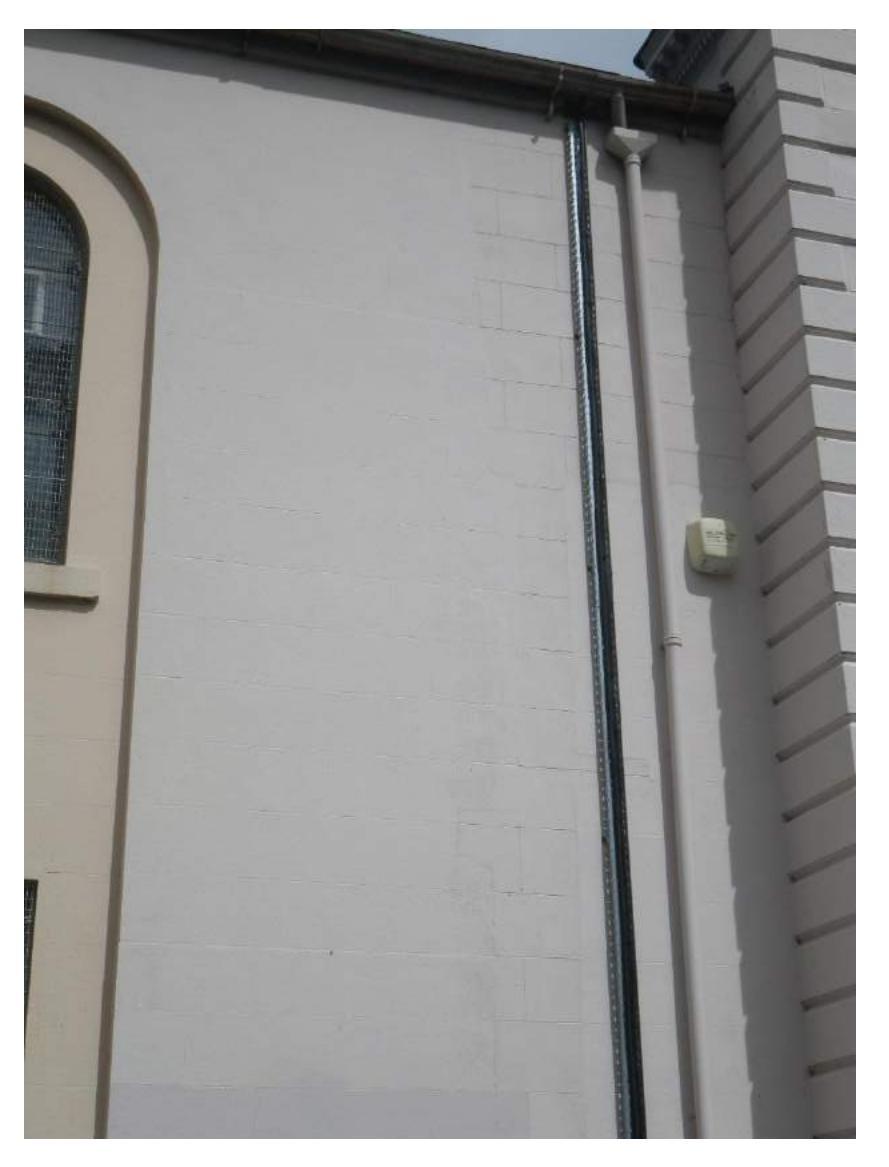
Evidence of Previous Repairs Main Church Render
